## Mortar Analysis Report: North Lodge, Heath House Prepared for: Donald Insall Associates

## Mortar / Plaster Analysis Report

| Site | Heath House, North Lodge |

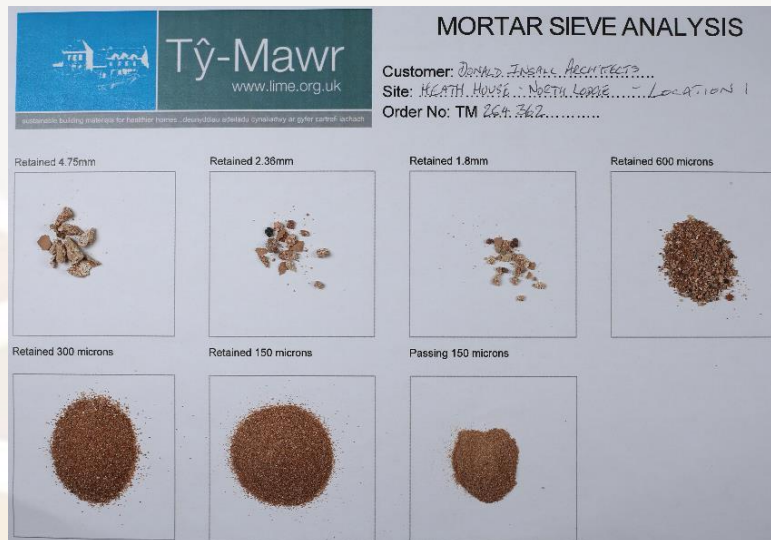
Sieve Analysis of Aggregate Particle Size

Dissolution of the sample material in acid resulted in a moderately active reaction, which started to slow down after 3 minutes, continuing to slow until ending after 8 minutes. There was clear evidence of incomplete dissolution in quite a number of the remaining particles.

The dissolution process removed 46% of the sample material, suggesting a mix ratio of 1.1:1 aggregate to binder, although incomplete dissolution will have skewed these figures.
