Anzio Camp, Leek

Ecological Assessment, Update Report

SLR Ref: 421-04017-00001

May 2012

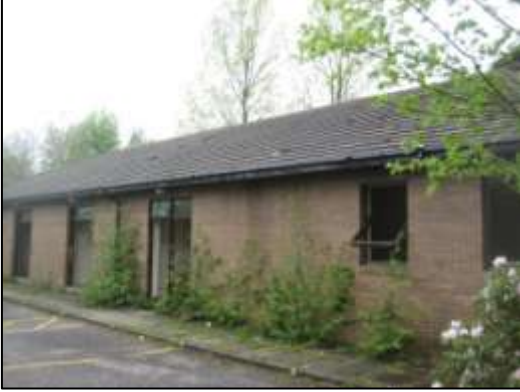
Building B1 Moderate Potential

<p>Description:</p> <p>A single storey brick building with a double pitch clay tile roof. The windows and doors are open. The brickwork is in good condition with no cracks, crevices or eroded mortar joints. The roof is of modern construction with a bitumastic membrane beneath the tiles.</p> <p>Potential Roosting Features:</p> <ul style="list-style-type: none">- Slipped and broken roofing tiles <p>Evidence of Bat Activity in 2012:</p> <ul style="list-style-type: none">- None

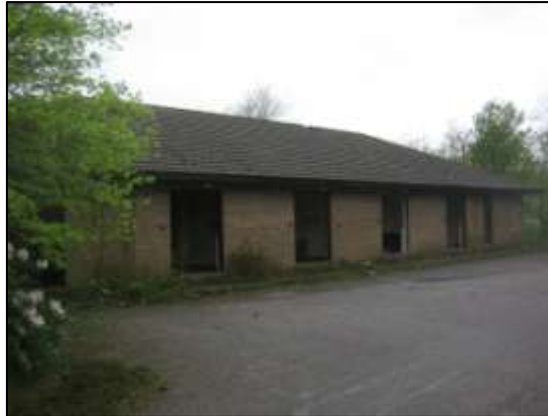
Building B2

**Moderate
Potential**

A single storey brick building with a double pitch clay tile roof. The windows and doors are open. The brickwork is in good condition with no cracks, crevices or eroded mortar joints. The roof is of modern construction with a bitumastic membrane beneath the tiles.

Potential Roosting Features:

- Slipped and broken roofing tiles
- Holes into soffit box

- None
-

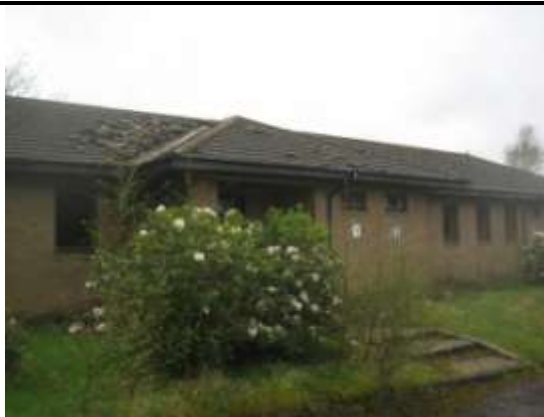
Building B3

**Moderate
Potential**

A single storey brick building with a double pitch clay tile roof. The windows and doors are open. The brickwork is in good condition with no cracks, crevices or eroded mortar joints. The roof is of modern construction with a bitumastic membrane beneath the tiles. An Internal inspection was not possible due to health and safety considerations

- Slipped and broken roofing tiles
- Holes into soffit box

- None
-

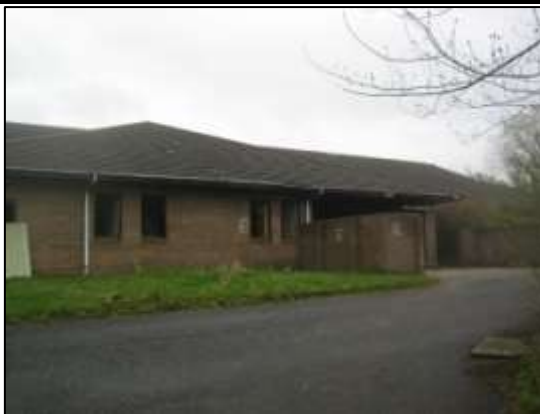
Building B4

**Moderate/High
Potential**

A single storey brick building with a double pitch clay tile roof. The windows and doors are open. The brickwork is in good condition with no cracks, crevices or eroded mortar joints. The roof is of modern construction with a bitumastic membrane beneath the tiles. An Internal inspection was not possible due to health and safety considerations

- Slipped and broken roofing tiles
- Gaps into soffit box
- Holes into cavity wall

- None
-

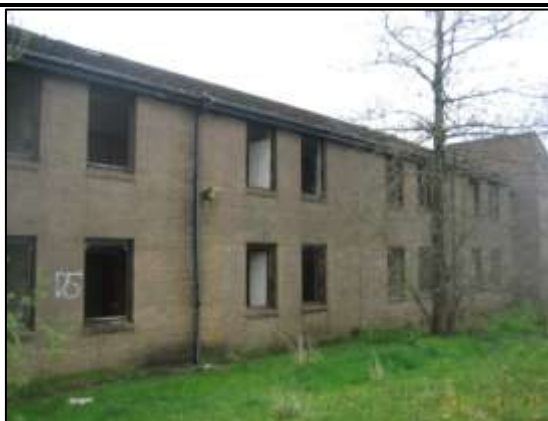
Building B5

**Moderate /
High Potential**

**Confirmed
Roost in 2006**

A two storey brick building with a multiple pitched clay tile roof. The brickwork is in good condition; though the roof has been broken open in many locations. The roof is of modern construction with a bitumastic membrane beneath the tiles. An Internal inspection was not possible due to health and safety considerations

- Slipped and broken roofing tiles
- Gaps into soffit box
- Some lead flashing remains on the eastern aspect

- None
-

Due to the damage to the buildings on the site it is likely that the majority of the roosts recorded in 2006, located within buildings B5, B6, B7, B8, B10 and B12 are no longer present. This is supported by the current findings from the bat surveys already carried out. Based on these findings it is recommended that mitigation for bats should be tailored for the bat assemblage identified in the 2006 bat survey.

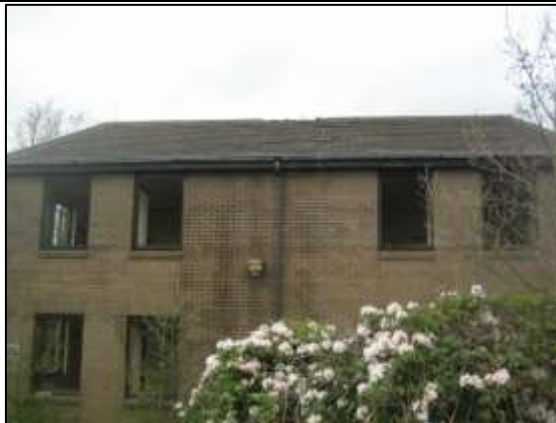
Building B6

**Moderate
Potential**

**Confirmed
roost in 2006**

A two storey brick building with a multiple pitched clay tile roof. The brickwork is in good condition; though the roof has been broken open in many locations. The roof is of modern construction with a bitumastic membrane beneath the tiles. An Internal inspection was not possible due to health and safety considerations

- Slipped and broken roofing tiles
- Gaps into soffit box

- None
-

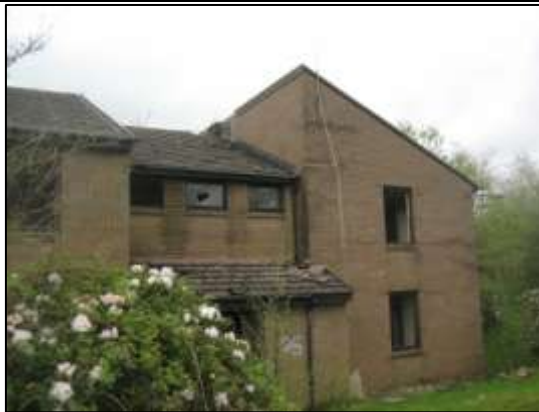
Building B7

**Moderate
Potential**

**Confirmed
roost in 2006**

A two storey brick building with a multiple pitched clay tile roof. The brickwork is in good condition; though the roof has been broken open in many locations. The roof is of modern construction with a bitumastic membrane beneath the tiles. An Internal inspection was not possible due to health and safety considerations

- Slipped and broken roofing tiles

- None
-

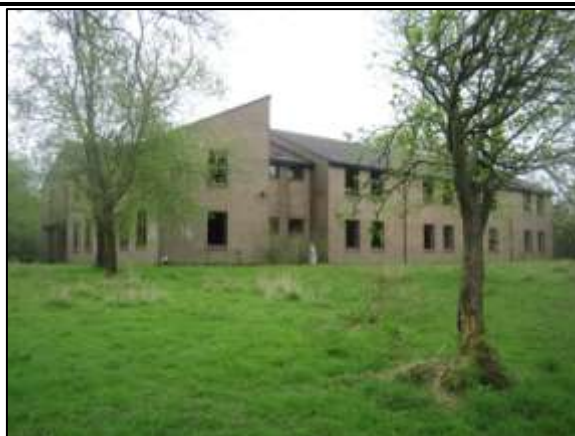
Building B8

**Moderate
Potential**

**Confirmed
Roost in 2006**

A two storey brick building with a multiple pitched clay tile roof. The brickwork is in good condition; though the roof has been broken open in many locations. The roof is of modern construction with a bitumastic membrane beneath the tiles. An Internal inspection was not possible due to health and safety considerations

- Slipped and broken roofing tiles

- None
-

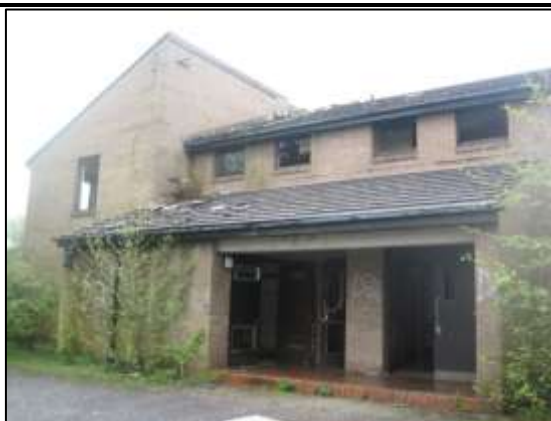
Building B9

**Moderate
Potential**

A two storey brick building with a multiple pitched clay tile roof. The brickwork is in good condition; though the roof has been broken open in many locations. The roof is of modern construction with a bitumastic membrane beneath the tiles. An Internal inspection was not possible due to health and safety considerations

- Slipped and broken roofing tiles

- None
-

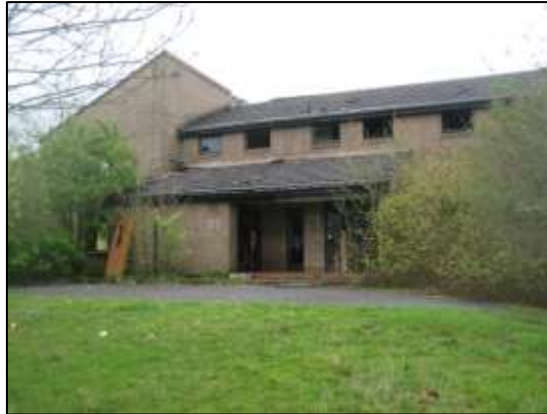
Building B10

**Moderate
Potential**

**Confirmed
roost in 2006**

A two storey brick building with a multiple pitched clay tile roof. The brickwork is in good condition; though the roof has been broken open in many locations. The roof is of modern construction with a bitumastic membrane beneath the tiles. An Internal inspection was not possible due to health and safety considerations

- Slipped and broken roofing tiles

- None
-

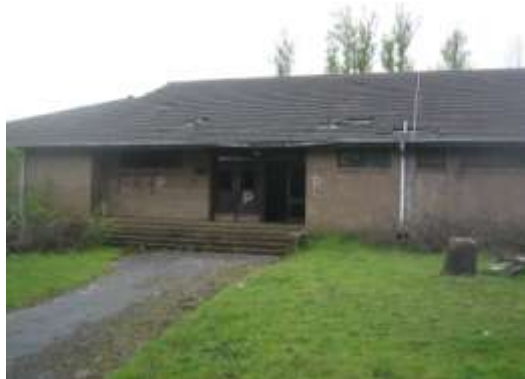
Building B11

**Moderate
Potential**

A one and two storey brick building with a single pitched clay tile roof. The brickwork is in good condition; though the roof has been broken open in many locations. The roof is of modern construction with a bitumastic membrane beneath the tiles. An Internal inspection was not possible due to health and safety considerations.

- Slipped and broken roofing tiles

- None
-

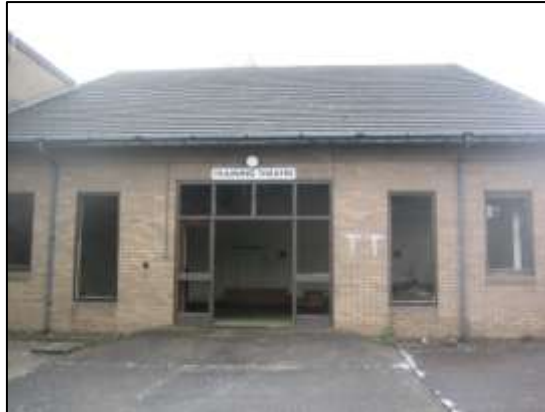
Building B12

**Confirmed
roost in 2012**

**Confirmed
maternity
roost in 2006**

A single storey brick building with a multiple pitched clay tile roof. The brickwork is in good condition; though the roof has been broken open in many locations. The roof is of modern construction with a bitumastic membrane beneath the tiles. The roof is of modern construction with metal beams and wooden joists, light levels were high, and the roof void was cool and drafty due to the number of holes in the roof.

- Slipped and broken roofing tiles
- Wooden soffit box on northern aspect

- Two droppings consistent with common pipistrelle were found in the roof void. The droppings appeared quite old.
-

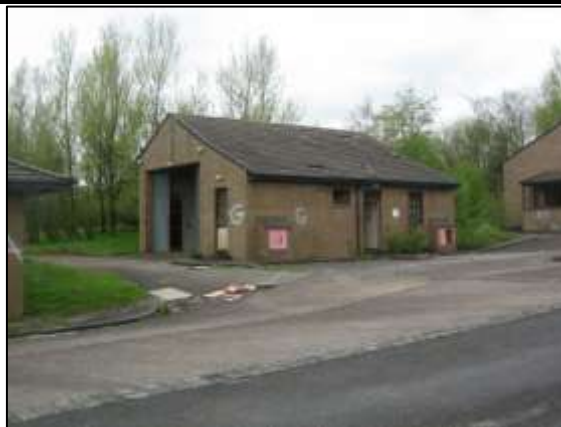
Building B13

**Moderate
Potential**

A single storey brick building with a single pitched clay tile roof. The brickwork is in good condition; though the roof has been broken open in many locations. The roof is of modern construction with a bitumastic membrane beneath the tiles. The roof void was cluttered with numerous wooden joists and metal beams, light levels were high and the roof void was cool and drafty.

- Slipped and broken roofing tiles

- None
-

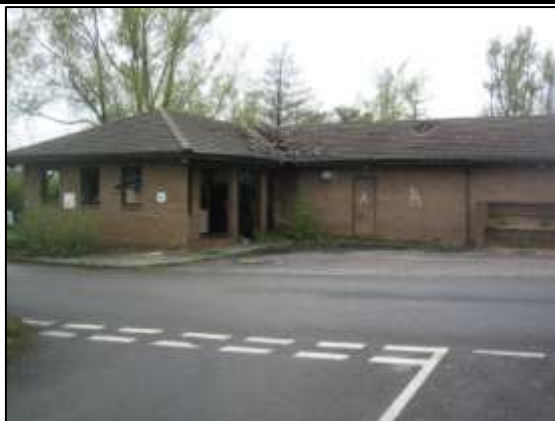
Building B14

**Moderate
potential**

A single storey brick building with a multiple pitched clay tile roof. The brickwork is in good condition; though the roof has been broken open in many locations. The roof is of modern construction with a bitumastic membrane beneath the tiles. An Internal inspection was not possible due to health and safety considerations

- Slipped and broken roofing tiles

- None
-

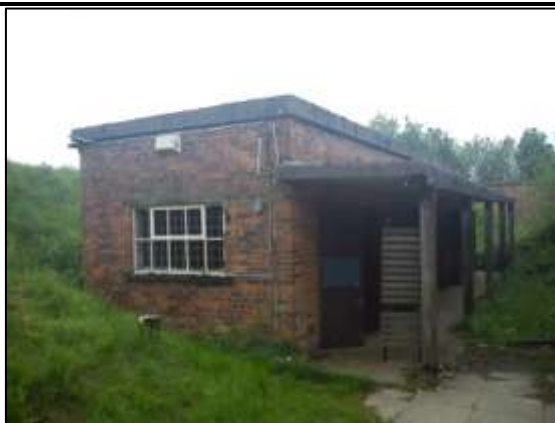
Building B15

**Negligible
Potential**

A single storey brick building with a flat concrete roof. The brickwork is in good condition. Light levels within the building were low to moderate.

- None

- None
-

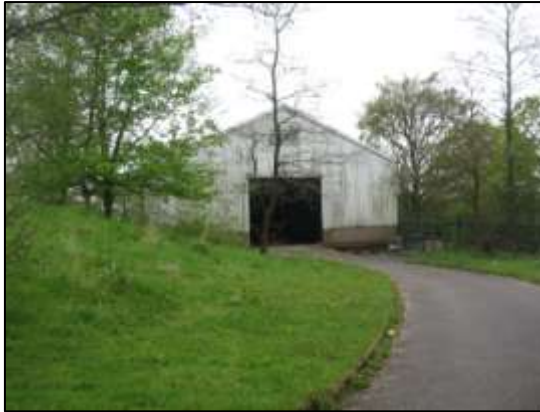
Building B16
Negligible
Potential

A single storey metal skin building, with a single pitched metal roof.

- None

- None
-

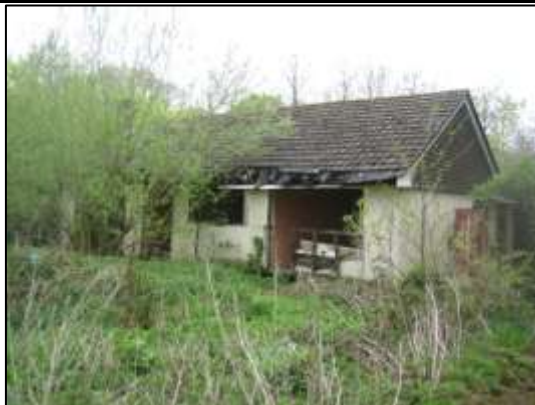
Building B17
Moderate /
High Potential

A single storey prefabricated concrete building with a pitched clay tile roof with hanging tiles on the east and west aspects. The building is in poor condition and the roof appears to be unstable, preventing any internal inspections.

- Slipped and broken roofing tiles
- Hanging tiles on east and west aspects

- None
-
