Activity Survey for Bats & Birds

St Edwards Hospital Chapel, Cheddleton

August 2013

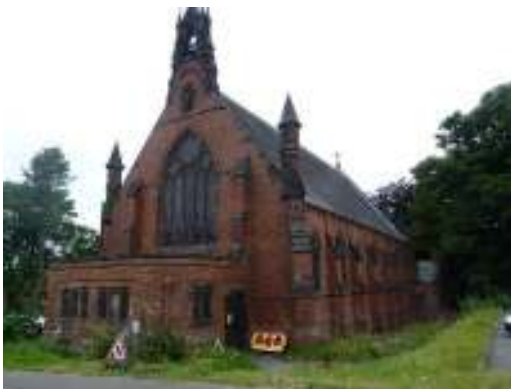
- 4.3 The chapel is located to the north of Birchtree Drive. It is a grade 2 listed building built c 1895-99. It is a brick structure with sandstone dressings and sandstone pinnacles and has three gable ends aligned north to south. It is proposed that this building be redeveloped into a dwelling. The chapel is 40 m long x 15 m wide. The brickwork and stonework is in fairly good condition, providing little in the way of crevices for bats and birds to utilize. Some windows have small breakages which are sufficient for bats and birds to use as possible entry points. The remainder of the doors and windows are intact. The roofing of the chapel, which is pitched and slated, has some raised or dislodged slates which bats could potentially climb

under. No external evidence of bats was found, but it should be noted that evidence can be removed by the external environment.

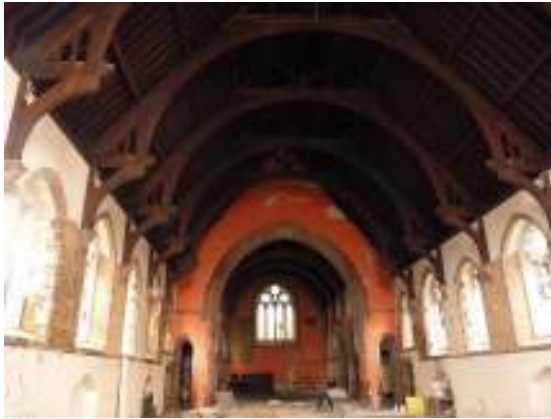
- 4.4 The interior of the chapel is a large open space to the rafters, with five smaller rooms including a

former WC and porches. The nave has a hammer-beam king post roof, and the chancel has a king post roof. The plain rendered walls with stone dressings, which are all in good condition, provide limited roosting opportunities. It was impossible to inspect between the roofing slates and the rafters due to the height. The main open-planned chapel room is ideal for preflight emergence, although it is pitted with daylight from the large windows. As bats prefer dark, secluded areas, this may discourage them from using the rooms for

roosting. Until recently, the chapel has been used by nesting feral pigeons (*Columba palumbus*). Thus, there is a substantial deposit of bird guano on the floor and timber regions, suggesting that this area has been occupied by this species for a number of seasons. A thorough inspection revealed no presence or evidence of bats, and it is highly probable that bats may have been displaced by the presence of *Columba palumbus* and the subsequent accumulation of bird detritus. The building is considered to have depreciated in its conservation value for bats.

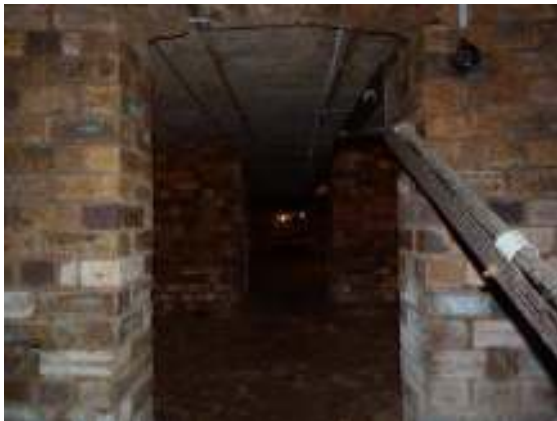
- 4.5 The cellar was also inspected for bat potential. There is no evidence of access points leading to

the exterior. The walls are brick and have very few crevices for bats. The crevices that were identified were checked for any physical signs of bats, but none were found. The cellar was identified as having low to moderate hibernacula potential for bats due to the limiting climatic variations and limited access.

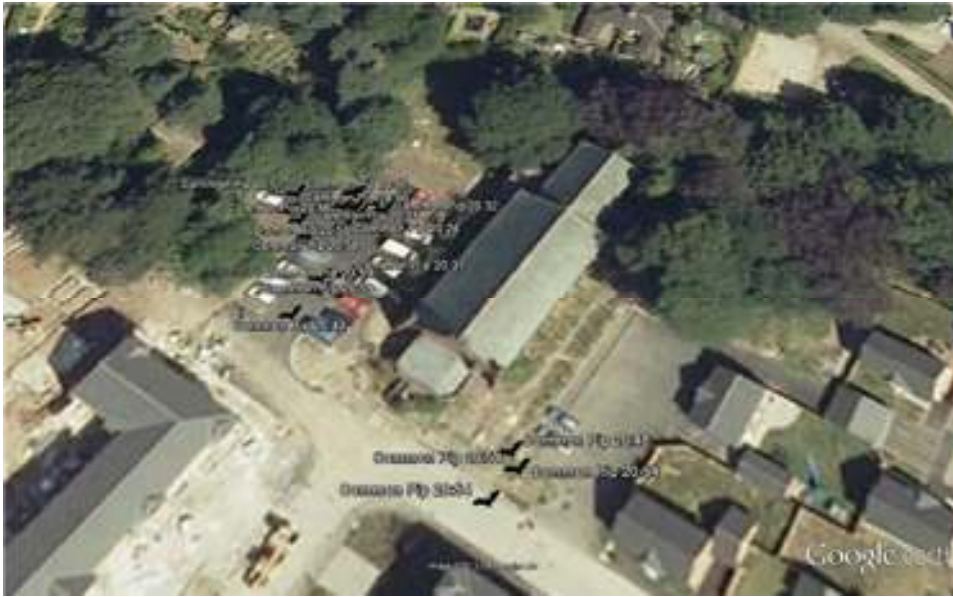
Figure 1: Location of bat activity during the first survey visit.

- The dusk emergence survey was conducted on 28th August 2013. The survey was conducted half an hour before sunset and two hours thereafter. Survey conditions were optimal with a mean ambient temperature of 16 °C. Foraging activity by a low number of bats (n=<24) was recorded across the rear amenity grassland area, and predominantly along the northern boundary hedgerow.
- Only 24 ultrasound recordings were made over the entire evening, with peak activity occurring between 20.32 and 21.20. Four species of bat were recorded. All calls were assigned to common pipistrelle. *Pipistrellus* sp. were recorded actively foraging in the garden before dispersing off site into the wider landscape. No bats were seen emerging from the building itself.

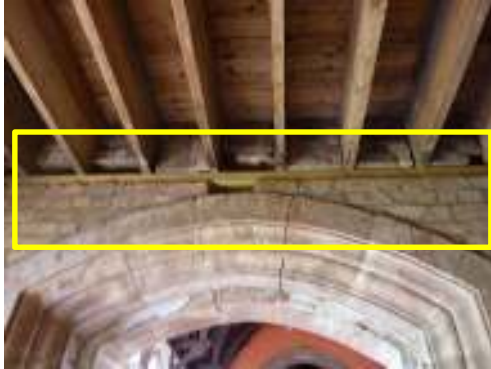
Plate 1: Potential bat roosting opportunity within the main area of the chapel.

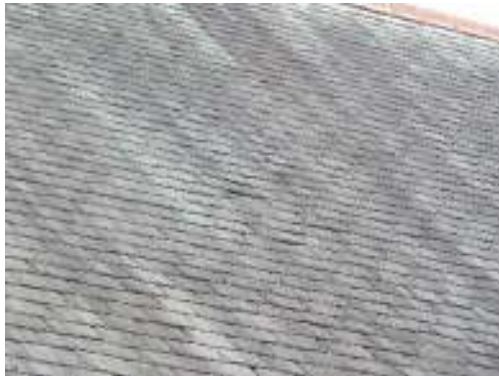
Plate 2: Dislodged roofing slates provide potential access for bats.

- 6.15 Ridge tile access features must be free of obstruction from any insulation materials. The raised tiles will allow bats access into the existing roost area. The ridge gaps should measure approximately 30 mm x 100 mm to maintain the existing access.
