**BOW111 Crow Trees Farm, Whiston Eaves,  
Staffordshire**

***Bat Inspection and Emergence Survey Report***

**June 2014**

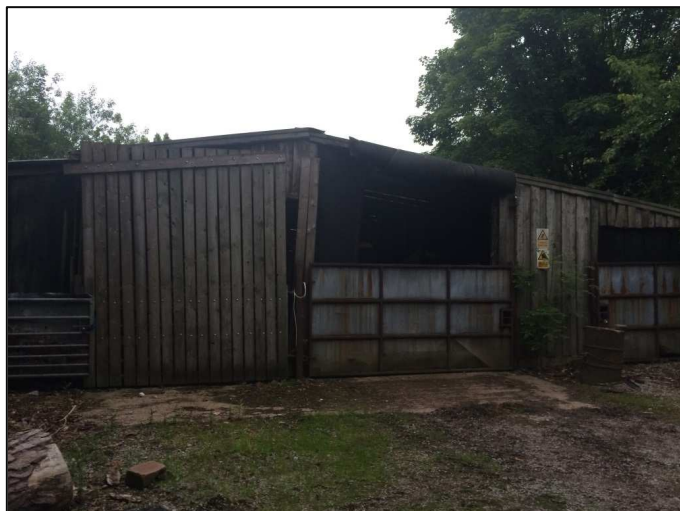
**North West Elevation**

- 3.3 The building is situated within the grounds of Crow Trees Farm adjacent to the access lane at the northern end of the site. The building is constructed in several sections. Outer walls in small places have sections of a single course of breeze block. Elsewhere the walls of the barn are a single skin of timber/metal sheeting. Numerous gaps were observed between the timber slats allowing light through into the internal of the building. The roof consists of steel corrugated sheeting which extends to overlap the edge of the roof. Perspex roof lights are present along the roof. The gap between the sheet walls and overlapping steel roof provide potential roosting opportunities for bats – however these gaps are quite wide and potentially draughty. No evidence of bats was found during the external inspection. The external inspection considers that roosting potential is **negligible / low**.
