Pre-development tree survey and Impact Assessment (BS5837:2012),  
56 Cheadle Road, Forsbrook

## 1.0. Introduction and site description

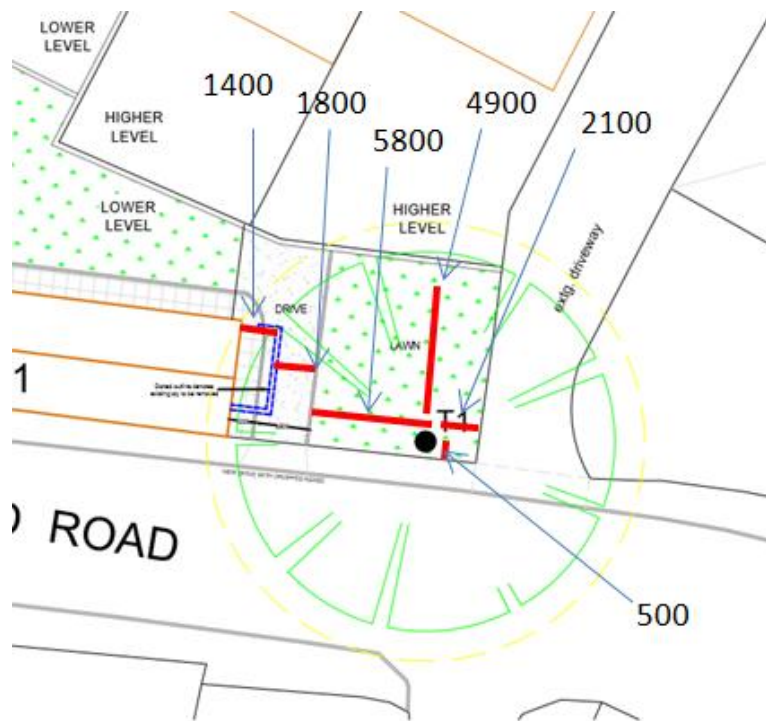
Recent clearance of debris and redundant brick walls on and around the former pigsty area has left the original ground level sloping from the tree base to the concrete flooring of the pigsty with the fine surface root structure intact.

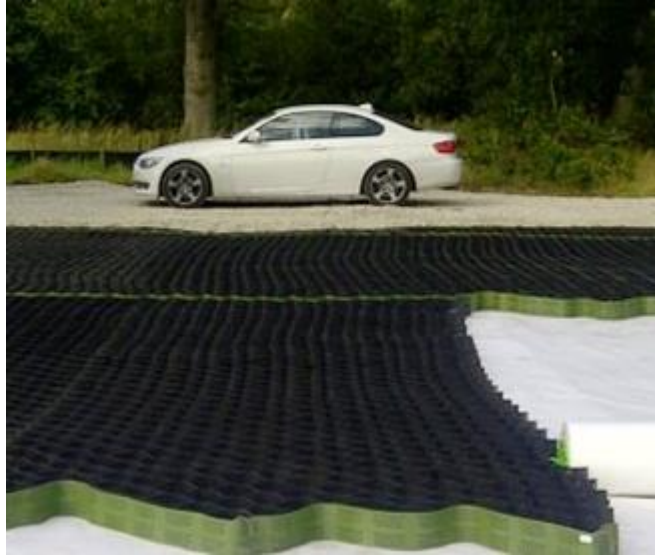
Cellweb Cellular Confinement System with its unique cellular structure and perforated cell walls reduces the vertical load pressure on sub soils above tree roots and prevents compaction. With clean granular materials as infill, air and moisture can reach the roots to encourage healthy prolonged growth.

vegetation need be removed. An image of the structure, illustrating it's appearance is shown below:

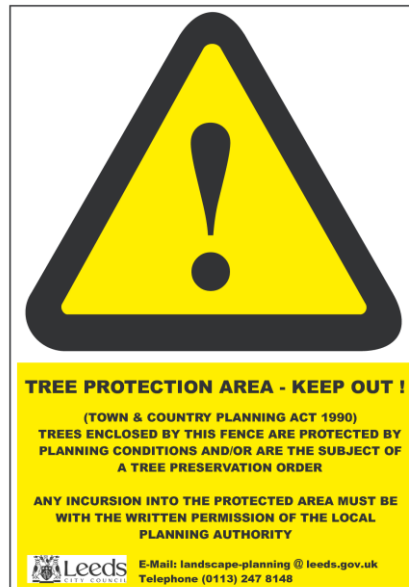
4.2.3 All weather tree protection posters (an example is detailed below) are to be securely fixed to the tree protection fencing in plain view.

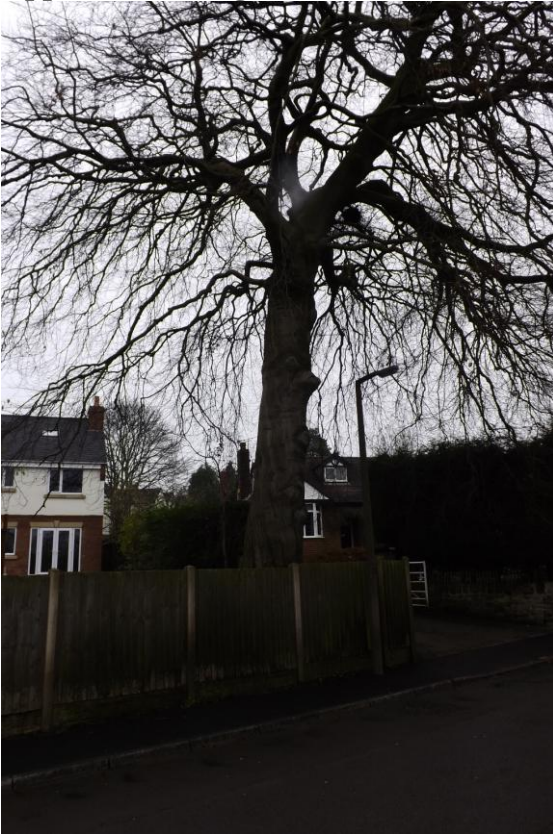
**Tree 1 from Draycott Old Road**

Tree no. and distance to road	Species	DBH	Radius (m)	RPA (sq.m)	Crown N	Crown S	Crown E	Crown W	Height	Age Class	Estimated remaining contribution (years)	Physiological and Structural Condition	Category	Preliminary Management Recommendation
T1	Copper beech	900	10.8	366	9	9	9	7	14	Mature	>40	Good structure and physiological condition. Root spread is restricted on all sides by walls and hardstanding at varying distance, although the tree appears to have adapted well to this and shows no signs of instability or physiological stress	A1	Crown raise over the road and neighboring driveways. the tree may benefit from a crown thin (up to 50%)

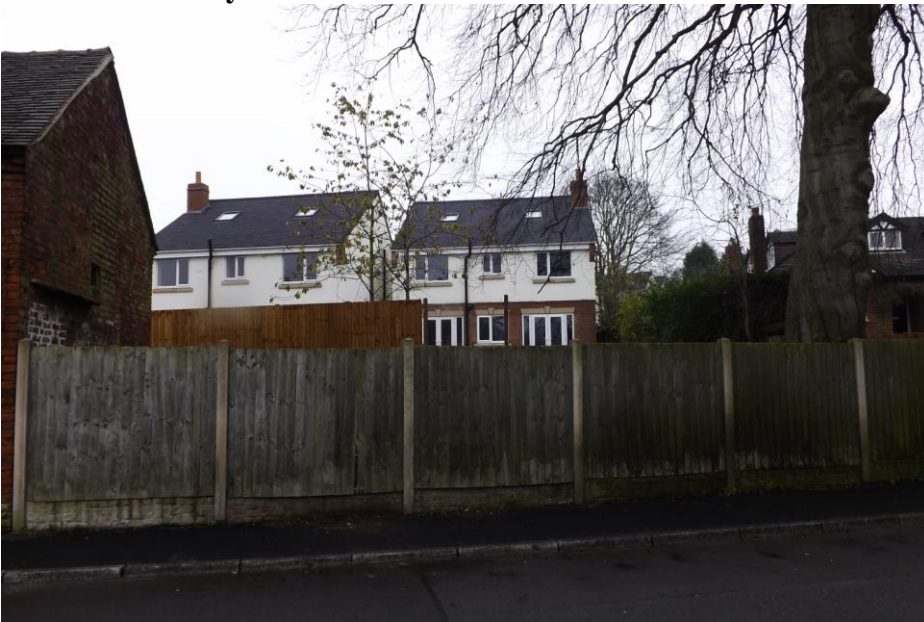
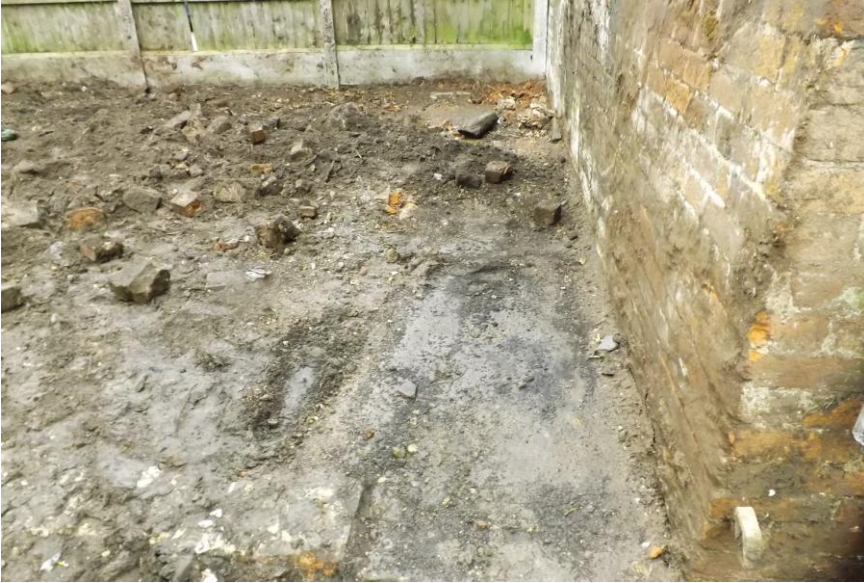
**Base of former pigsty (concrete)**

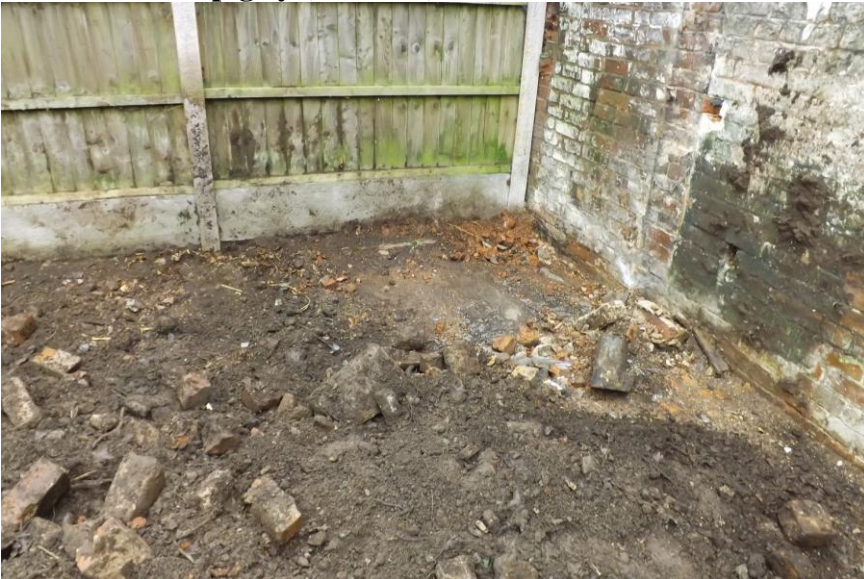
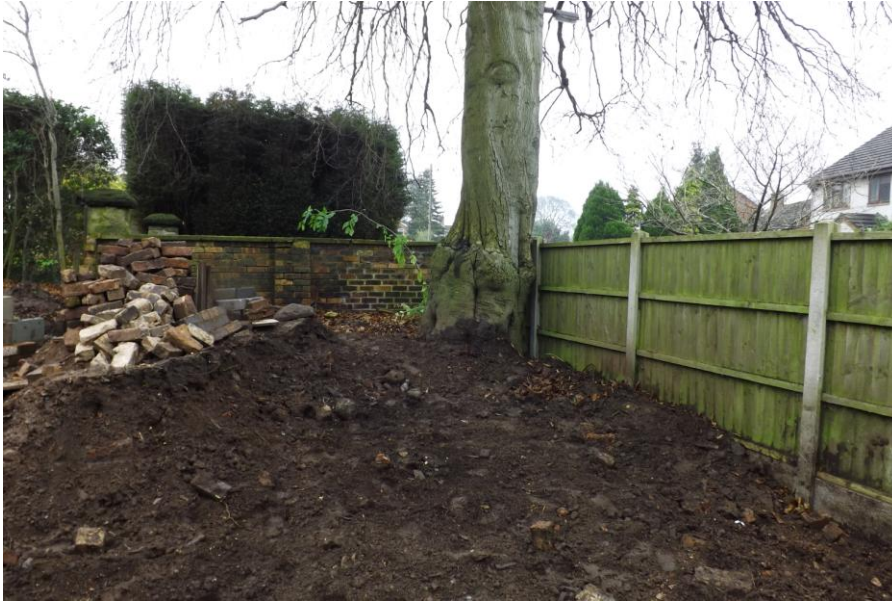
**Debris above original earth level cleared**

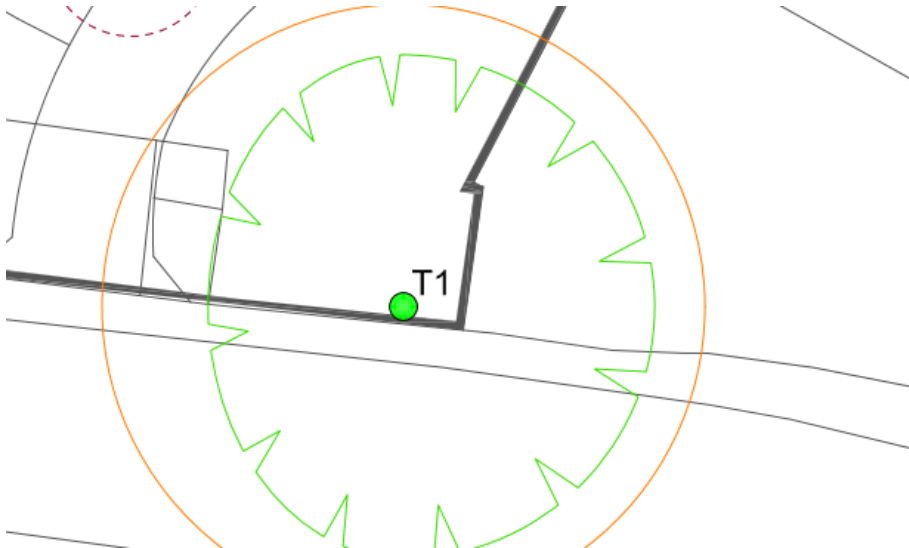
## **Appendix 2: Tree location maps**

**3.0 Results: A map detailing the location of trees and their Category determined is located in Appendix 2, all other trees are noted as being below 150mm DBH and outside the requirements of BS5837. Trees below 150mm DBH but above 75 mm DBH are included in the topographical survey of the site.**
