CONTAMINATED LAND RISK ASSESSMENT
PHASE 1 DESK TOP STUDY AND SITE WALKOVER SURVEY

**ASD Metal Services
Biddulph**

Our Ref: SES/ASD/TR/1#1

Date: 21st October 2014

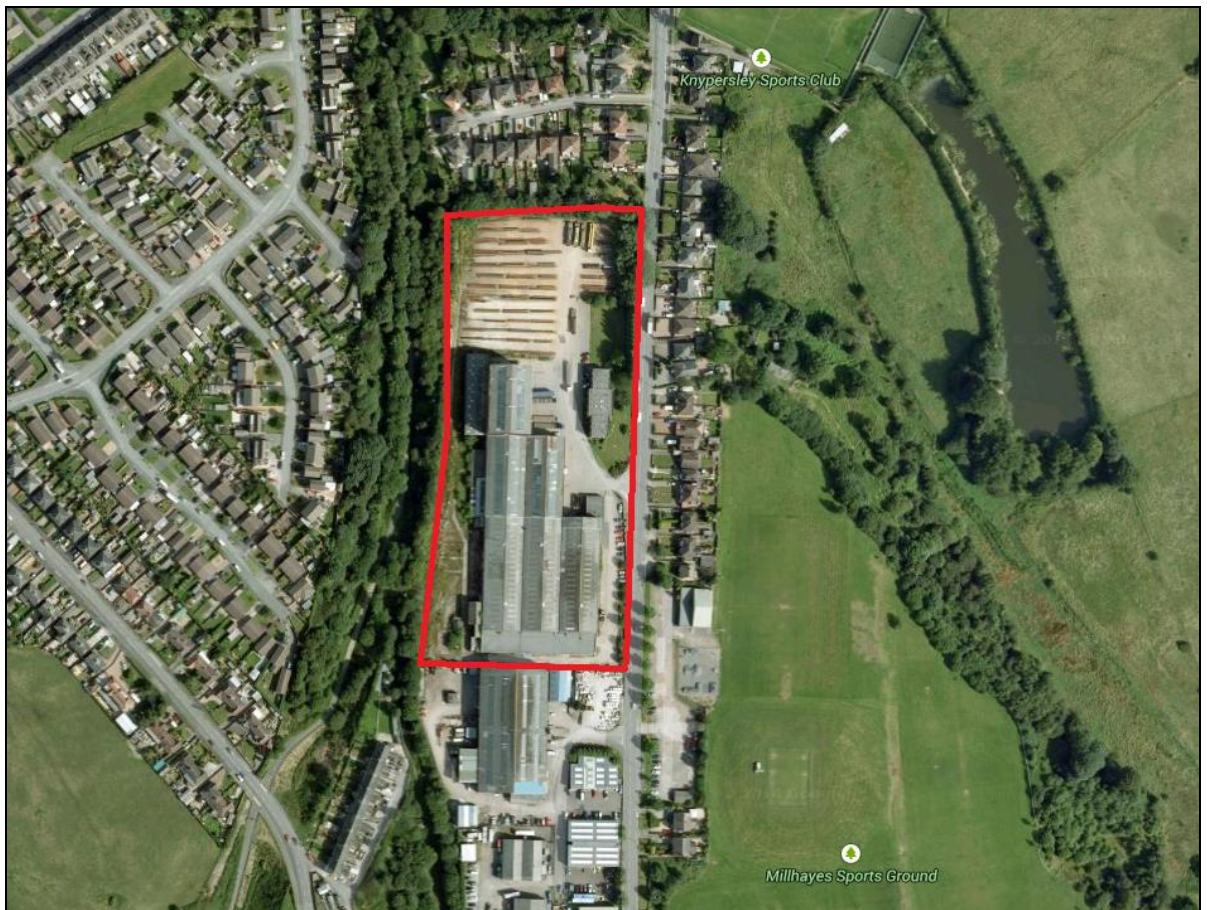
Photo 1 Aerial view

The site assessed for this investigation currently comprises 2.854 ha of land located off Tunstall Road, Biddulph. Residential properties bound the site to the north, with a road to the east, an industrial estate to the south and trees to the west. A metal services company occupies the site (Photographs 1-11). The site and surrounding land slopes down to the north and east.

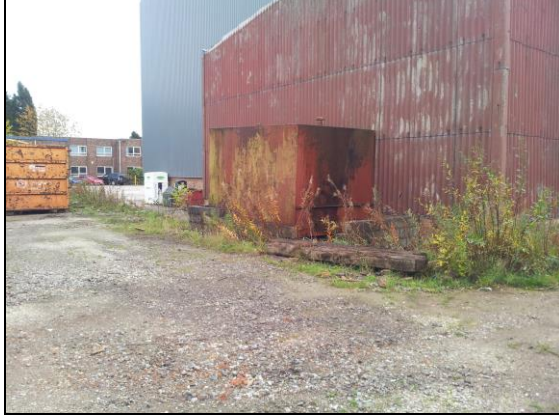
PHOTO 2 View NW to NE

A redundant diesel fuel tank is located to the north-west of the site (Photo 2). A smaller new diesel and AdBlue tank are located east of the redundant tank (Photo 3).

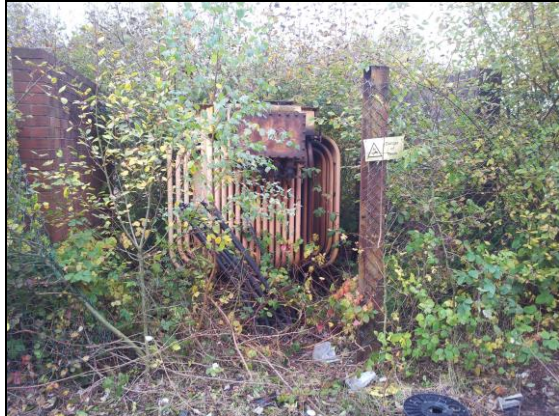
PHOTO 4 View to the SW

A disused electricity transformer is situated on the south-west of the site (Photo 4).

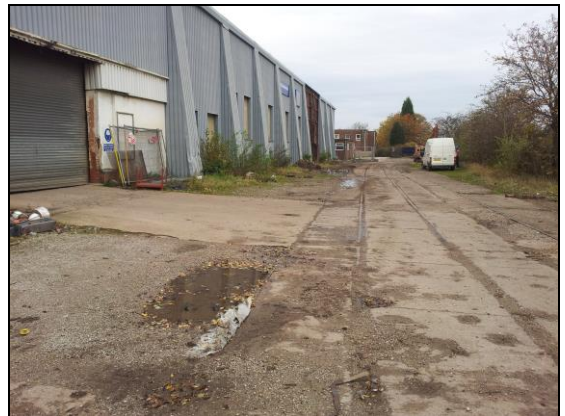
PHOTO 5 View SE to NE of old rail lines

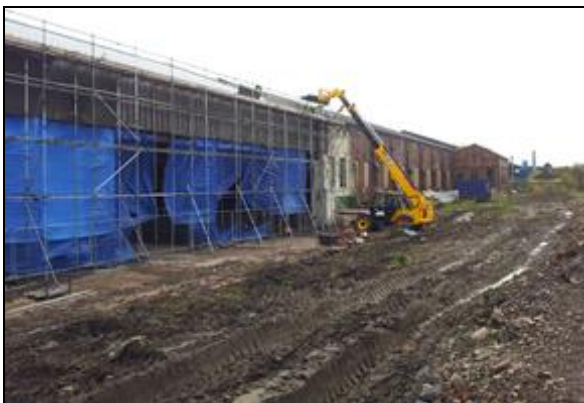
PHOTO 8 Concrete asbestos removal

- the site surface of the building was concrete. No surface cracks or holes were evident.
- no significant staining of the ground or spillages were noted outside of the building or around the former sub-station
- concrete asbestos was being removed from the roof by a licenced contractor during the time of the walkover survey.

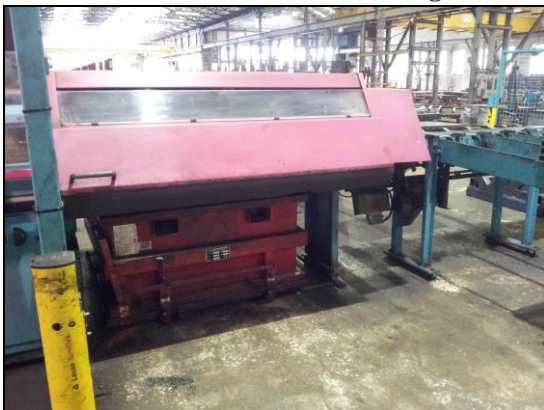
PHOTO 10 View inside the building

No significant leaks or spillages of cutting fluid/oil was noted within the building as drip trays are fitted within the machines (Photo 10).
