**Preliminary Roost Assessment for Bats & Birds**

**Location: ASD Metal Services, Tunstall Road,  
Knypersley, Biddulph, Staffs, ST8 7AQ**

**Date: 29<sup>th</sup> October 2014**

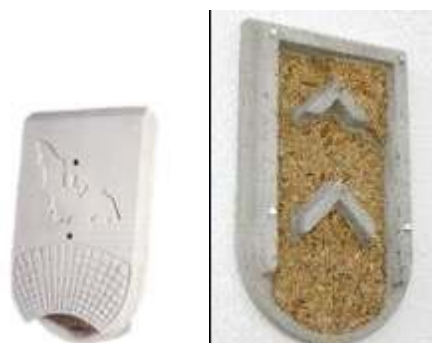
Illustration of recommended bat 1FQ designs

The development should incorporate a number of bat boxes; where possible, developments should include small access points suitable for bat access and/or wall-mounted bat boxes (1FQ-style bat box), rendered into new buildings. Further information for providing access to roosting bats can be found on the Bat Conservation Trust website at [http://www.bats.org.uk/pages/new\\_build.html](http://www.bats.org.uk/pages/new_build.html). It is recommended that bat boxes, such as the Schwegler 2F-DFP, are installed within trees surrounding the site.

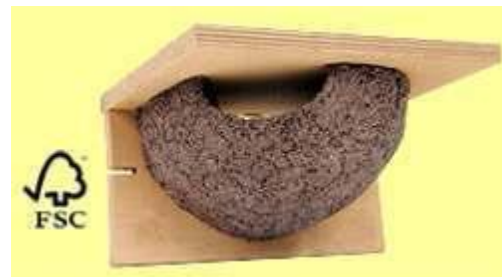
House sparrow nest

Recommendations are given to enhance the site for nesting birds in future, including the provision of bird boxes.

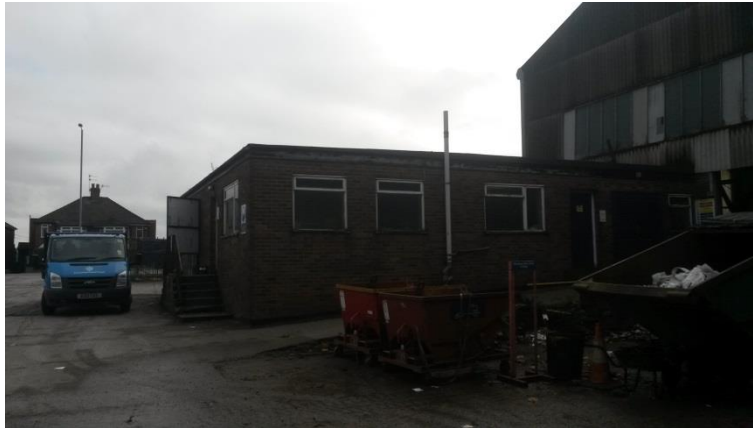
Image 1: B2

B2 – Single-storey brick building, with flat roof. No gaps, cracks or other suitable roosting sites were visible. The joins of the roof and walls is tight, with no gaps underneath the fascia boards.

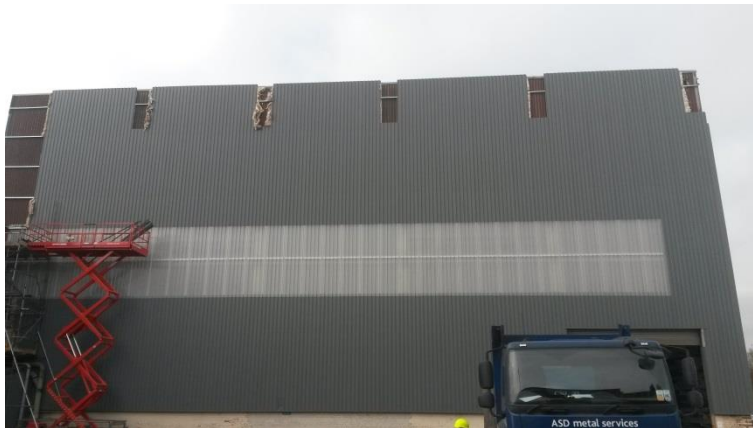
Image 2: B3 exterior

B3 – Large warehouse structure. This is steel-framed, clad in a double layer of corrugated steel, with rock-wool style insulation, a low brick base, and a pitched corrugated steel roof. Large sections of transparent corrugated plastic are present both in the walls and ceiling. Due to the materials used in its construction, this building will undergo extreme temperature fluctuations, making it unsuitable for bats. The building interior is also very light, with no suitable roosting sites or dark corners evident.

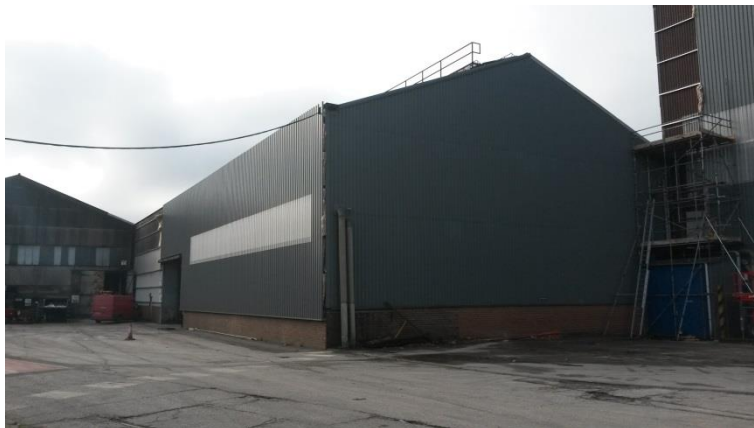
Image 4: B4 exterior

B4 - Large warehouse structure. This is partially steel-framed, clad in a double layer of corrugated steel, with rock-wool style insulation, and partially has brick walls clad externally in a layer of corrugated steel. The roof is a series of pitched roof sections composed of corrugated steel. Large sections of transparent corrugated plastic are present both in the walls and ceiling. Due to the materials used in its construction, this building will undergo extreme temperature fluctuations, making it unsuitable for bats. The building interior is also very light, with no suitable roosting sites or dark corners evident.

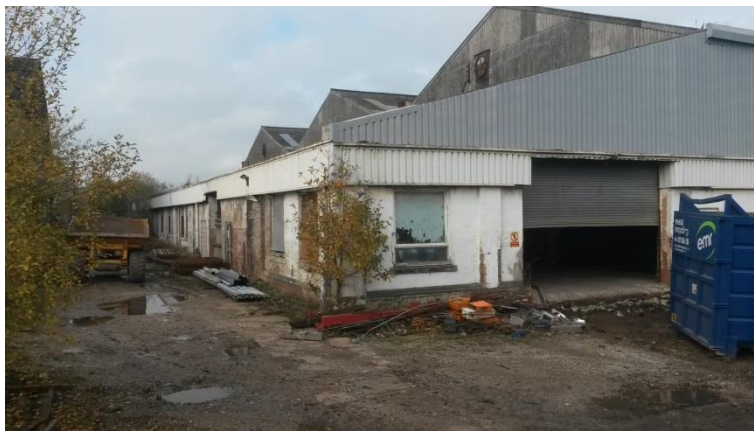
Image 7: B5

B5 – This is a 'lean-to' style building, on the southern end of B4. It has rendered brick walls and a single-pitch corrugated steel roof. Soffits and fascias are tightly sealed, providing no suitable access points. The windows are shuttered with steel plating, leaving no suitable access points for bats. The interior is open to B4 on the northern side, and through a large doorway on the eastern side. No suitable crevices were found through internal or external inspection.

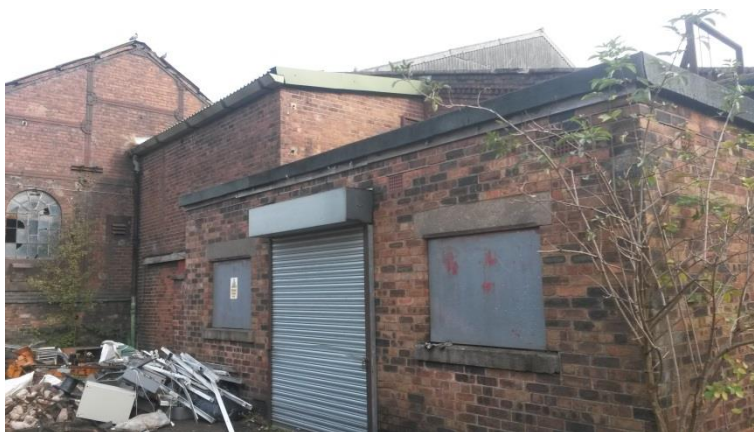
Image 8: B6 & B7

B6 - Small, single-storey, flat roofed, brick structure, with steel shuttered windows and no visible gaps for access or roosting.

B7 - Small, single-storey brick structure, with single-pitch corrugated steel roof. No windows are present, and no visible gaps for access or roosting.

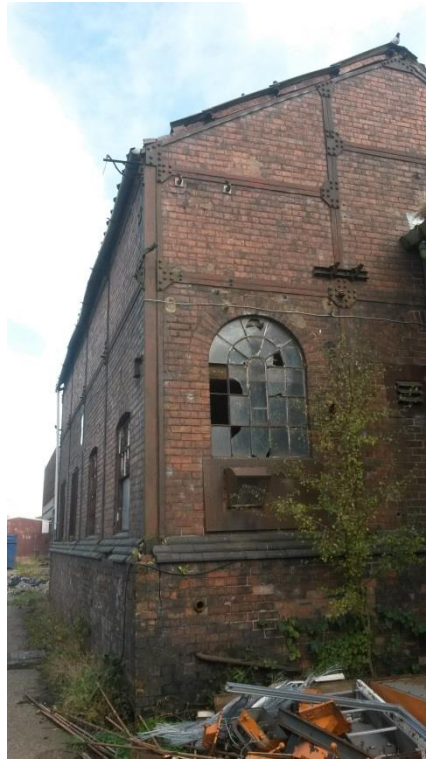
Image 9: B8 exterior

B8 – Two-storey brick building, with pitched, steel-framed, corrugated roof. Much of the glazing is missing from the windows, leaving the interior very exposed to weather and daylight. Upon inspection of the interior it was found that a large number of pigeons are nesting within this building, further reducing its potential for bats through disturbance and fouling.

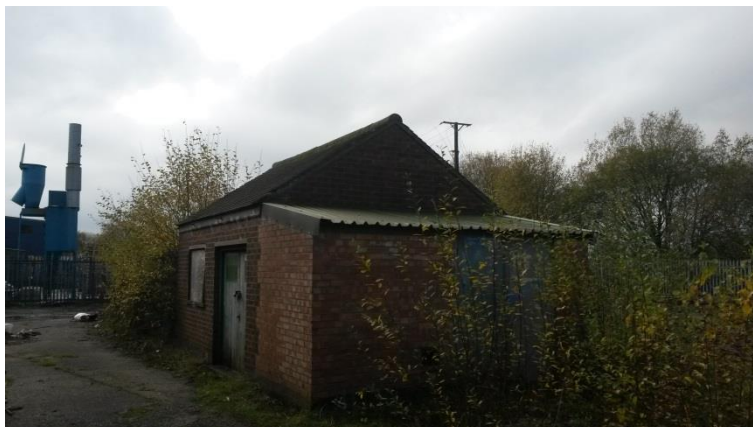
Image 11: B9 – northern and eastern elevations

B9 – Small single-storey brick building to the west of the main site. This former electrical substation comprises of two sections. On the northern side is a small 'lean-to' style extension, with a single-pitch corrugated metal roof. The original building has a pitched tile roof; timber-framed, with open eaves and lined with bitumen-style roofing felt. The roof shows a number of slipped/raising/missing tiles; particularly at the northern gable end. Windows on the east and west sides of the building have been boarded up with chipboard, leaving gaps at the top, which may be used by bats for access and/or roosting opportunities. The building interior is very dark, with the only light entering coming from the gaps at the top of the window boards. No evidence of bat presence was discovered during the survey, although the presence of the roofing felt means that a space is present between the roof tiles and the felt; that could not be inspected without a destructive search (which is not legally permitted).

The former electrical substation shows moderate potential to support bats, although no evidence of bat activity was identified. Coupled with the inspection constraint identified during the inspection, it is considered that further surveys would need to be conducted in the primary timing of year when bats are active and roosts are established. This period is May to September, with the optimal time being June to August. The activity surveys should consist of at least two activity surveys, which will comprise of either two dusk emergence surveys, or a dusk emergence survey and dawn re-entry survey (not within one 24 hour period, as this would class as one survey visit). If bats are identified using the building, then further activity surveys maybe required to obtain sufficient information for a Natural England Licence application. All surveys will be In accordance with the Bat Conservation Trust guidelines (BCT, 2012).

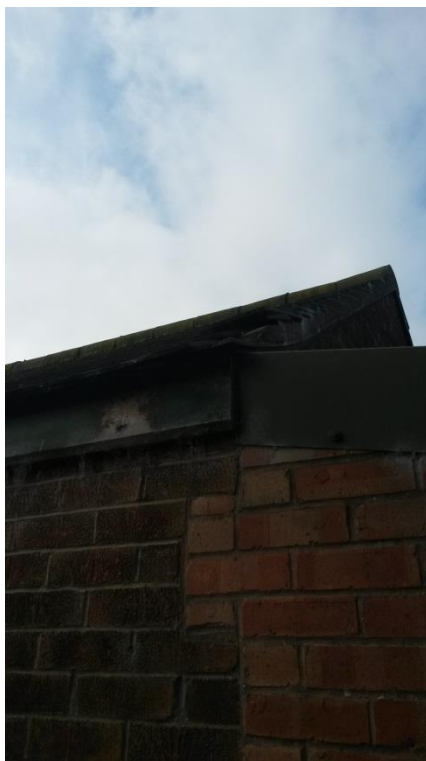
Image 12: B9 – lifted tiles & missing mortar at northern gable end

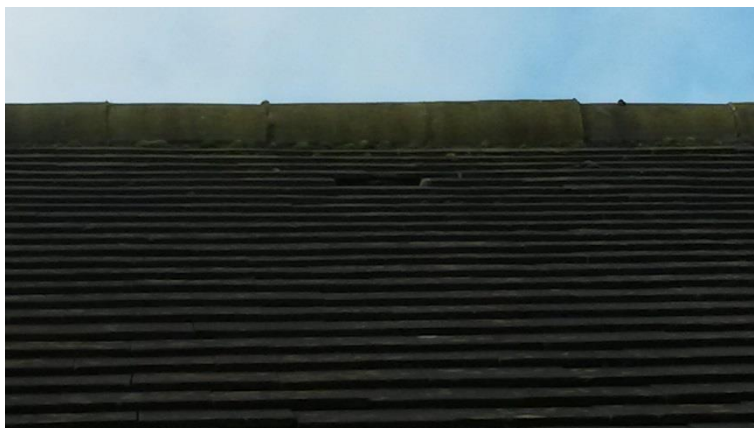
Image 13: B9 – missing tile on eastern side of roof

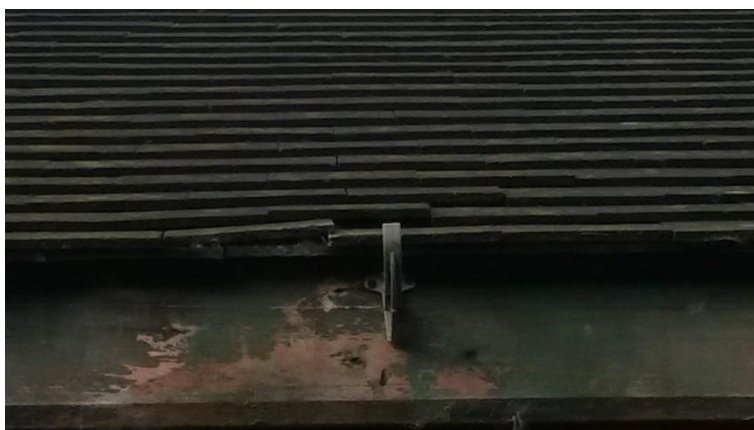
Image 14: B9 – Gaps at eaves on eastern side of roof

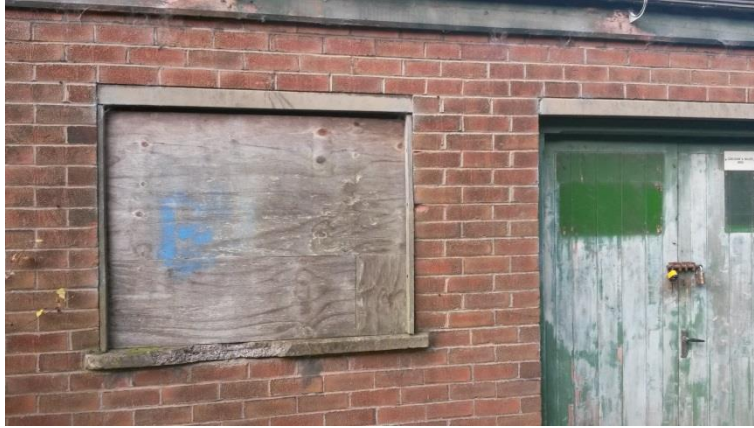
Image 15: B9 – Boarded window on eastern side, with gap at top

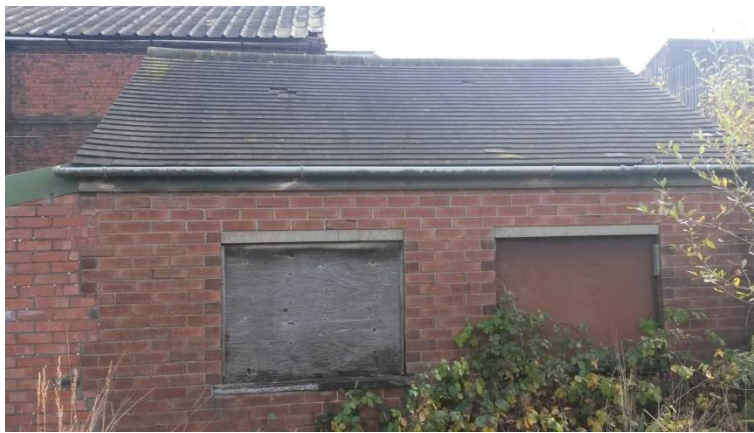
Image 16: B9 – western elevation – showing gaps in roof and boarded windows with gaps
