Wormhough Farm, Rushton Spencer

Proposed Shed Demolitions

An Ecological Appraisal (with particular reference to bats and breeding birds)

WORMHOUGH FARM, Rushton Spencer
Proposed Shed Demolition (Shed 1) - Bat and Breeding Bird Assessment (August 2014)

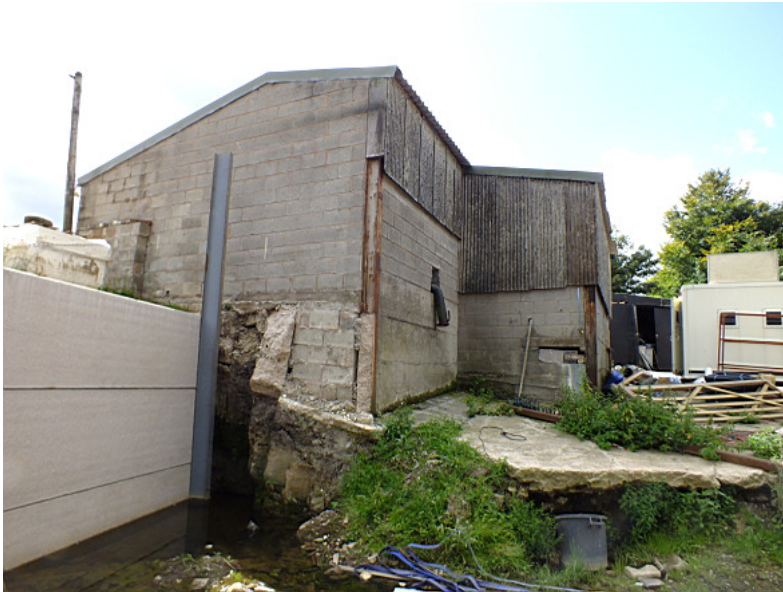
Both sheds have been constructed fairly recently (compared to the many stone barns in the locality). Shed 1 is constructed on split levels with sections a, c & d slightly above section b. The bottom half of the building is of breeze-block construction, with upper wall sections of asbestos sheeting, topped by a metal sheet roof (see photos 1-4). The ridge and lower corners are supported on reinforced steel girders.

Photo 1: Asbestos 'cladding' on the upper half of the W-facing walls is single-skinned with no voids behind. No bat droppings were found on the ground underneath.

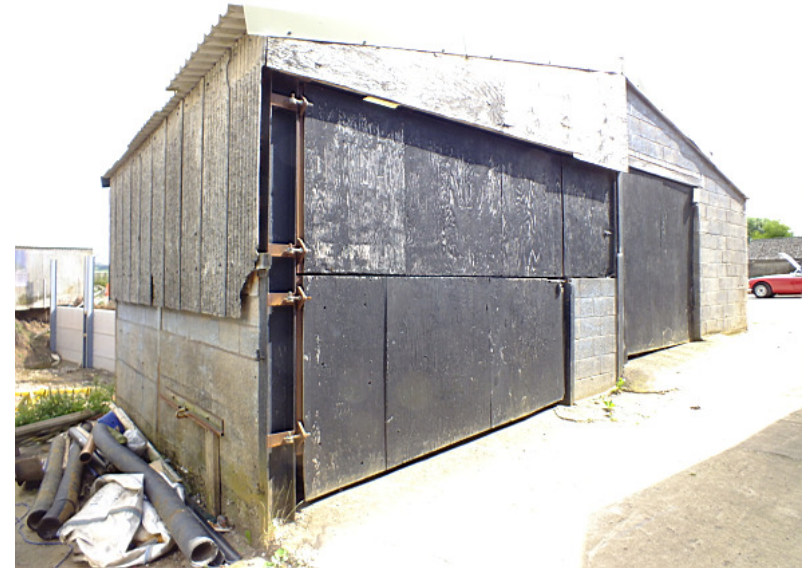
Photo 2: From the SW corner, the detail of the upper wall can be seen. The small gap below the fixing timber could be inspected thoroughly.

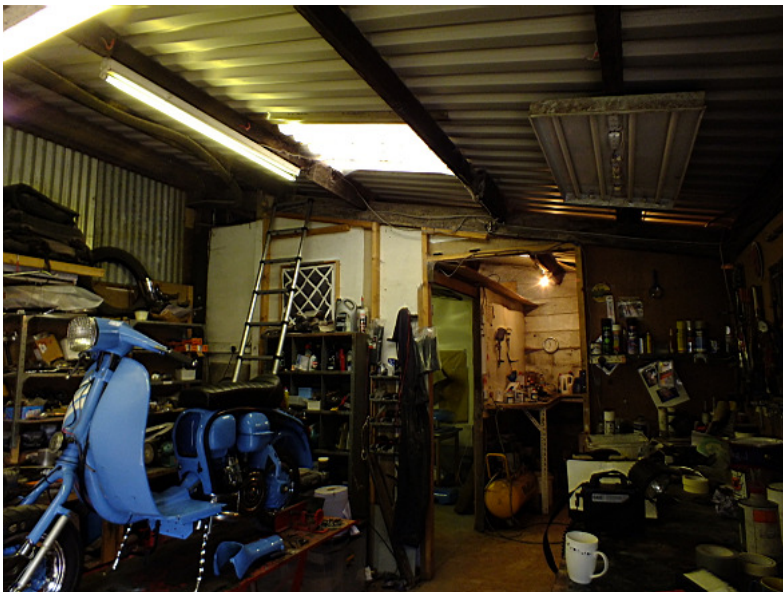
Photos 3, 4 and 7 show the interiors of the buildings. Photo 3 shows the main workshop area in Shed 1, with the void above the spray shop (section c) visible near the ladder. There is very little overlap between the courses of block-work and the asbestos sheeting and most gaps have been plugged with sealant to exclude the wind and rain. Above the overlap, the asbestos sheeting forms a single-skinned wall with no cavities. It is also considered that any small cavities in the roof and walls would be very exposed and poorly insulated against heat or cold. Overall, this suggests that neither barn offers spaces or conditions likely to attract roosting bats.

Photo 3: Inside, the workshop (section a) is actively used with no suitable Barn Owl roost space. No evidence of bats was found in the void above section c.

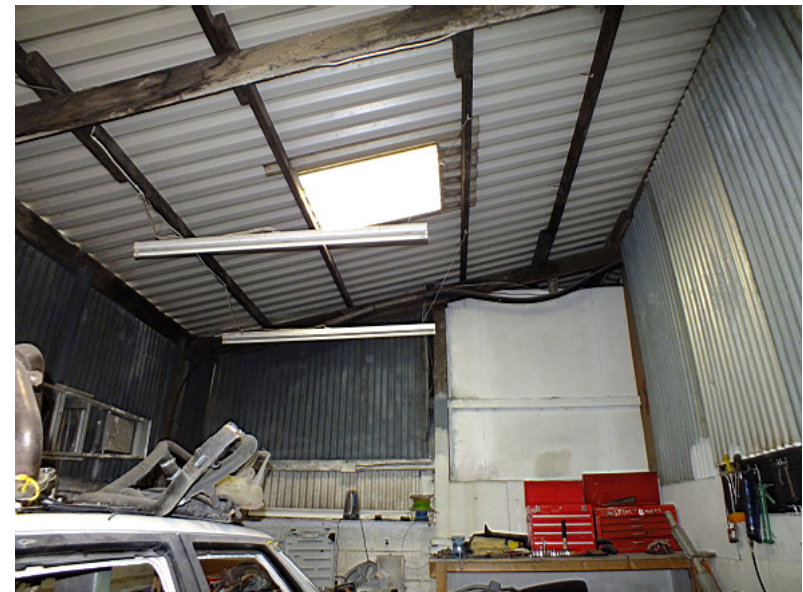
Photo 4: Section d interior showing single skin walls and roof. The void above the white wall of section c was inspected from section a.

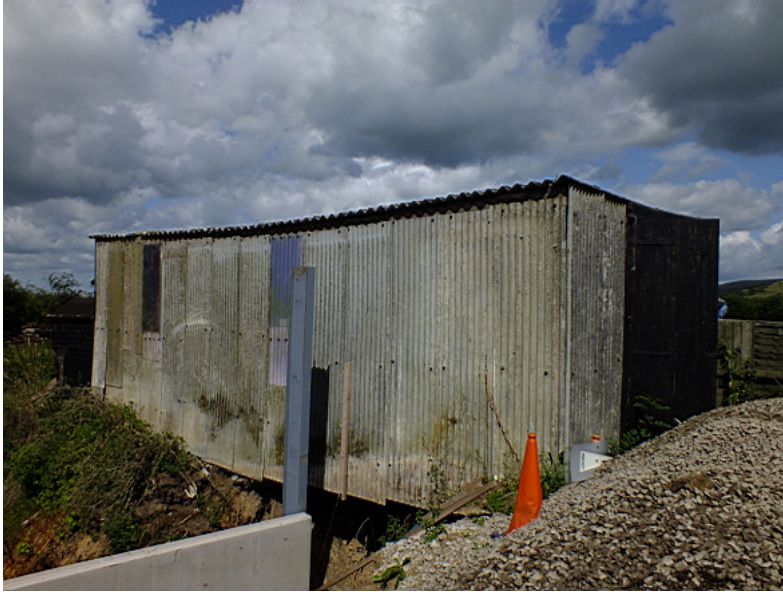
Shed 2 is beginning to slump into the adjacent void. It is constructed entirely of galvanised tin sheeting fixed to a wooden frame (see photos 5-7).

Photo 5: From the exterior, Shed 2 also looks to have poor prospects for roosting bats. Most access points along the roof edge have been stopped up to exclude wind and rain.

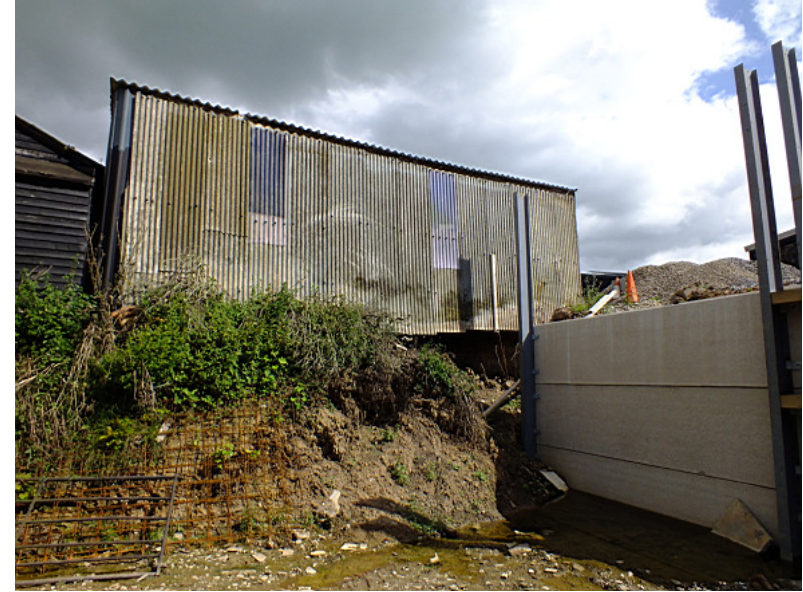
Photo 6: Construction of the retaining wall has allowed slumping of soil from under the shed leaving its floor unsafe.

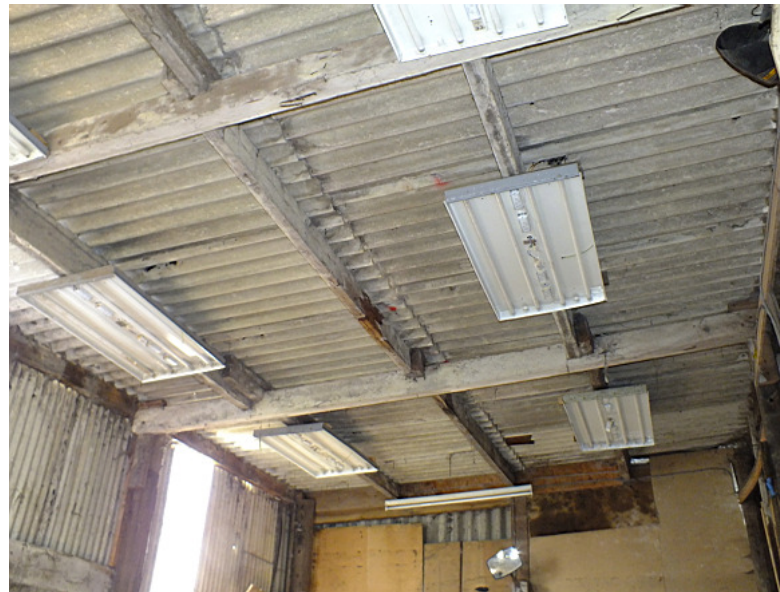
Photo 7: The interior has no beams to attract roosting owls: walls are single skinned metal sheeting. No bat droppings were found beneath the partially clad end wall.
