Project
Felthouse Farm, 17th Century Farmhouse
conservation repairs & reinstatement of Grade II Listed farm house

Title
sections : as existing

Status
SURVEY DRAWING

Drawing Number:	Revision:
AL05	-

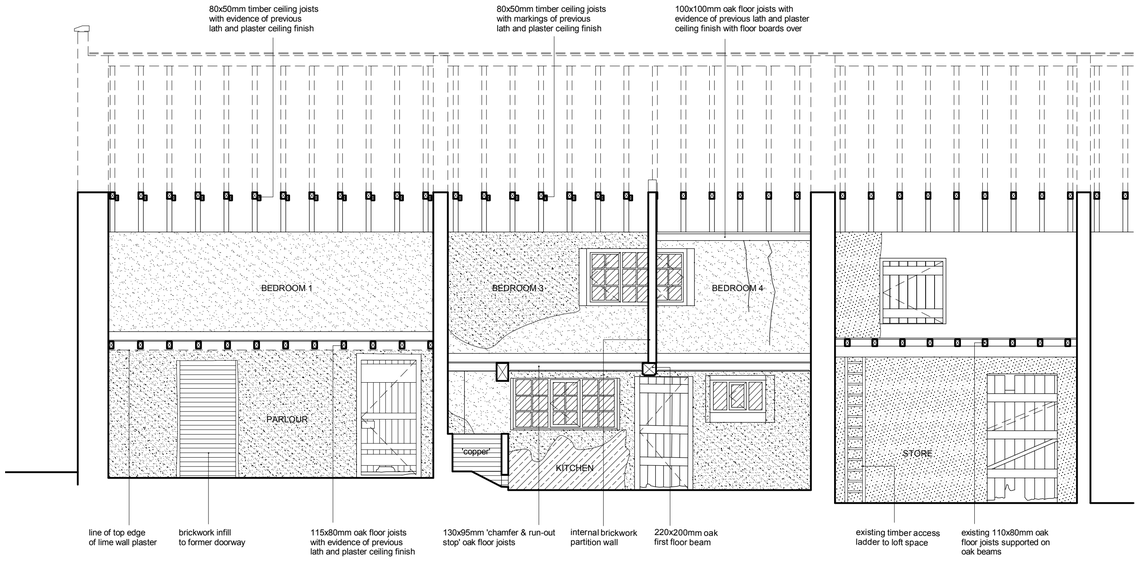
i n t e r n a l f r o n t e l e v a t i o n

(l o o k i n g n o r t h D - D 1)

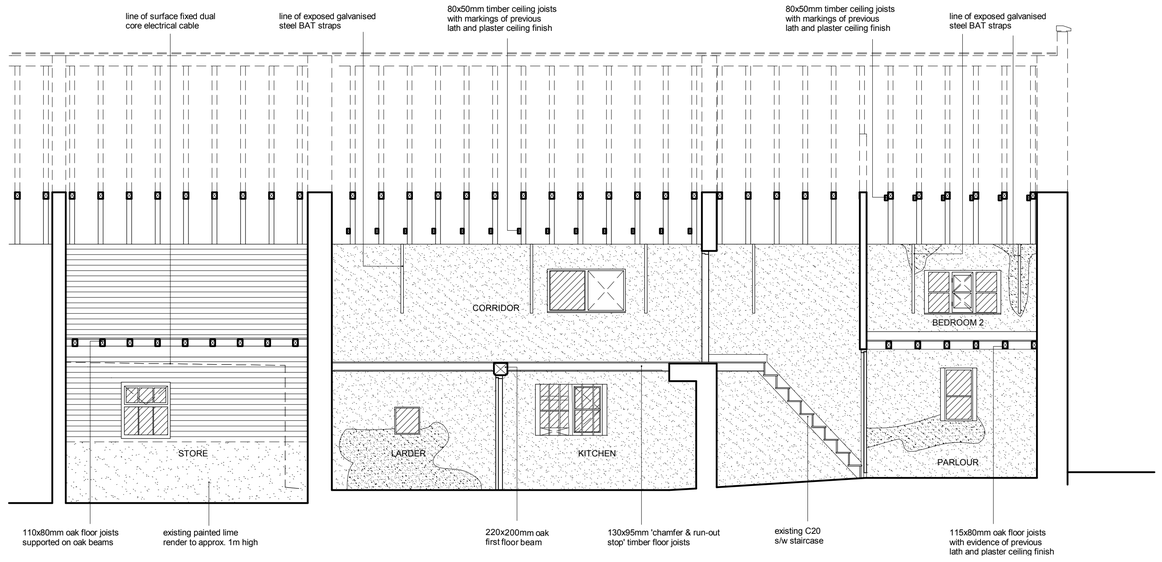
i n t e r n a l r e a r e l e v a t i o n

(l o o k i n g s o u t h E - E 1)

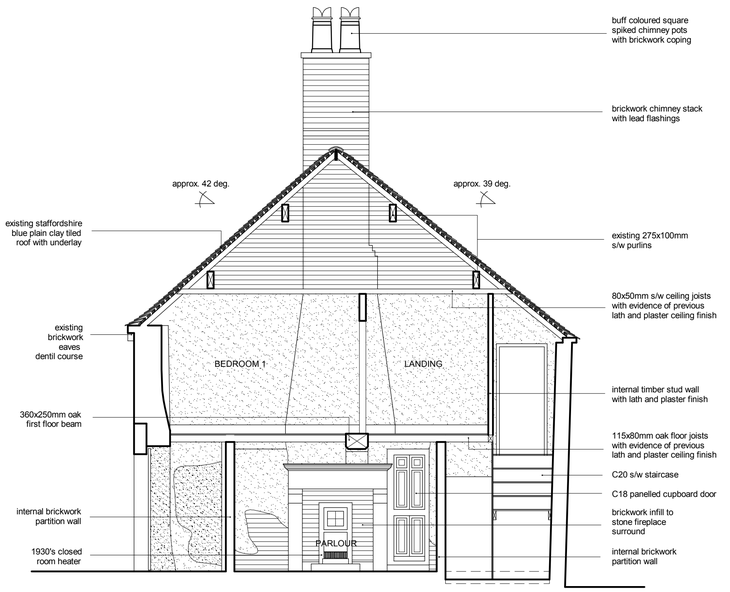
i n t e r n a l m i d w a l l e l e v a t i o n

(l o o k i n g e a s t A - A 1)

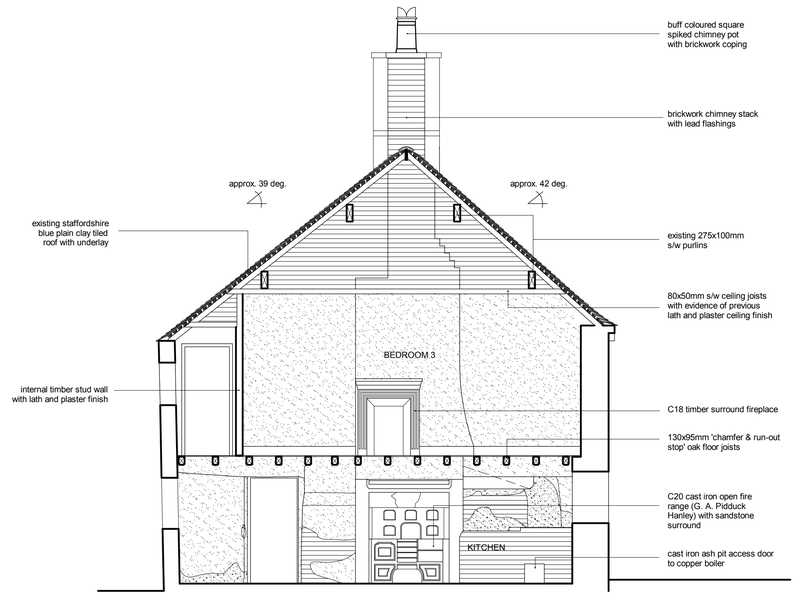
i n t e r n a l m i d w a l l e l e v a t i o n

(l o o k i n g w e s t B - B 1)

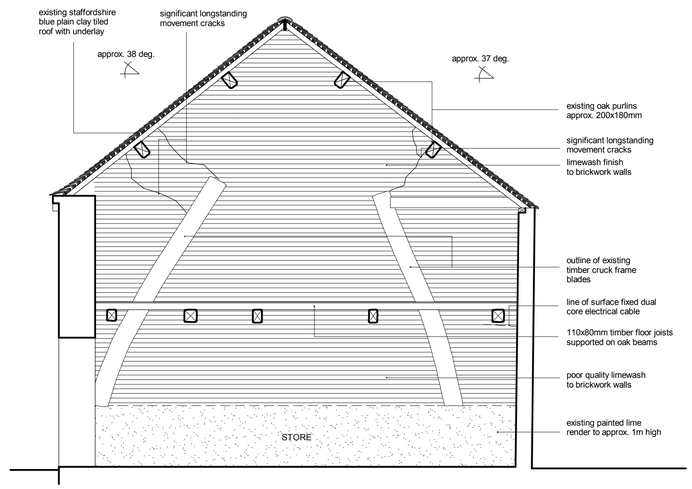
i n t e r n a l m i d w a l l e l e v a t i o n

(l o o k i n g e a s t C - C 1)
