Project
Whitehough Hall Gazebo, Ipstones

Title
Existing Plan, Elevations and Section

Project No 16-067 Drawing No. AS(0)03 Rev

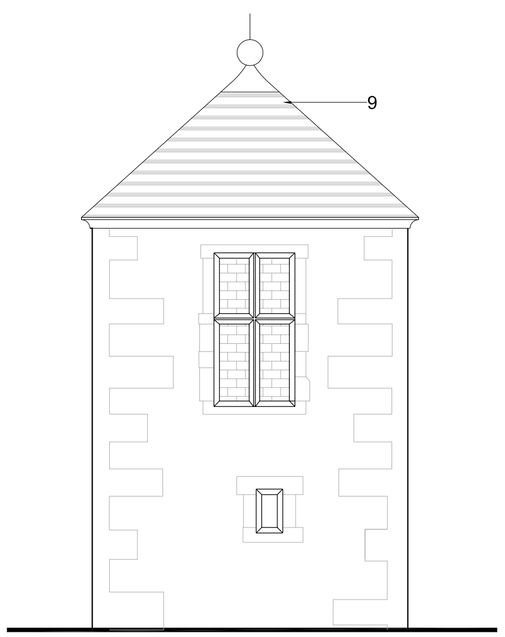
South Elevation

6. Southern cruciform window has been bricked up, internal plaster to splayed jambs remain, timber lintel above could not be inspected but will probably require replacement. Stones missing to the cill area.

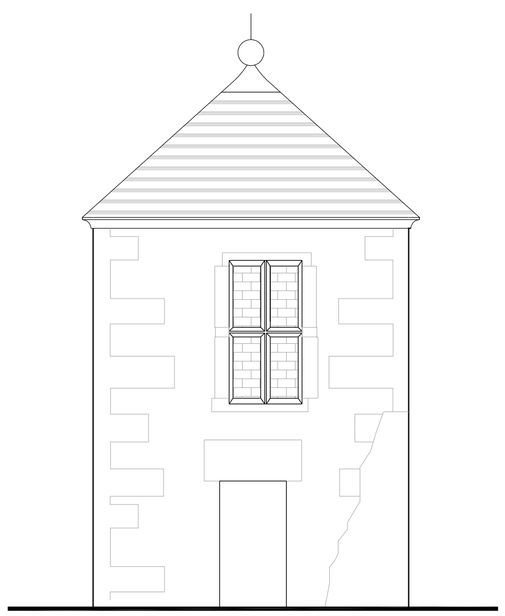
North Elevation

1. Internal stonework has become loose and dislodged in the area to the side of the north window, this area needs to be inspected more closely and stones may need to be re-bedded.

7. Northern cruciform window has been bricked up, internal timber lintel has degraded and has become loose, replacement lintel is required. Some missing stones to internal window cill area.

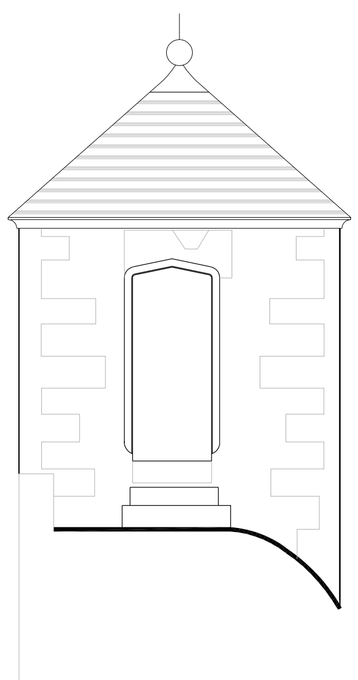
East Elevation

4. Small southern small opening, proper inspection could not be obtained.
5. East door missing, 1no hinge pin and latch pin remain however have corrosion, timber lintel above door has been lost and needs replacement. Some stones are missing to the internal threshold area.

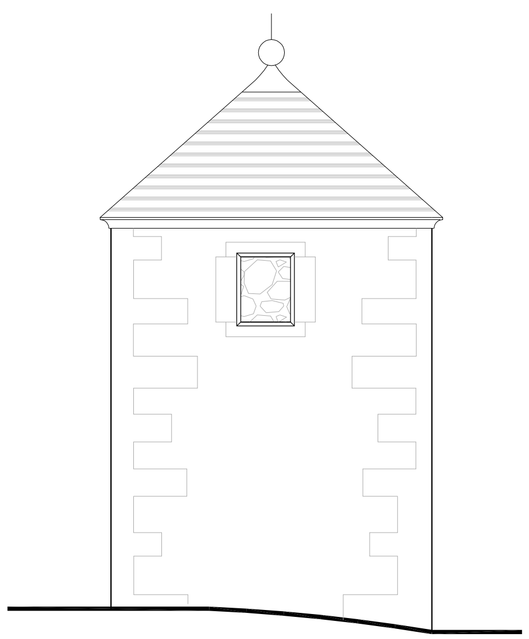
West Elevation

8. Window has been infilled with rubble stone, window is missing and requires replacement.
9. The roof is generally sound, however there are some missing and displaced tiles. There is some cracking and missing mortar internally in which the tiles are attached. The lead sphere above appears to have been damaged.

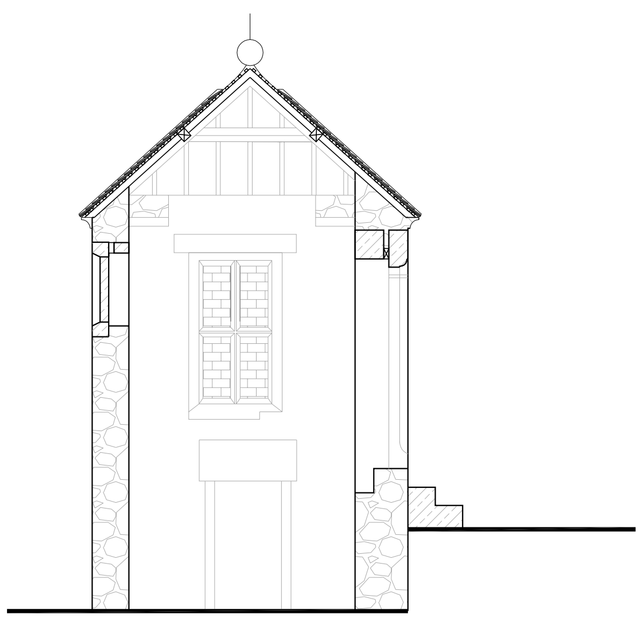
Section A-A

10. The majority of the internal plaster is missing.
11. The first floor and its support structure is missing and will require replacement.

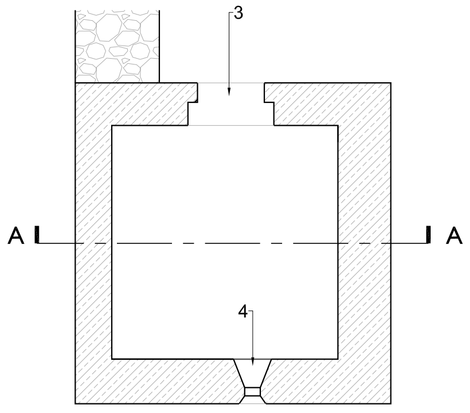
Lower Level Floor Plan

Lower level Ground Floor has an earth floor and stone thresholds.

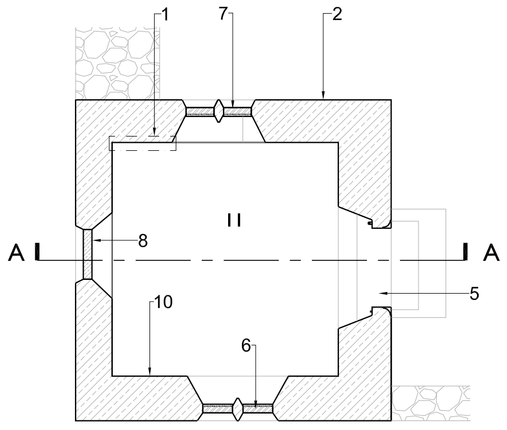
Upper Level Floor Plan

Upper floor level is missing completely.
