Mrs Whiting
Barn behind Endon Bank Farm
Church Lane
Endon

13th July 2009

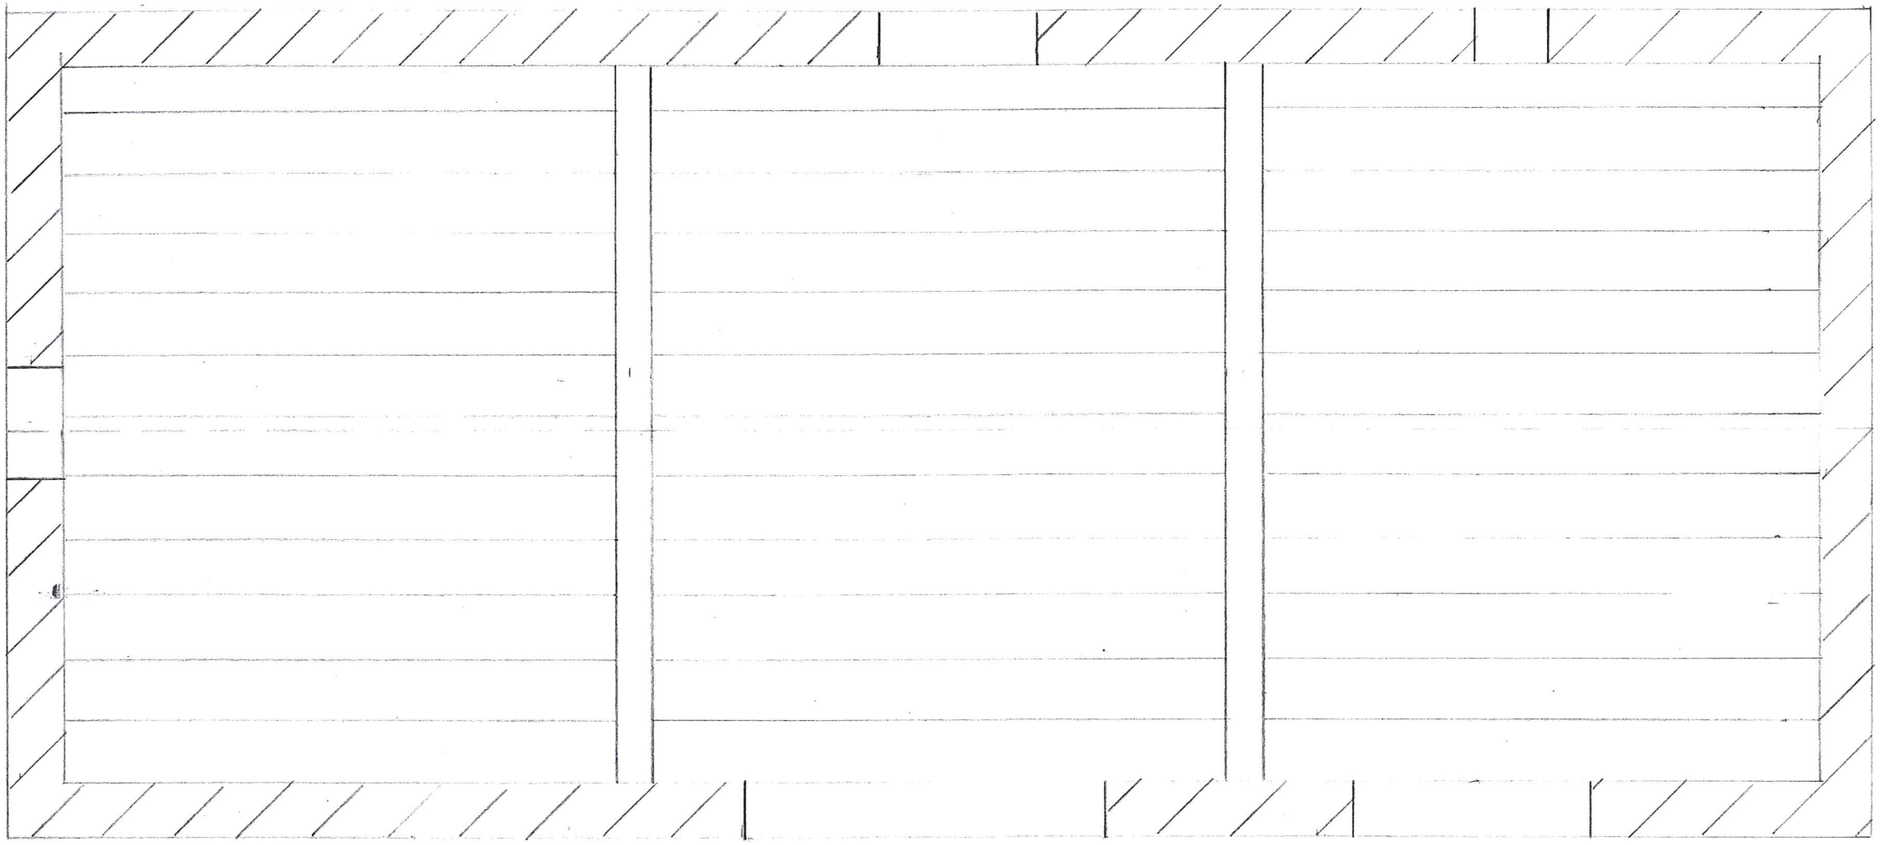
North Gable

Timber beams have been fitted for a hay loft floor and fixed at all points touching external walls to give the building some support so to stop movement to walls and tie the building together.
There is still work to be done to roof, a truss to be put in position and last of beams and slatted floor to go in.

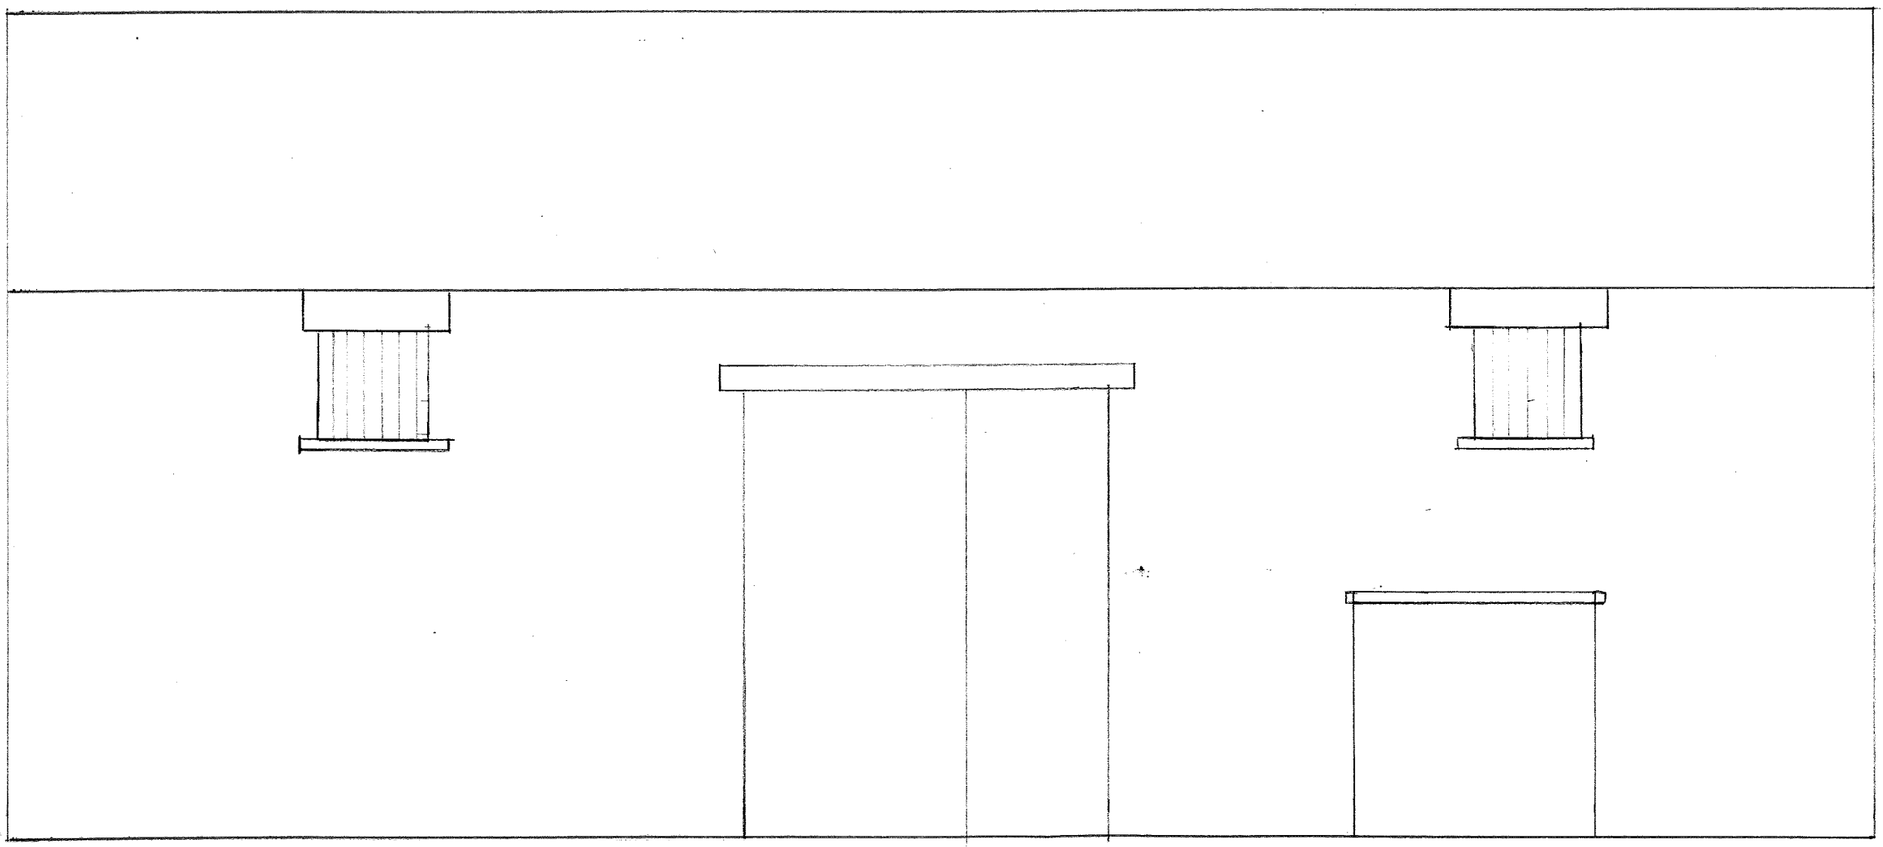
1:50
East Elevation Front

Bad points in stone work have been repointed.
There are around 20 small vent holes to this elevation not shown.
Windows and doors are surrounded by stone quoins and heads and cills, other than opening altered pre 1990.

Roof has been re-roofed with a collared rafter construction with oversized ridge supported by old trusses, this still gives a 3600mm clearance for hay loft.
Re-tiled using felt to avoid tiles being blown off inside through openings in barn.
Pitch hole doors have been reinstated and a set of steel doors to main opening due to their size.
Old openings have been sealed using concrete blocks.

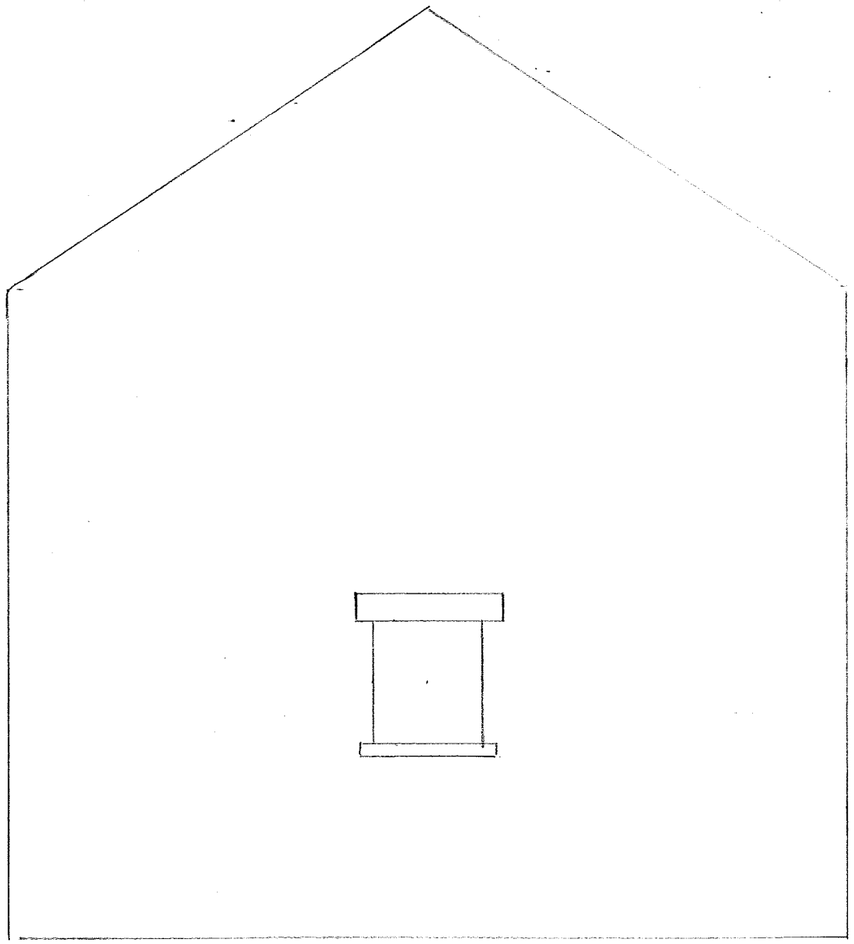
1:50
South Facing Gable

South gable has diminishing ground, so is higher than the North. A pitch hole opening has been added to the South gable to add more light in to dark end of barn, but has since been blocked up. A barn floor has been added to give wall stability as all walls are either bowed or cracked. A slatted floor was to be added suitable for storing hay/straw.

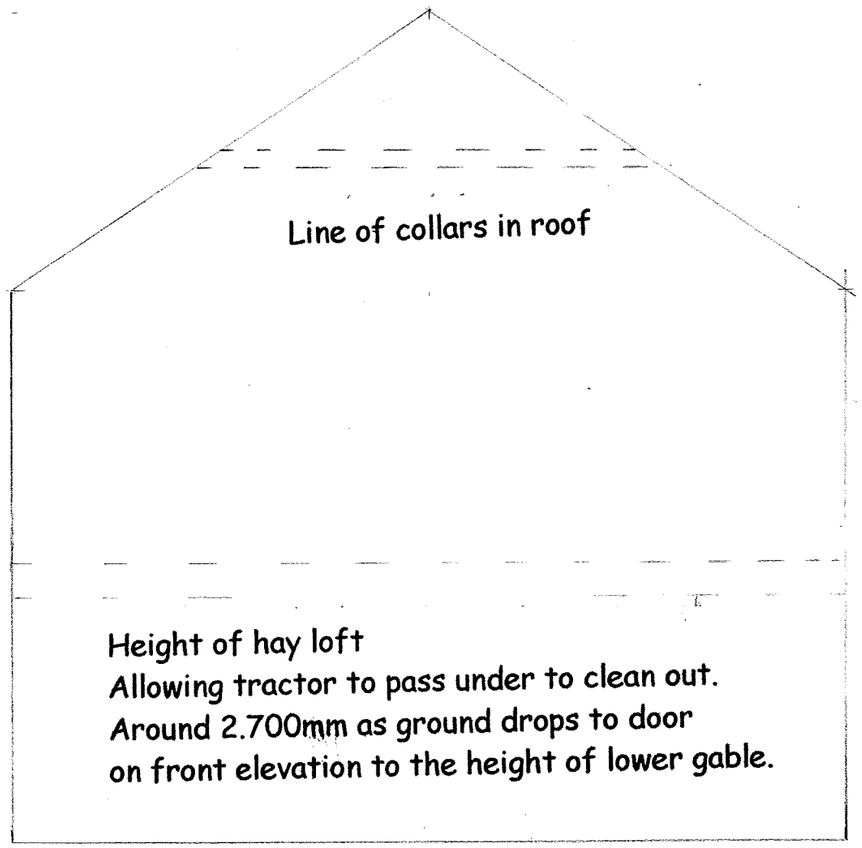
North Facing Gable
Crack to left side has been joint tied and pointed.
Once again small vertical slits are randomly placed across the gables.

Height of hay loft
Allowing tractor to pass under to clean out.
Around 2.700mm as ground drops to door
on front elevation to the height of lower gable.

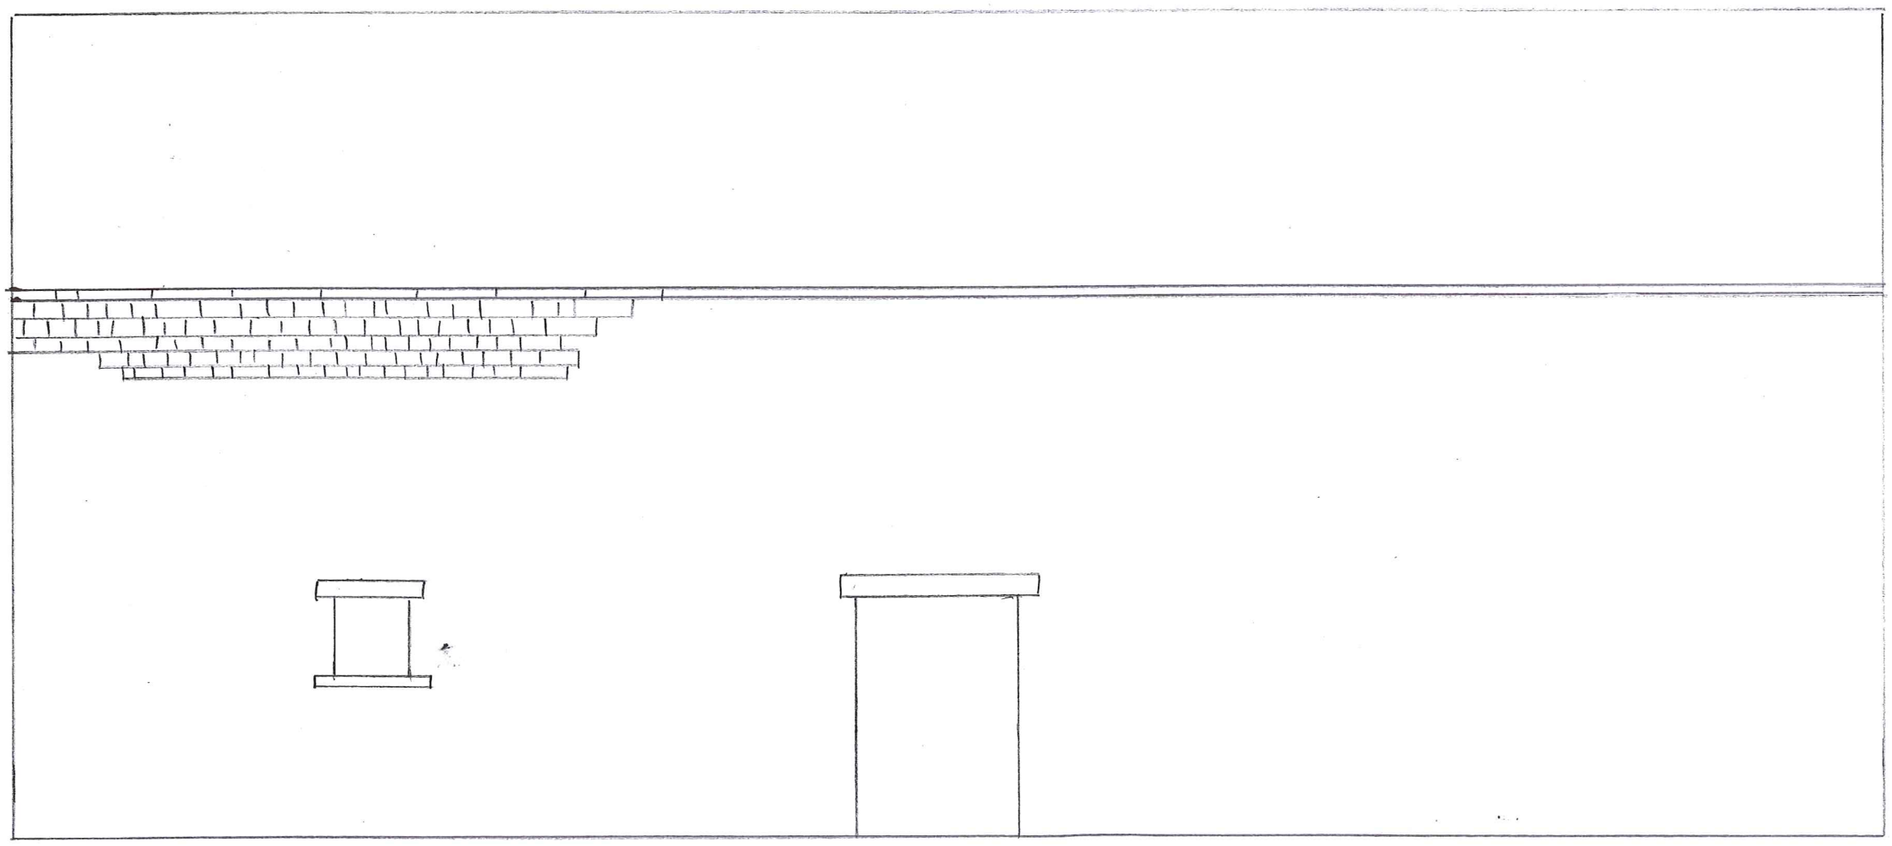
1:50
West Elevation

Small section of back was rebuilt
using fallen stone and lime mortar.
