THE OLD RECTORY, KINGSLEY

CONDITION 7
SMD/2020/0506

SCHEDULE AND PLAN OF HISTORIC PAVED SURFACES

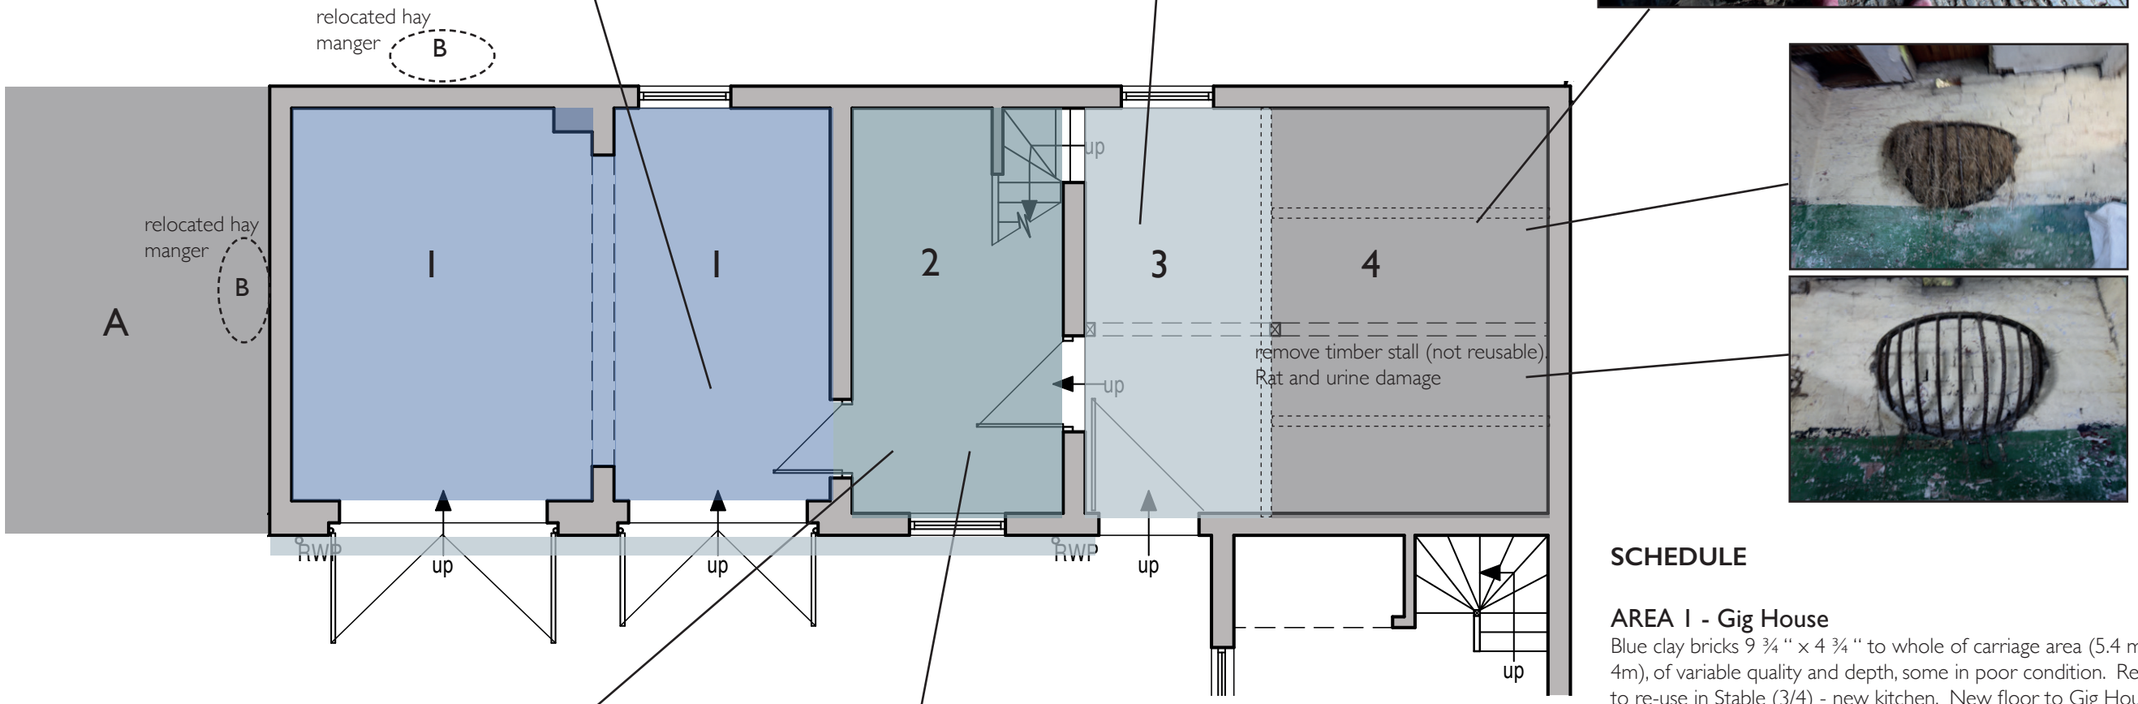
AREA 1 - Gig House
Blue clay bricks 9 ¾ " x 4 ¾ " to whole of carriage area (5.4 m x 4m), of variable quality and depth, some in poor condition. Remove to re-use in Stable (3/4) - new kitchen. New floor to Gig House to be concrete.

AREA 2 - Harness Room
9" x 4 ½ " blue bricks (4.10 m x 2.10m) - 1-inch deep. Relay in-situ.

AREA 3 - Stable gangway
Blue clay bricks - 9" x 1 ¾ " (1.7m x 4m). Very poor condition and mainly broken - majority cannot be salvaged. Re-use small area (2m^2) as edging to external areas if feasible once lifted (e.g. perimeter apron).

AREA 4 - Stable stalls floor
Square setts 4" x 4" (granite or clay, laid to falls, with drainage channel) Area - 2.8m x 3.9m. Drainage channel is not re-usable. Lift and re-lay setts to external area of building (see A on plan - approx. 11sm).

HAY MANGERS
Relocate to gable and roadside elevation (B)
