## MAP REGRESSION

## PHOTOGRAPHS

### Stableblocks

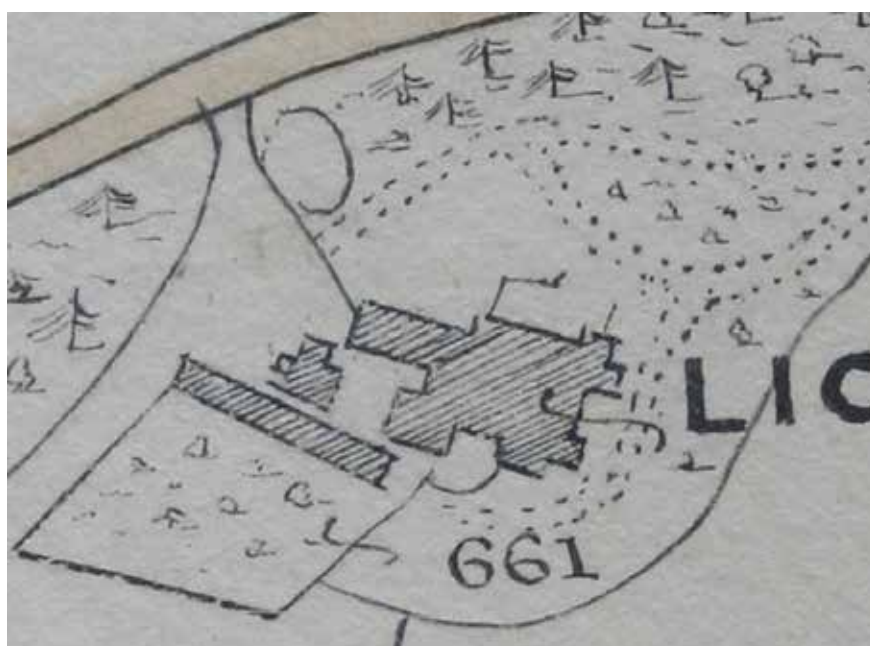
### 1844 Tithe map (detail - left)

The stable range is one continuous, linear block, with the building to the north being detached. This is supported by the surviving physical evidence.

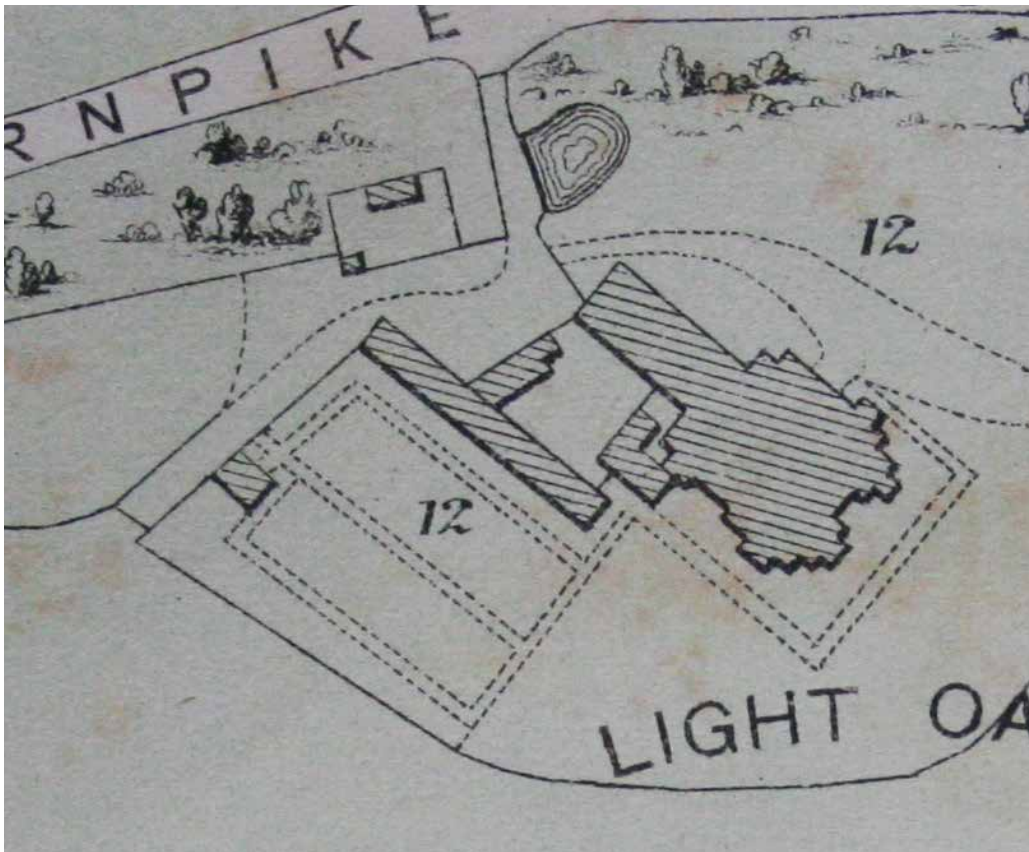
#### 1874 Estate Plan (Lightoaks Deeds) - detail above

By this date the detached enclosed compound with dog kennels had been constructed to the north of the stable block and the stables had been attached to the barn.

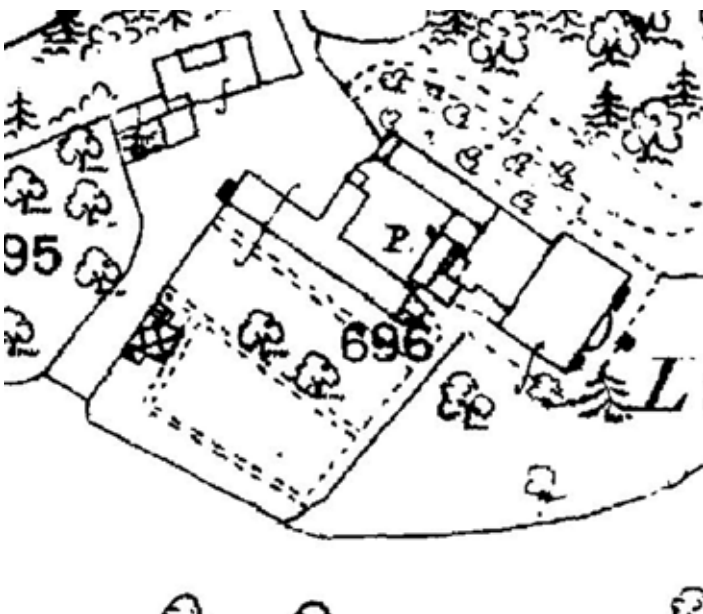
#### 1881 First edition Ordnance Survey map (scale 1:2500) of 1881 - below left

Although the 1881 map shows the buildings as perpendicular to each other, the physical evidence suggests that the foot of the "T" was built on a very slight angle, which is exaggerated in the 1874 estate plan.

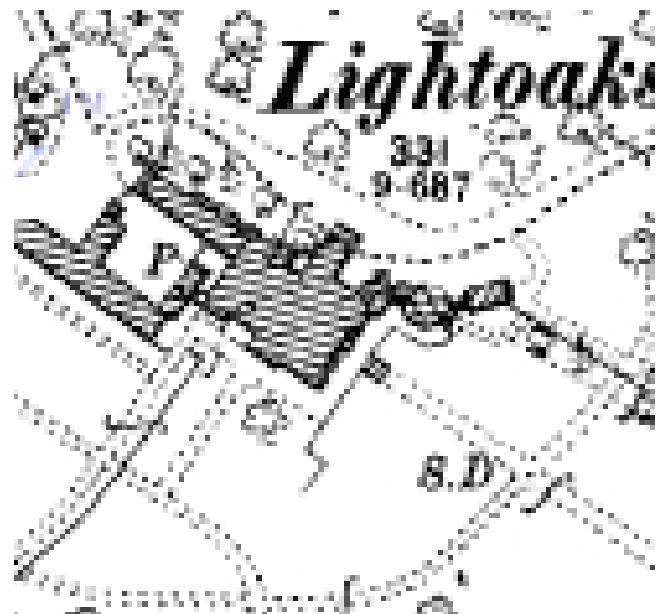
#### Ordnance Survey map (scale 1:2500) of 1900 OS - below right

The harness room had been built during the re-ordering of the main service areas of the house

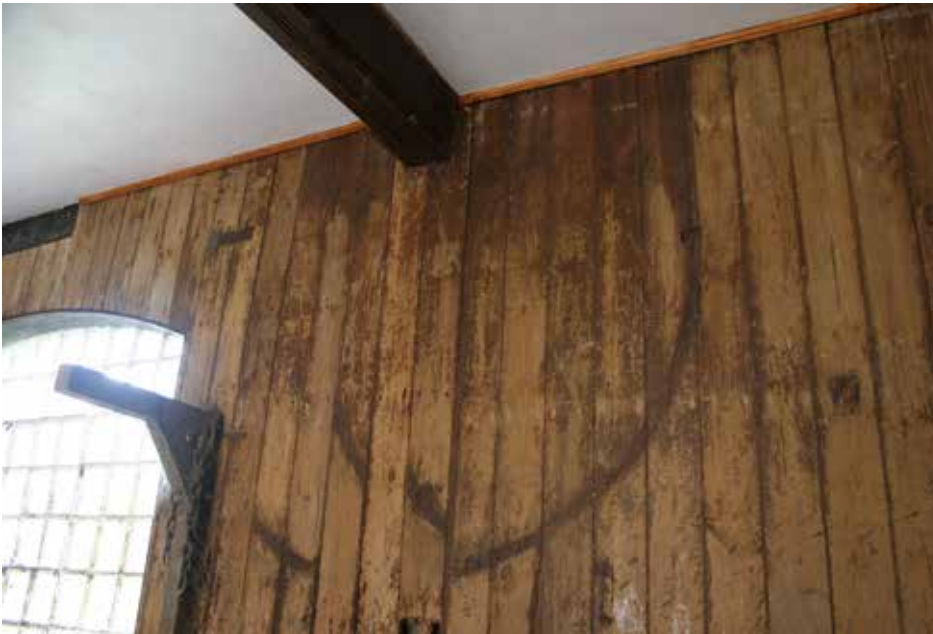
### **Impression - left**

Ghosted impression of both former iron mangers and timber boarded baffles from the c1890 refurbishment within the timber boarded lining to the pair of central stalls - now within the garage

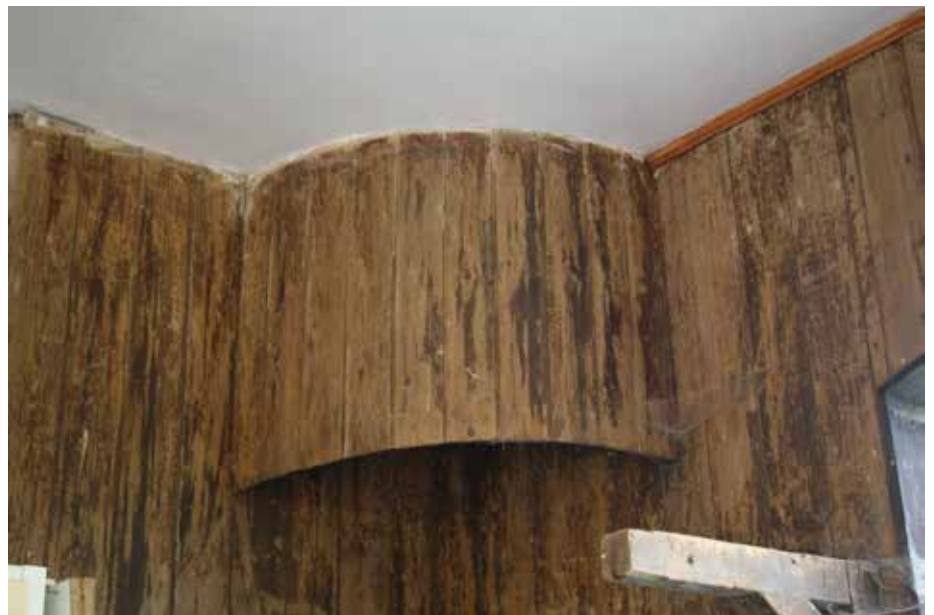
### **Boarded baffle - right**

One of two boarded curved baffles surviving from the c1890 refurbishment and now contained within the garage. This is located below the chute / hatch in the hayloft floor and prevented hay from dropping onto the stable floor

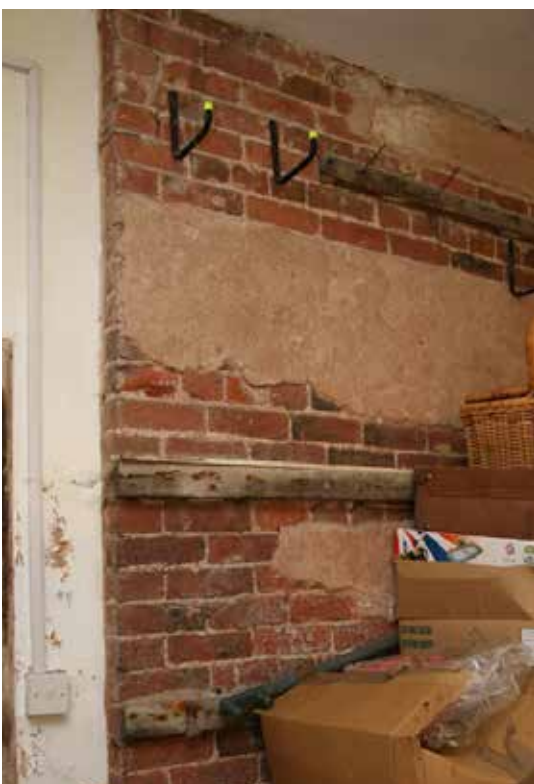
### **Eastern Stableblock - below**

Brick party wall between the two stables. The brickwork may have been plastered originally, and later battened to take the boarded lining of c1890, which has been removed from this wall

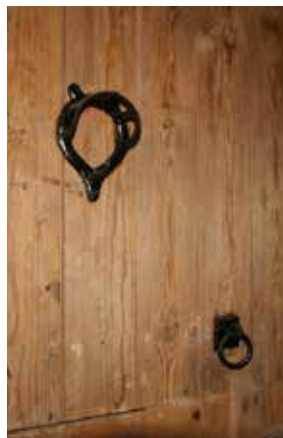
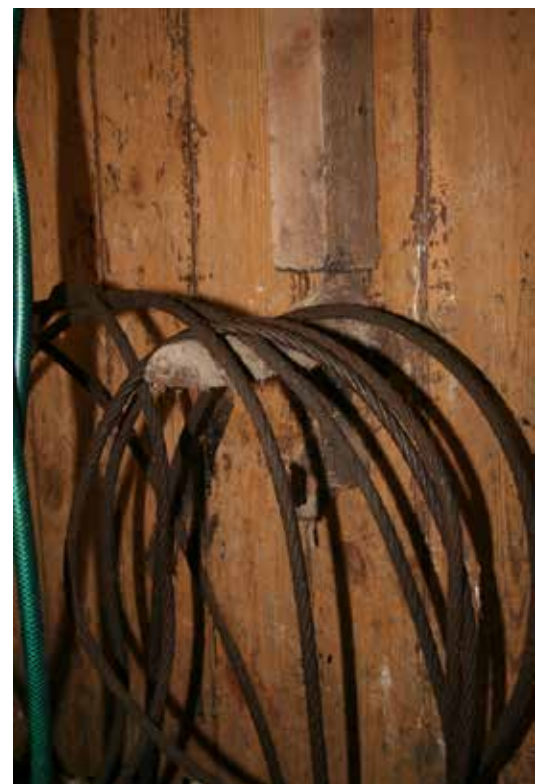
iron bracket for a saddle or harness, one of many Musgrave's fittings of c.1890.

**Below** - harness bracket and tether ring

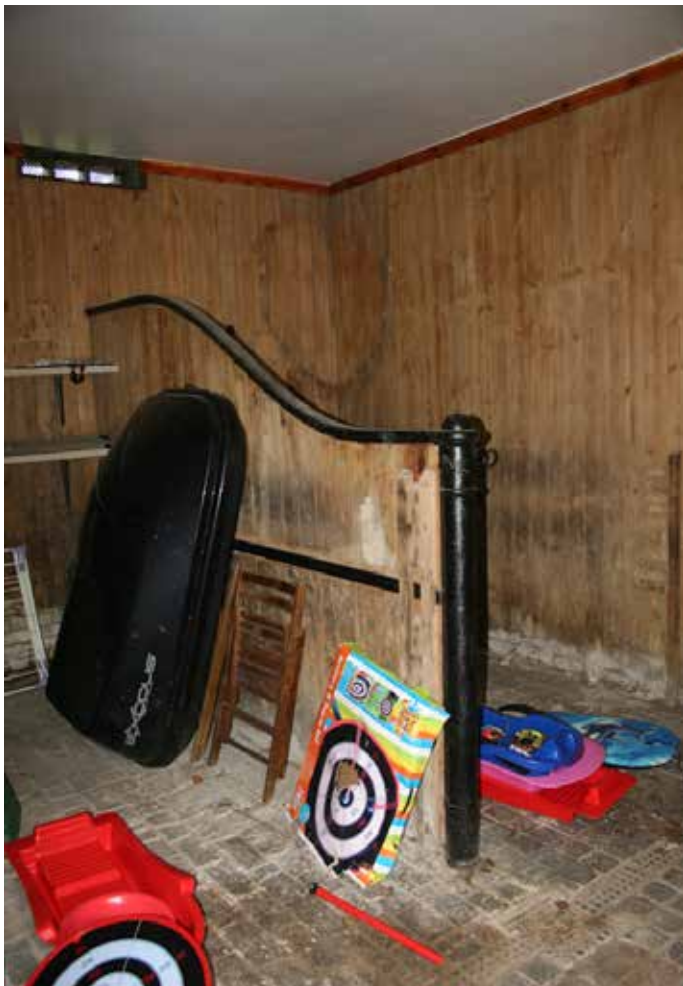
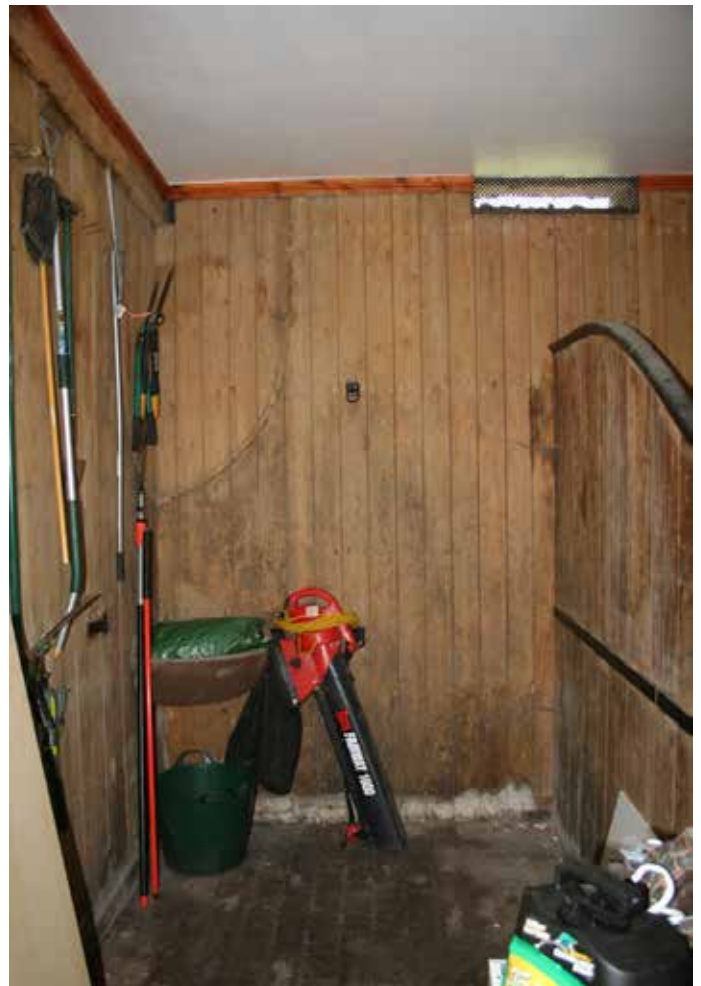
### **Stable fittings and stalls of c1890 by Musgrave's of Belfast**

Musgrave's Patent horse stall fittings with iron 'ramp', iron 'barrier sheath' and cast-iron post with integral tether rings.

Musgrave's cast-iron posts in-situ, of c.1890, cast-iron water bowl. The original mangers, probably also by Musgrave's, have all been removed.

Timber-boarded linings were probably made locally by a joiner and are very simple, compared with many of Musgrave's bespoke stable fittings, which incorporate ornate metal stalls.

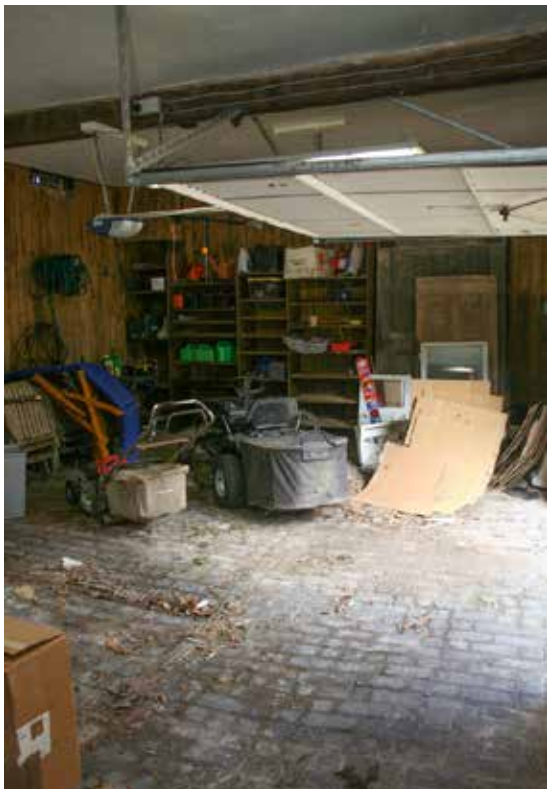
**Far Left** - garage replaced four stalls but linings and blue-brick paving was retained

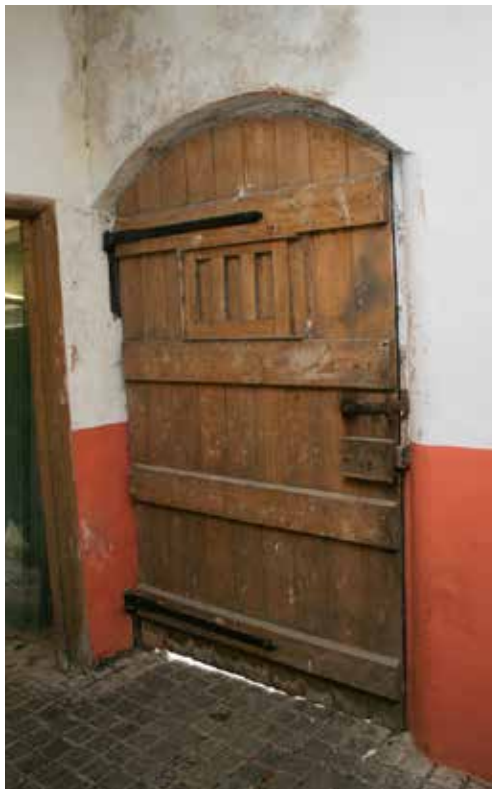
**Left** - boarded door to the stable on strap hinges with sliding hatch for ventilation (possibly a late C19 replacement of the original 1820s door)

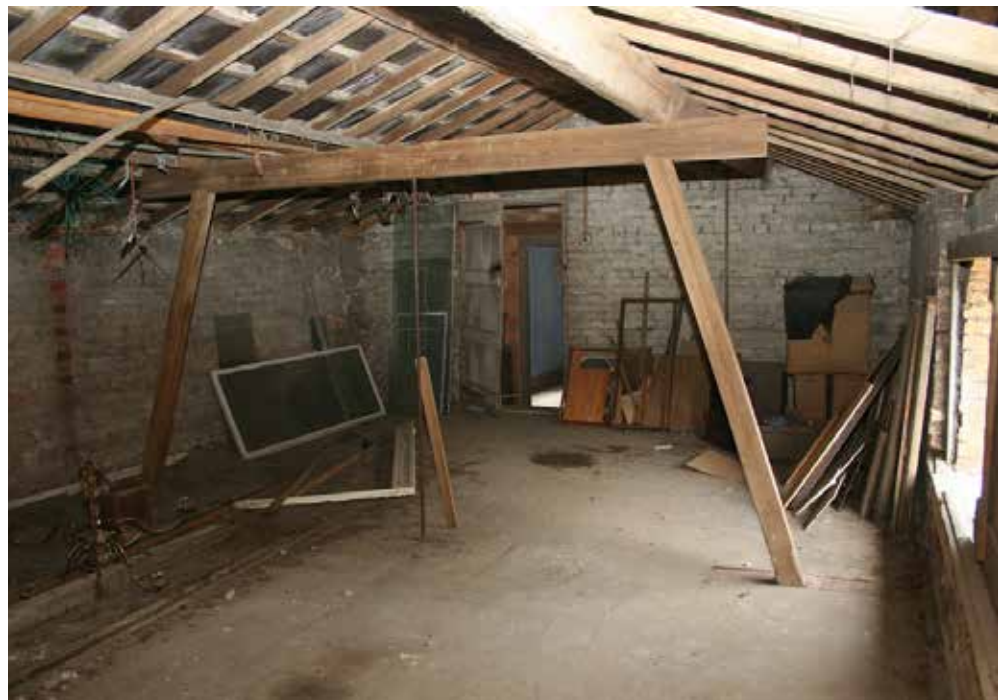
### **Hayloft - right**

The two bays over the garage were adapted, the original brick dividing wall removed and replaced with a pair of struts, collar and tie-rod to support the purlins in the 1890s.

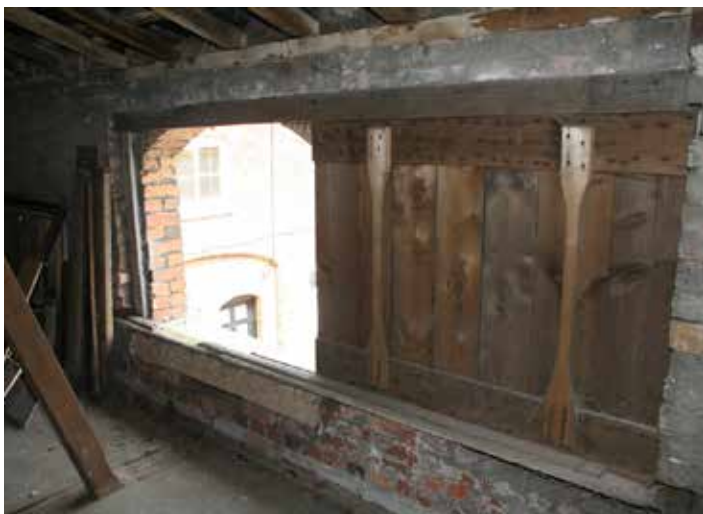
horizontal sliding shutter to hayloft over garage (late C19) in original opening

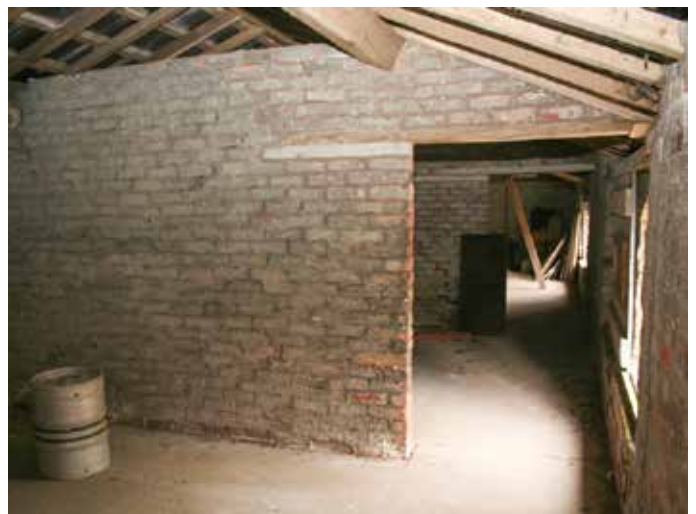
**Below right** - original brick dividing wall over the stalls to the eastern bay

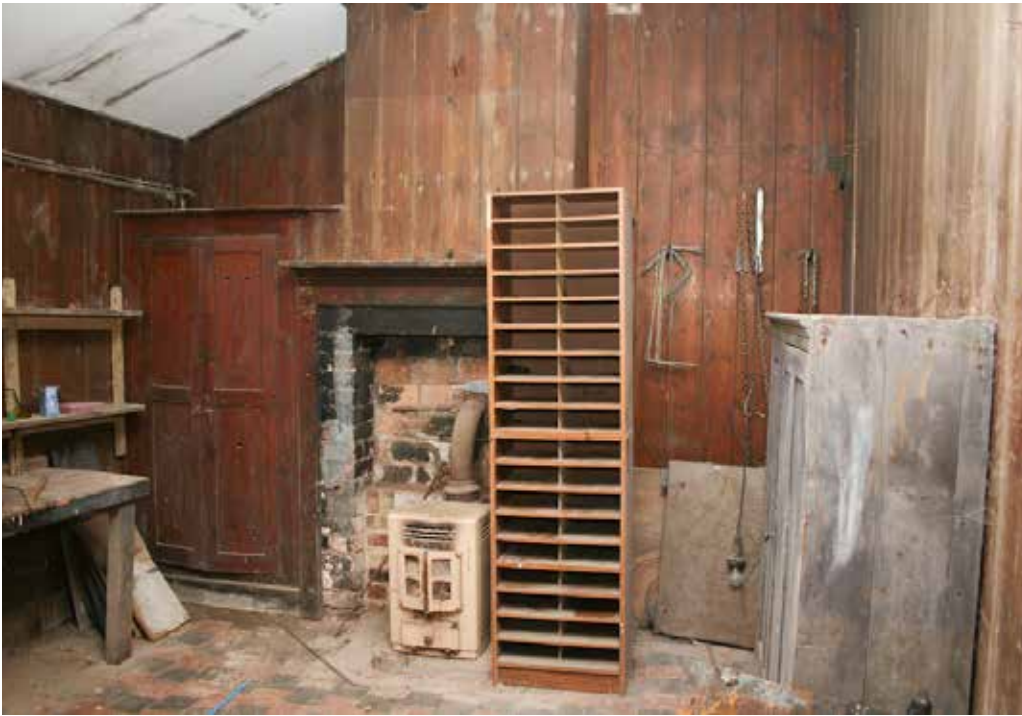
### Above - Harness Room

The Harness Room dates from c1890 and contains a fireplace to provide heating for the groom and stable hands whilst they worked on maintaining the harnesses. The original stove has been replaced.

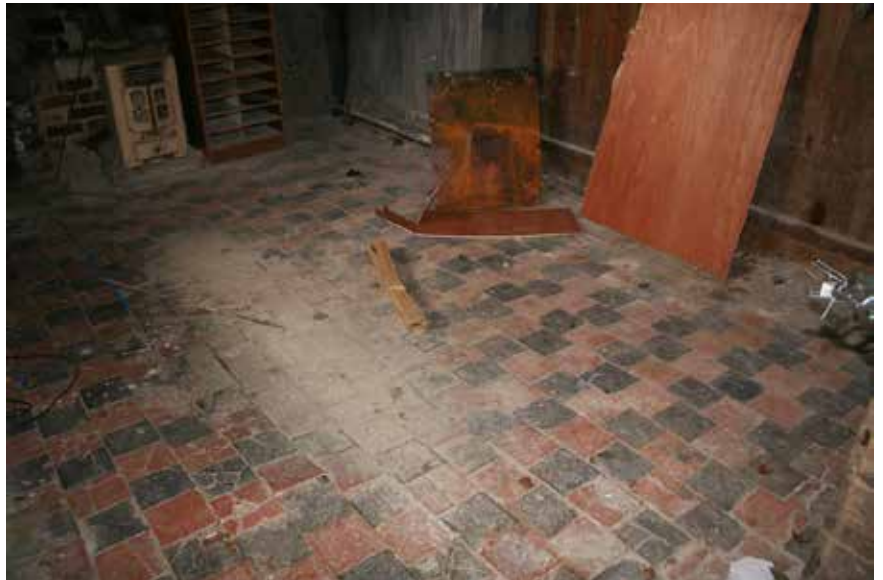
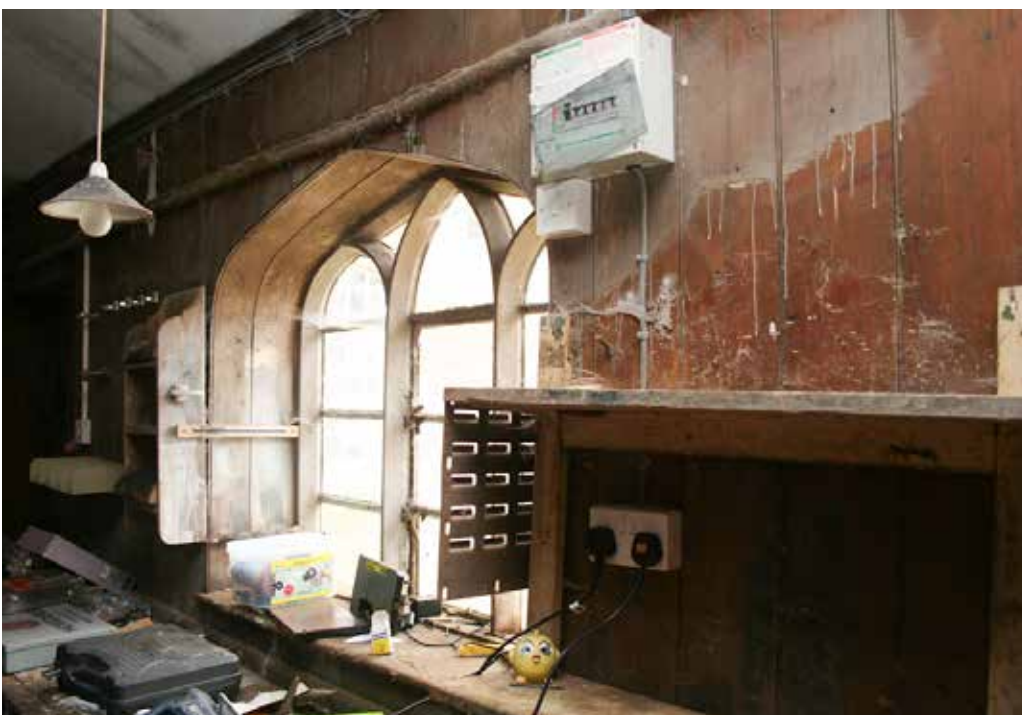
### Harness Room - courtyard wall

**Right** - red and blue tiled floor of the Harness Room, c.1890

The Harness or Tack Room was also lined in boarding, with scratch mouldings. The detail of this and the Gothick arched window suggest an early 19th century detail, but the map regression proves otherwise. The earlier window was re-used in this location. Fittings for the harness room were designed to create a dry environment for the tack: harnesses, saddles and bridles, although the fittings have been removed.

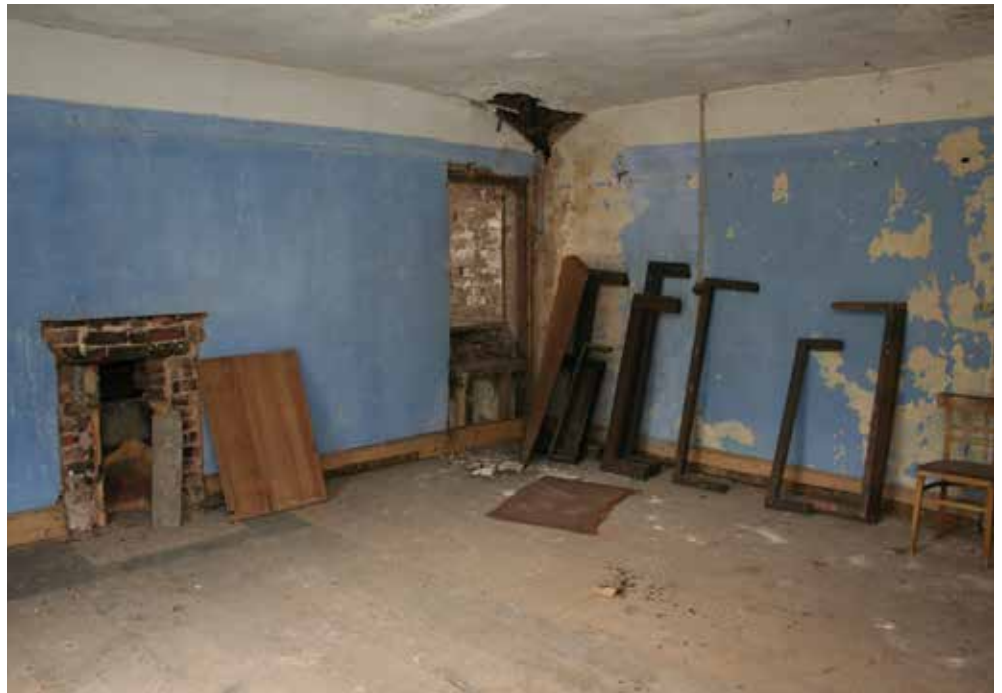
Right - fireplace hearth has been removed. This was a later addition when this part of the building was made into habitable accommodation

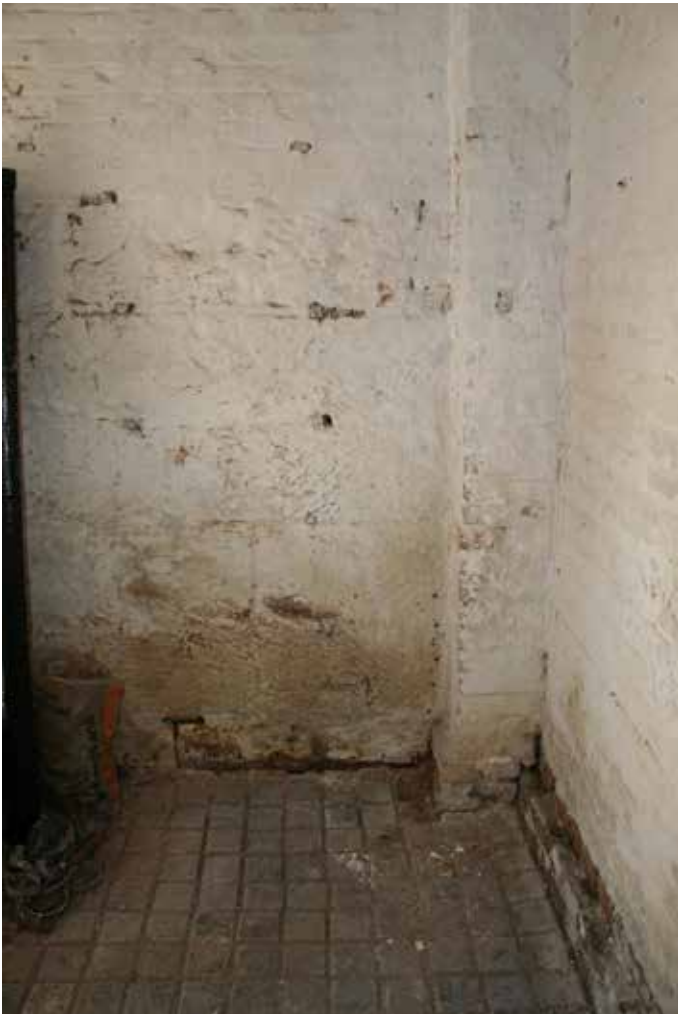
Above left - stone masonry wall, at low level to the internal cross wall, with six courses and large blocks of regular tooled pink ashlar, probably the remnants of an earlier building, with later blue brick floor.

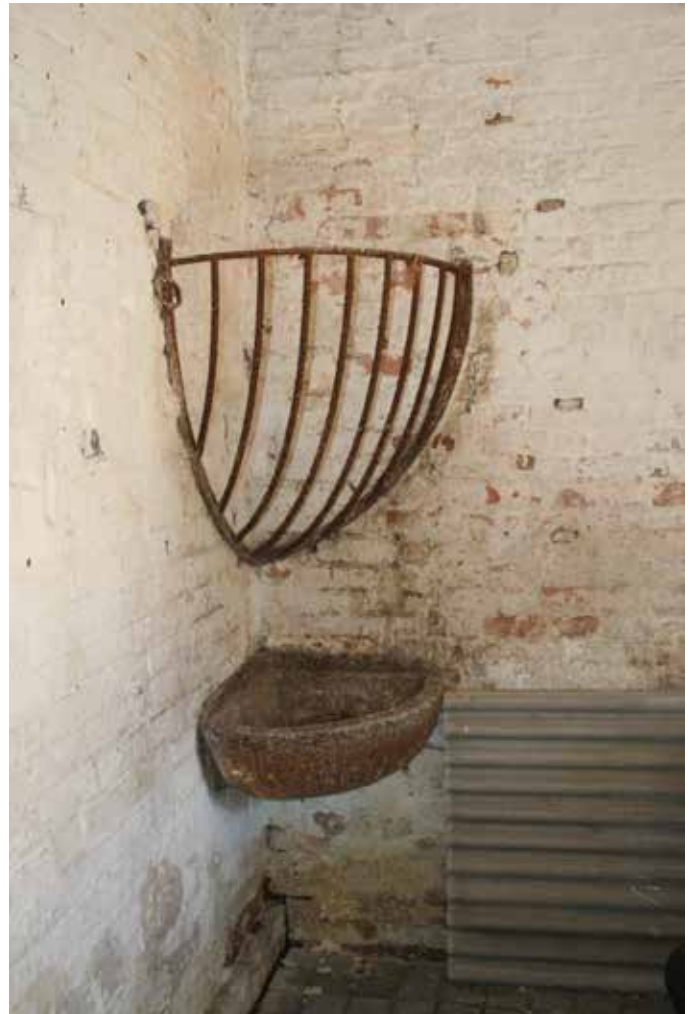
Above right - the only original iron manger left within the complex is contained within the stable to the Bothy and a cast-iron water bowl or mash bowl, both by Musgrave's, ca. 1890

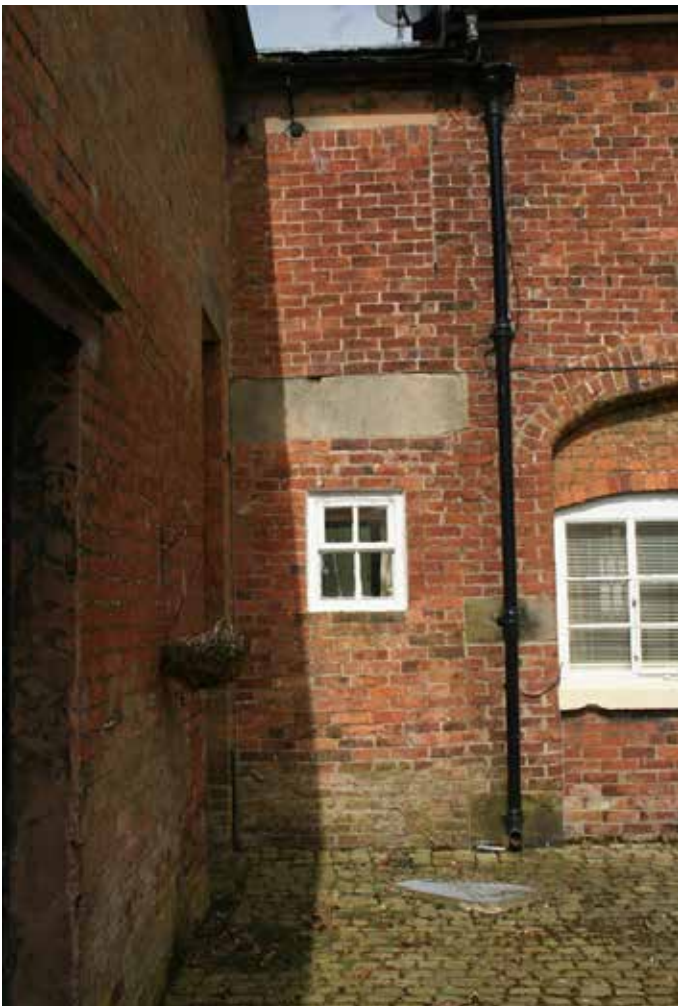
Left - junction of The Bothy and the Stables - the gap was infilled by 1874 and had a ground level doorway (later infilled), which would have provided a through-route to the outer stable yard and a first floor hay loft or window.

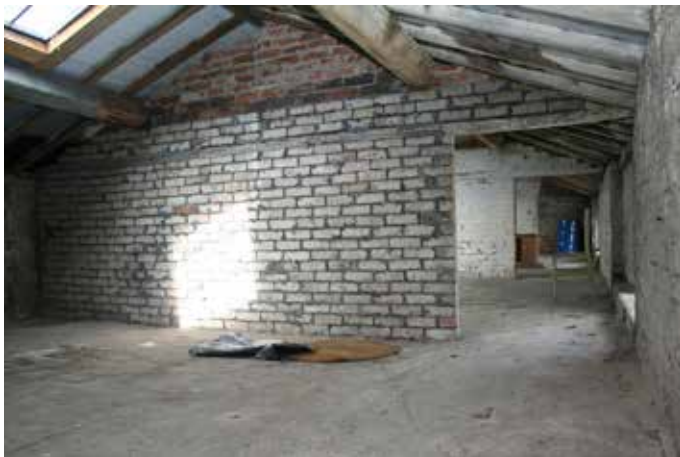
Above left - first floor - the eastern bay was retained complete at this level with the same arrangement of shuttered openings to wall.

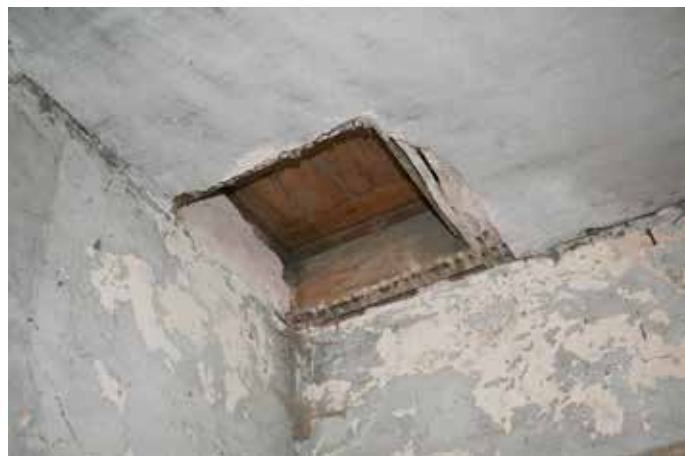
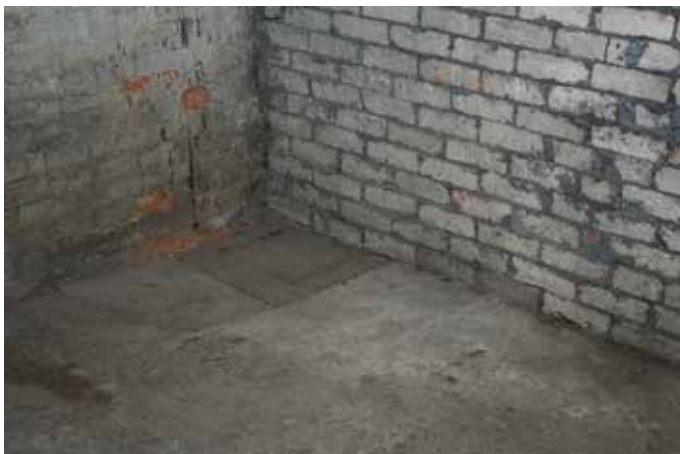
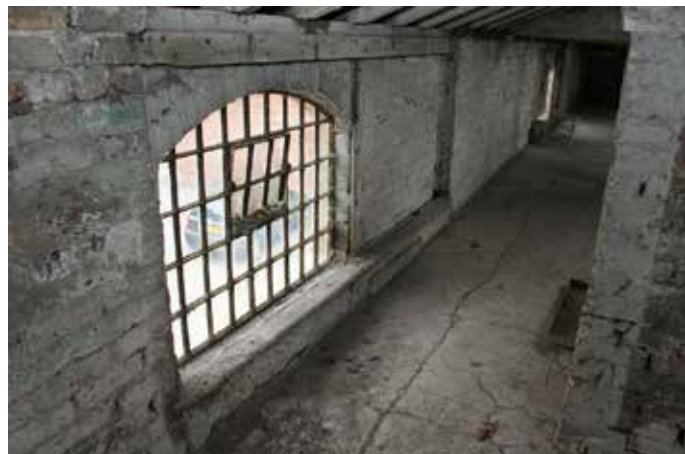
Above right, below and right- original feed hatches and plastered ceilings for the stables were retained in-situ in each corner of this block

Below right - cast-iron fixed lights were installed to replace the original sliding shutters. The rebated brickwork for the shutters remains in-situ

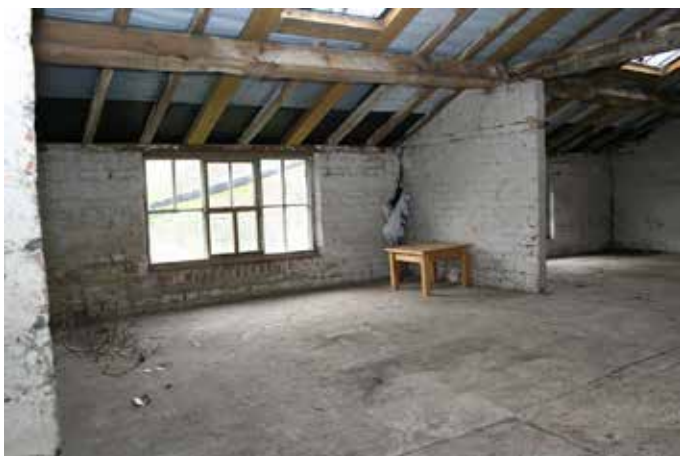
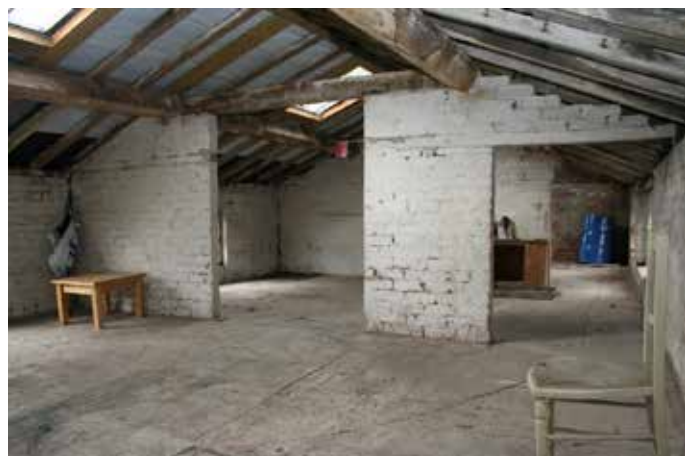
### **First floor - below left and right**

The central two bays to the first floor of the 'laundry wing' were opened up, with the removal of a large section of central brick wall and additional windows were inserted to create a usable room, whilst lime-ash floors were retained in-situ. The purpose of the rooms is unknown at this late 19th century date.

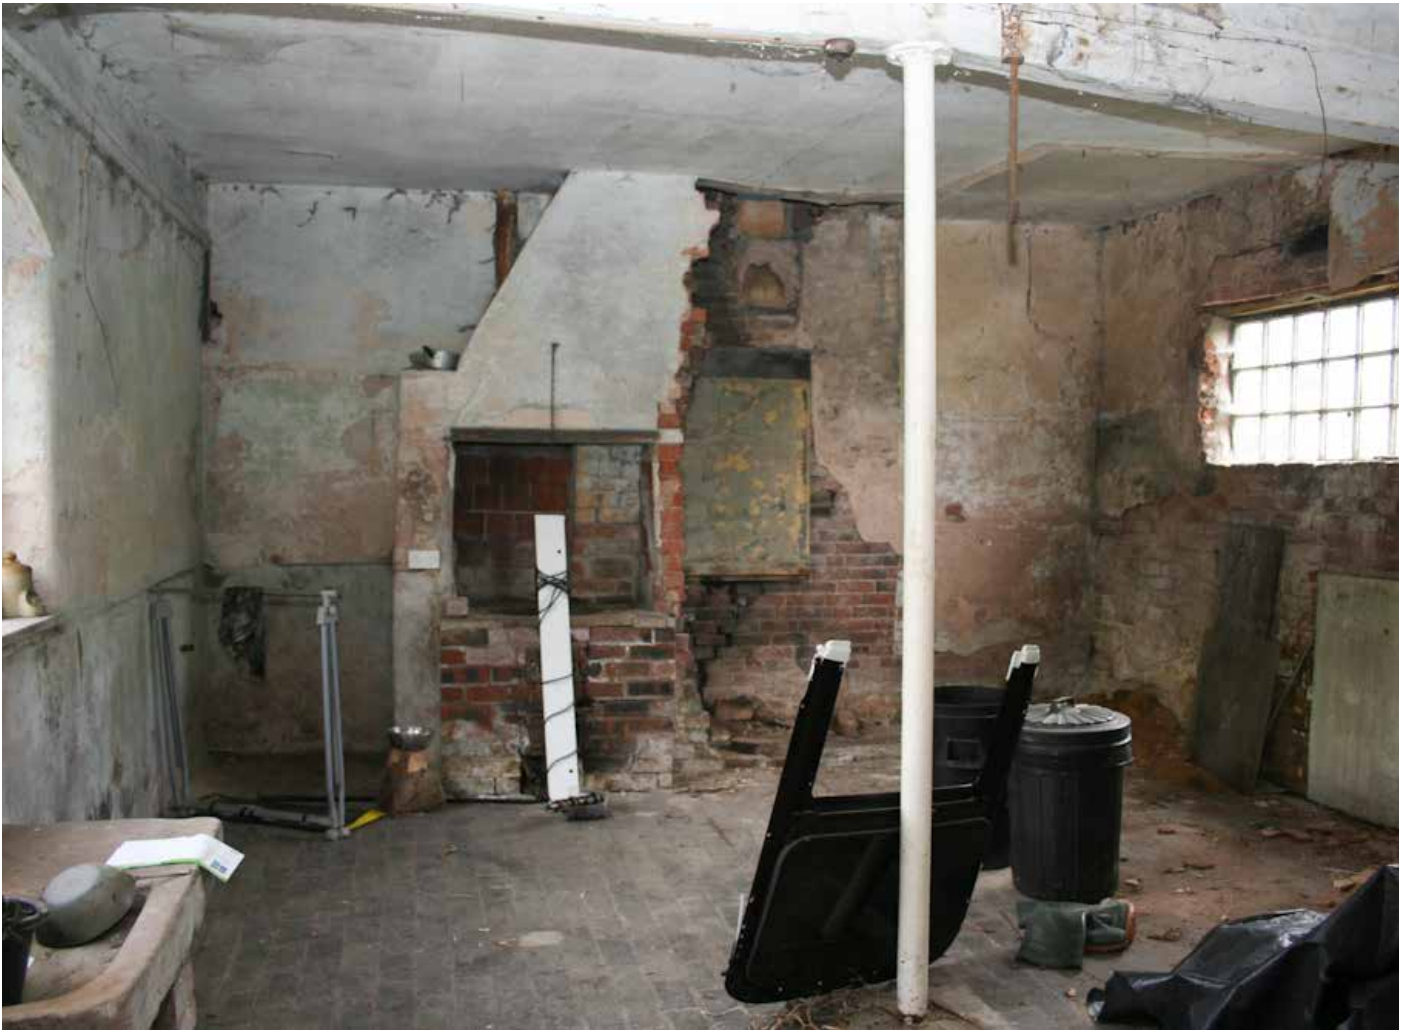
### **Western Stableblock (Ground Floor)**

Late 19th century Laundry Room, converted from a pair of stables (four stalls). The internal dividing brick wall was removed at ground floor level and replaced with an oak beam and cast-iron post, supporting the loadbearing brick wall above and the joists.
