**Building Fabric Condition Assessment**

**PLANNING APPLICATION FOR THE CONVERSION OF A REDUNDANT  
GROUND FLOOR SHOP/RETAIL PREMISES (AND BASEMENT) CURRENTLY  
CLASS A2, FINANCIAL AND PROFESSIONAL SERVICES AT 1 CLERK BANK,  
LEEK ST13 5HE, INTO A RESIDENTIAL DWELLING**

**DECEMBER 2015**

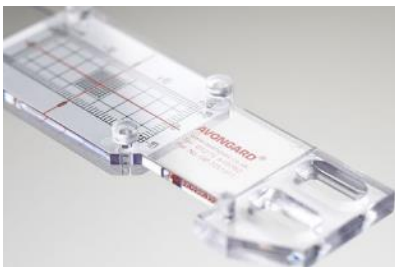
It cannot be determined from this inspection whether the cracks in the masonry were evident in 2003 when the remedial work was carried out, and if they were whether they have moved since, and the gaps continued to grow. With the benefit of time, there are recognised methods to monitor movement cracks and displacement on masonry and other structures such as fixing a tell tale as the image below and recording the position / gap over period of time. However in this instance it would not be practical or cost effective to leave the structure for any length of time to determine any movement.

The structure is exhibiting signs of structural defect and any movement should be arrested before serious defects occur within the building leading to partial collapse.

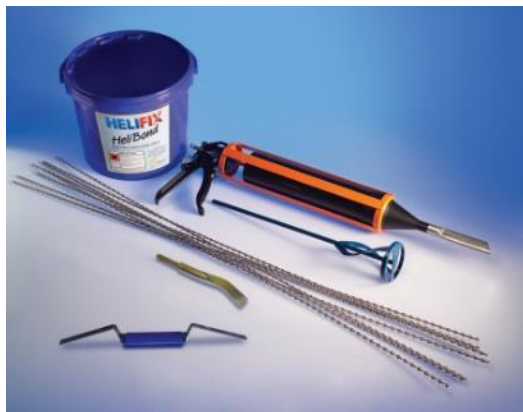
Building regulation would require a minimum of 665mm of brickwork on a corner to the side of a door or window to ensure stability of the corner, unless a steel column is incorporated within the wall, or similar. The slender corner has allowed the wall at right hand (as viewed from the front) to bow out under the load from above. To counteract the effect of weight of the walls, etc from above onto the steel beam(s) which tend to naturally press down and outwards in a sort of pyramid fashion, which is resulting in the slender walls being pushed out. It is proposed to build up the masonry to the side of the window to increase the width of the masonry return by approximately 375mm . equivalent to 1 ½ brick lengths (of those in the building) using engineering bricks, or concrete blockwork laid flat to provide additional support to the steel beams above, and tied into the existing brick structure using stainless steel crocodile ties. The existing brick corners at the side of the window, currently exhibiting cracks in the pebble dash render are to be tied/stitched together to prevent any further movement, before building the additional masonry, to tie the front of the building together at ground and lower half of the first floor, where the walls have bowed. The corners to be stitched using stainless steel helical bars inserted into holes drilled across the corner of the masonry (pebble dashed render removed to facilitate and to cover over following installation of metal stitching). A series of holes at every 4<sup>th</sup> brick course, through the bricks to be drilled at approx. 45 degrees off centre through the corner of the masonry from the front wall diagonally into the side wall, deep enough to penetrate into the outer leaf, but not too deep to protrude through the other side. Helical stainless steel rods to be pushed into the holes into the holes packed with chemical resin grout to bond the brickwork and tie the corner of the building together to prevent further movement.

The additional masonry added to widen the piers to the side of the window, together with the metal stitching and ties will ensure the pyramid effect of the weight of the walls, etc bearing down on the ends off the steel beam cannot move the wall outwards any further.
