Structural Appraisal

Property: **THE BARNS LOWER FARM**
CONSALL

Date: November 2016

Project Ref: 16397

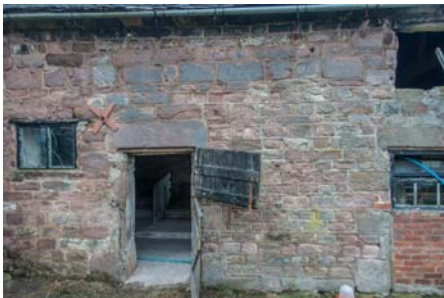
BUILDING '2A'		
4.21	Masonry (Walling)	
	Common Defects:	
	<ul style="list-style-type: none"> Inherent material defects i.e. poor firing, material selection, mixing. External environmental influences i.e. aggressive chemicals, sulphate attack, freeze thaw action, weathering. Physical damage i.e. collision, associated defects i.e. eccentric loading. Poor Repairs incorrect pointing. 	
	Observations:	
	Stone: No significant material defects noted, localised mortar loss on external face.	P36

Comment:	
	Two elevations have been reconstructed recently the remainder appear satisfactory localised superficial surface degradation noted in stone and brickwork.
