**DAYTIME BAT SURVEY &
ECOLOGICAL SCOPING SURVEY AT
LAND OFF BROOK STREET,
BROWN LEES, KNYPERSLEY,
STAFFORDSHIRE**

JULY 2017

RACHEL HACKING ECOLOGY

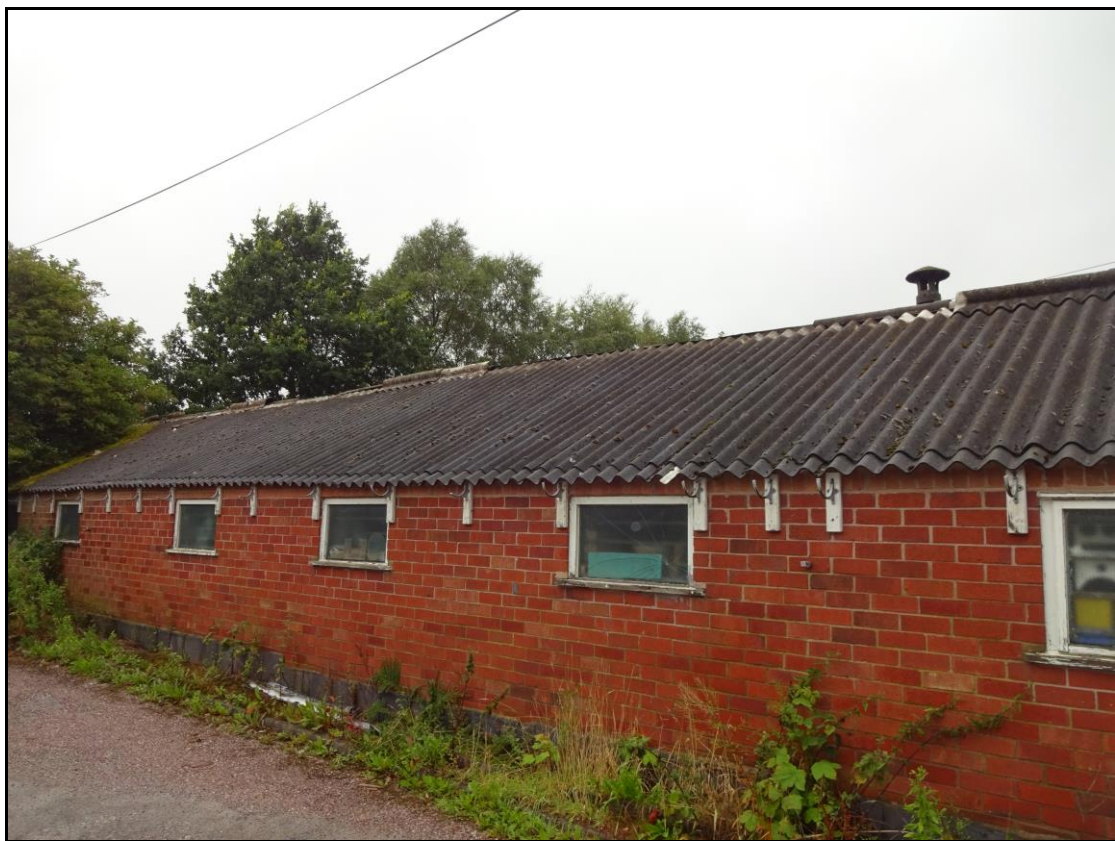
- 3.1 The main workshop is a single-storey brick-built warehouse with a flat roof (see Photograph 1 and the front cover of this report). It has been extended to the northern elevation. The external brickwork is in good condition, with no missing bricks or damaged mortar. The wooden windows and doors are in good condition. These are flush with the brickwork, heavily cobwebbed and do not provide potential bat access points into the building or a suitable bat roosting cavity. The roof of the building is constructed of corrugated metal panels and roofing felt. The roof appears to be in good condition, although the view was limited. The edges of the roof are well-sealed, particularly on the corrugated pitched roof which has been sealed with mortar beneath the eaves, preventing any bat access opportunities.
