## THE TOWER, COMPTON MILL, LEEK

### Schedule of Repair Work

Chambers Conservation Ltd, March 2018 – Issue 2

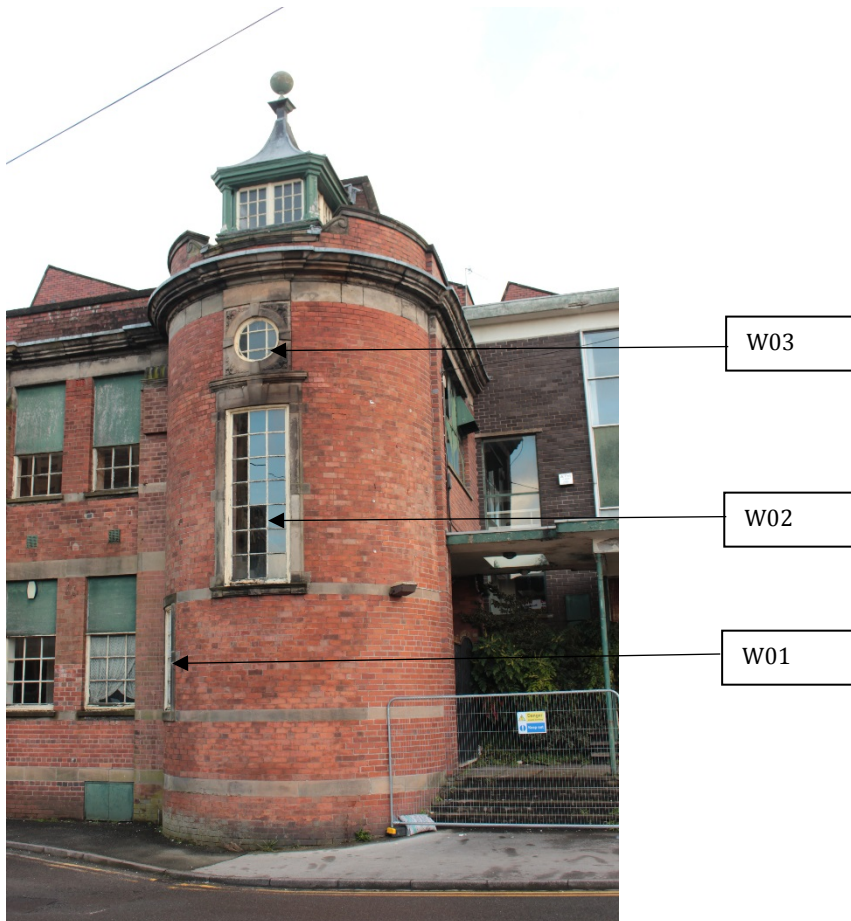
There are three different windows (aside from those in the lantern). Two rectilinear, fixed-light casement, and a circular oculus at high level. As indicated on the reference drawing, these windows are referenced, starting from the ground up, as W01, W02, W03. Works are referenced accordingly. Note W01 and W02 are **curved** and replacement sections will therefore have to follow the appropriate radius.
