SUTTON BARN, BROOK LANE, ENDON

LEVEL 3 SURVEY

Prepared on behalf of MR and MRS D PENNINGTON

21ST SEPTEMBER 2016

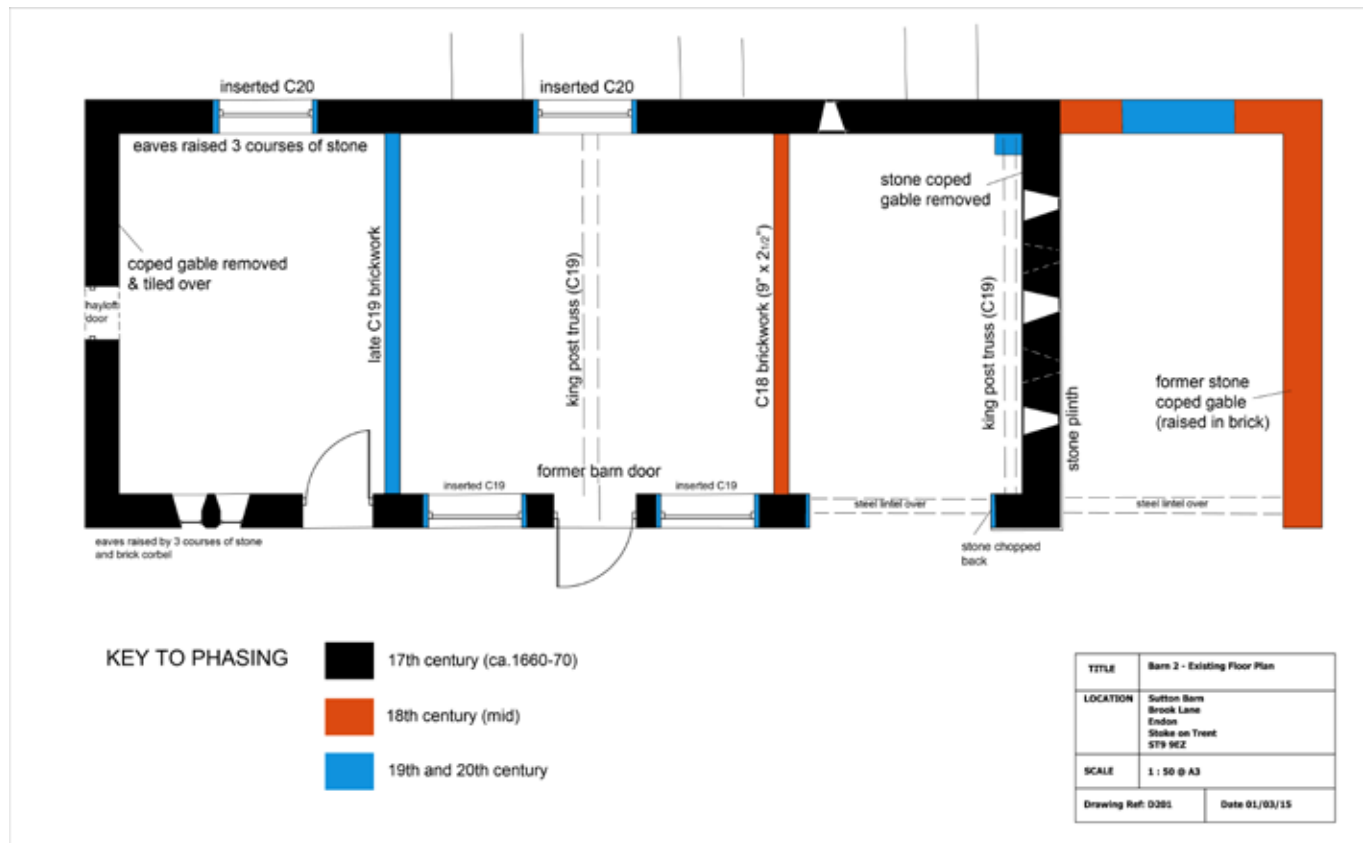
Plate 1 - Phase drawing showing the development of the building, as: Phase 1 - a stable and barn, Phase 2 - as a stable and cowhouse, Phase 3 - as a stable, cowhouse, store and cart bay, Phase 4 - stable, milking shed and two cart bays

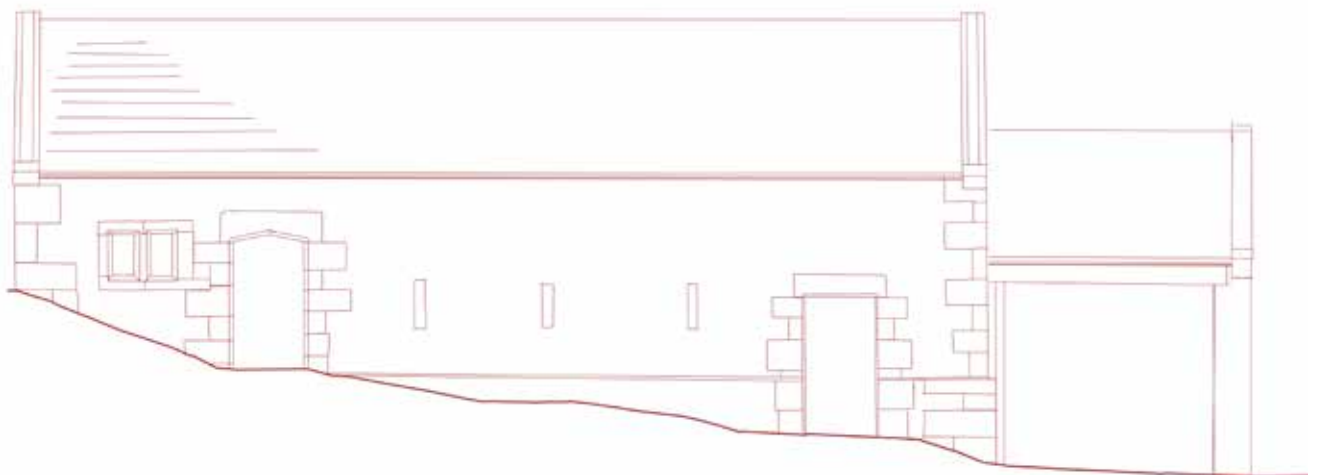
Plate 2 - Reconstruction drawing showing the probable appearance of the 17th century combination barn and stable, with the later 18th century cart bay, prior to 19th century remodelling

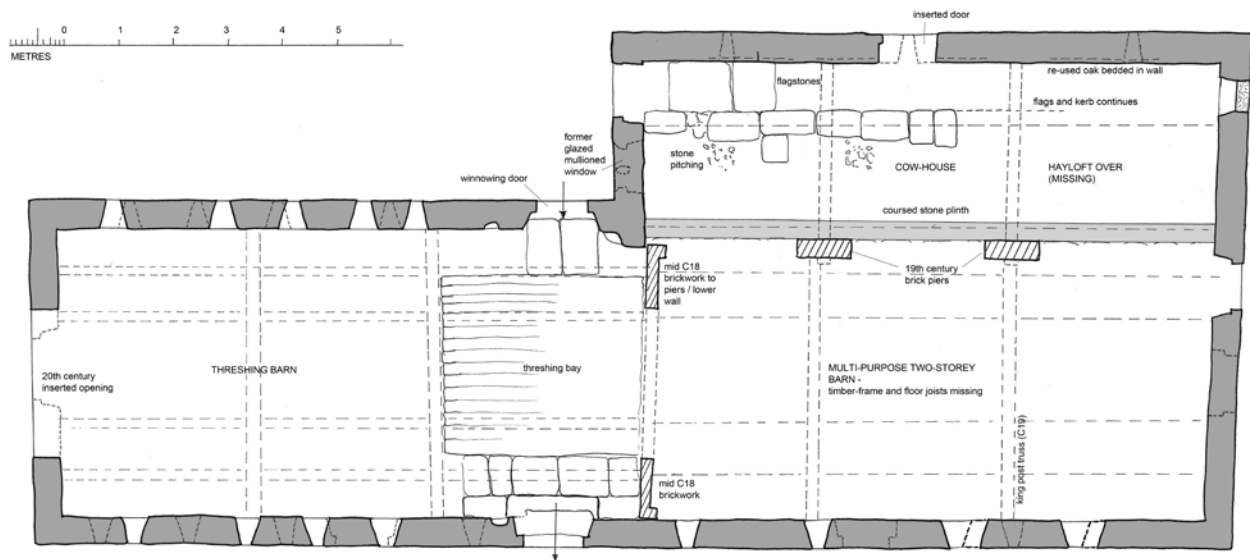
Plate 3 - Bank Barn - measured survey drawing overlaid with notes. Main phase is illustrated in dark grey tone. Inserted brickwork is hatched.

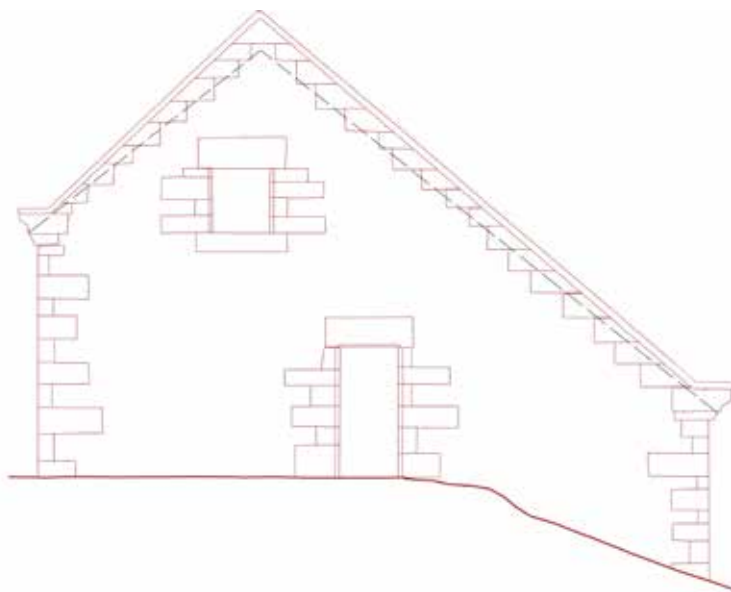
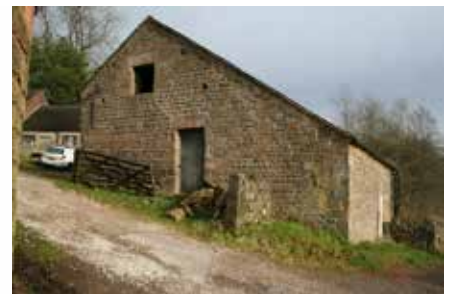
Bank Barn - reconstruction drawing of the south elevation showing the original form of the roof with stone copings and the current pitch and alignment (dotted)
