HBL ASSOCIATES LTD.
STRUCTURAL REPORT

RIDGEFIELDS FARM

CELLARHEAD

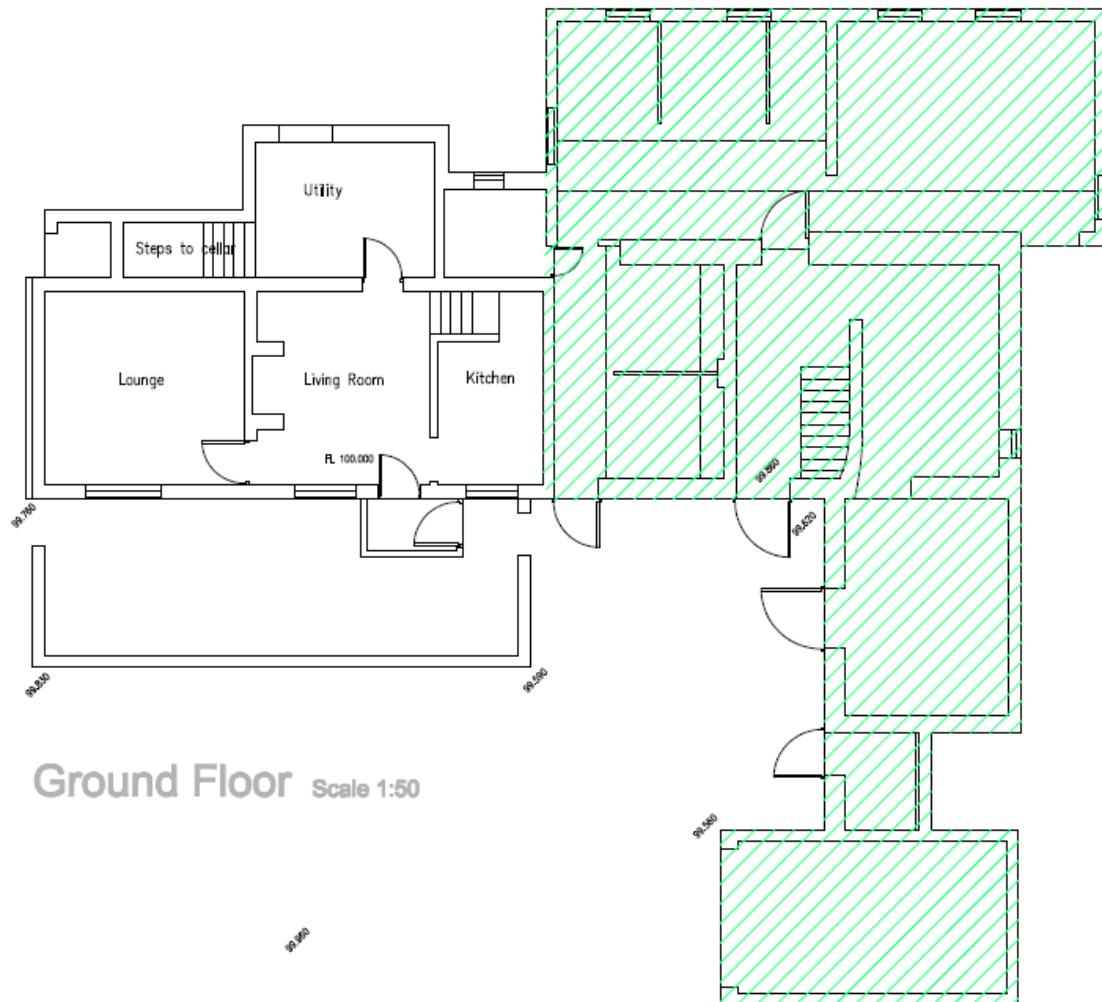
Figure 2-1

- 2.1. The extent of the existing buildings examined are shown coloured green in the plan below and take the form of a two storey section of barn with an internal staircase flanked on either side by a single storey outrigger to the rear and a smaller single-storey store and garage building to the front.
