## **Building Fabric Condition Assessment**

### **PLANNING APPLICATION FOR THE PARTIAL DEMOLITION OF THE SINGLE STOREY PORTAL FRAME BUILDING at 14 FOUNTAIN STREET, LEEK**

March 2021

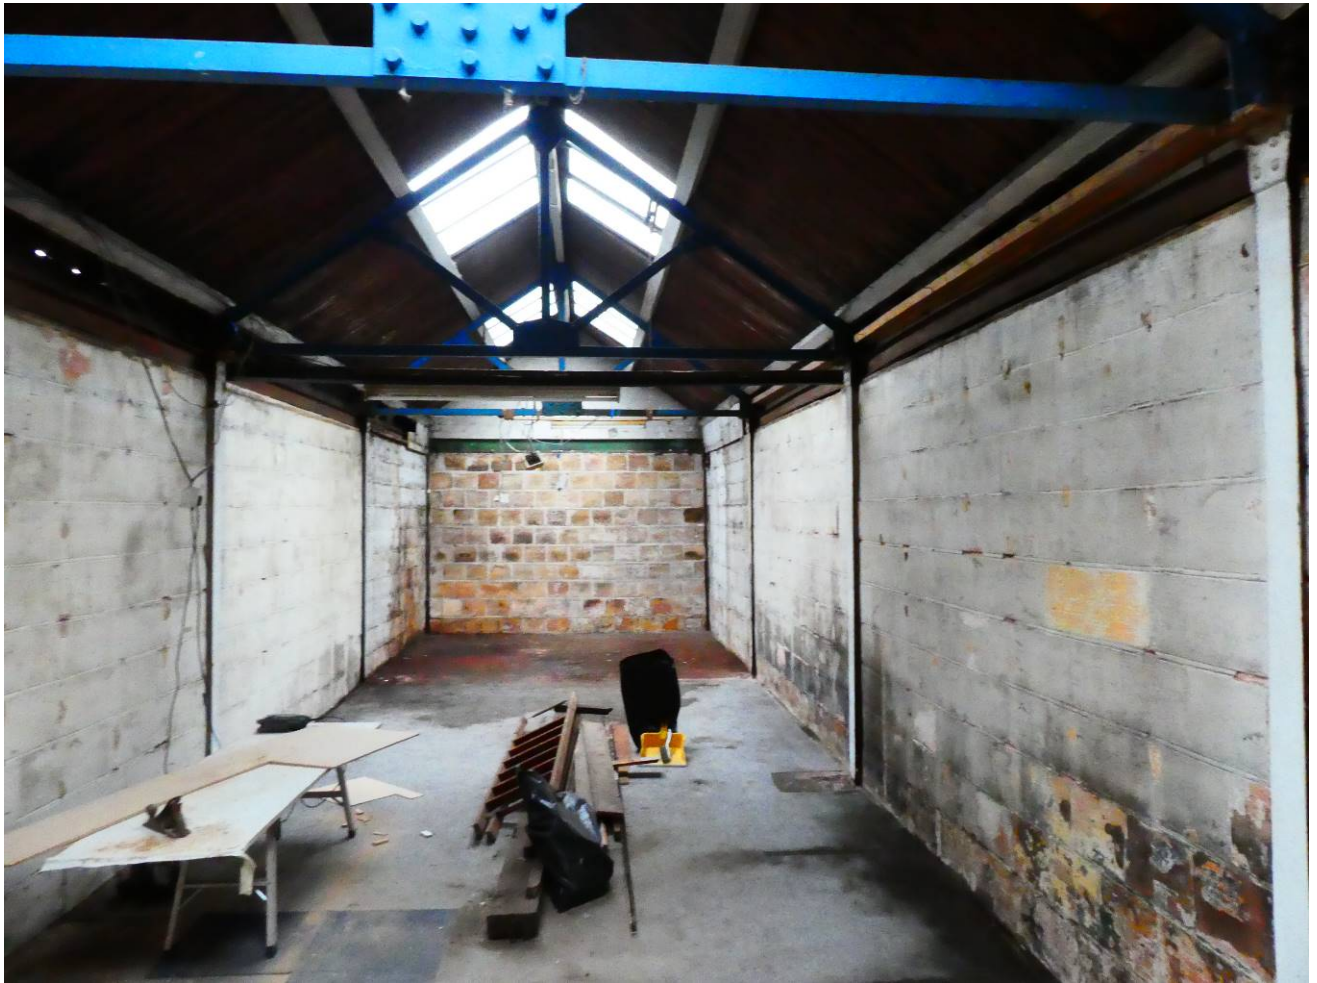
- 4.1 The existing building is a two storey brick construction with a single storey portal frame building to the rear having a street facing gable and the ridge running almost perpendicular to the road.
- 4.2 The building is set at a peculiar angle to the street frontage and tapers down in length. The two storey first section the building is approximately 13.4m across the longest wall from front to rear, and is approximately 1m narrower at the rear than at the front.
- 4.3 The rear single storey portal frame part of the building is marginally longer than the front section, approximately 14m long, but the side walls are now parallel, approx. 3.7m internally.
