## **STRUCTURAL REPORT**

**FAIRCLOUGH**  
**CONSULTING STRUCTURAL ENGINEERS**  
The Old Stables, Potts Lane, Ollerton. WA16 8SF  
Tel: 01565 653768

**Ref No:** 180602

**PROPOSED ECO SELF BUILD RESIDENTIAL DEVELOPMENT**  
**THORNCLIFFE LANE, LEEK, STAFFS**

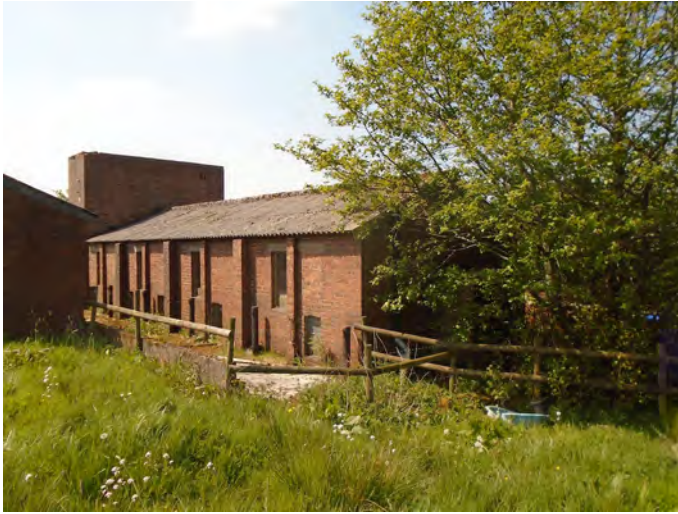
*Building B.*

12. The elevations are plumb within normal tolerances. Horizontal lines are level within normal tolerances. There are no signs of structurally significant or recent foundation movement. One of the concrete lintels is cracked. There are more cracks in this building than building A but they do not represent an overall structural defect with the building. There are some horizontal cracks at window head level, and cracks to both gable elevations. There are some stepped diagonal cracks adjacent to windows at the ends of both side elevations. All of these cracks are old. The brick infill to the windows is not properly bonded to the adjoining brickwork. There is a tree in close proximity to the North gable. Lintels to the South gable opening and to internal walls are missing.

13. The roof structure consists mainly of steel trusses supporting timber purlins. Some of the trusses have been replaced with timber trusses. There is significant rot to some purlins. The roof covering is corrugated asbestos sheeting. The trusses, both steel and timber, are very light-weight by current standards and will not be strong enough to support increased roof loads (for example from insulation, plasterboard, etc).

15. The foundations do not meet current building regulations standards but as a conservation project it would not be appropriate to expect them to do so. There has been little foundation movement in the past and provided the loads on the foundations are not significantly increased there is no particular reason to expect structurally significant foundation movement in the future. Increasing the height of the eaves and providing a new roof with insulation and plasterboard etc would be acceptable providing the building remains single storey. The tree in close proximity should be removed.

16. To avoid potential problems with reinforcement corrosion in the future I recommend that the lintels are replaced with new. It would therefore be sensible to re-build the small amount of brickwork above the lintels and that would deal with the majority of the brickwork cracks. All embedded steel in the elevations should be removed. All other cracks should be raked-out and re-pointed. The brick infill panels to the windows should be removed or re-pointed as required by the proposed conversion scheme.

17. A new roof structure will be required to support the increased loads from a domestic roof.

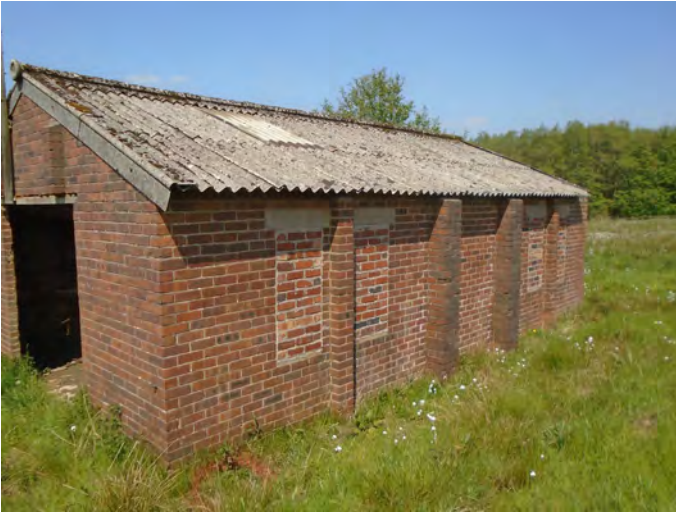
*Building C.*

20. The elevations are plumb within normal tolerances. Horizontal lines are level within normal tolerances. There are no signs of structurally significant or recent foundation movement. The lintel to the South gable elevation is very slender and should be replaced. There are some cracks, mainly at or above lintel height. The brick infill to the windows is not properly bonded to the adjoining brickwork. There are significant cracks to the North gable elevation caused by rust expansion of embedded steel.

21. The roof structure consists of steel trusses supporting timber purlins. The roof covering is corrugated asbestos sheeting. One of the trusses has been replaced with a timber truss. The trusses are very light-weight by current standards and will not be strong enough to support increased roof loads (for example from insulation, plasterboard, etc).

23. The foundations do not meet current building regulations standards but as a conservation project it would not be appropriate to expect them to do so. Provided the loads on the foundations are not significantly increased there is no particular reason to expect structurally significant foundation movement in the future. Increasing the height of the eaves and providing a new roof with insulation and plasterboard etc would be acceptable providing the building remains single storey.

24. To avoid potential problems with reinforcement corrosion in the future I recommend that the lintels are replaced with new. It would therefore be sensible to re-build the small amount of brickwork above the lintels and that would deal with the majority of the brickwork cracks. All embedded steel in the elevations should be removed. All other cracks should be raked-out and re-pointed. The brick infill panels to the windows should be removed or re-pointed as required by the proposed conversion scheme.

25. A new roof structure will be required to support the increased loads from a domestic roof.

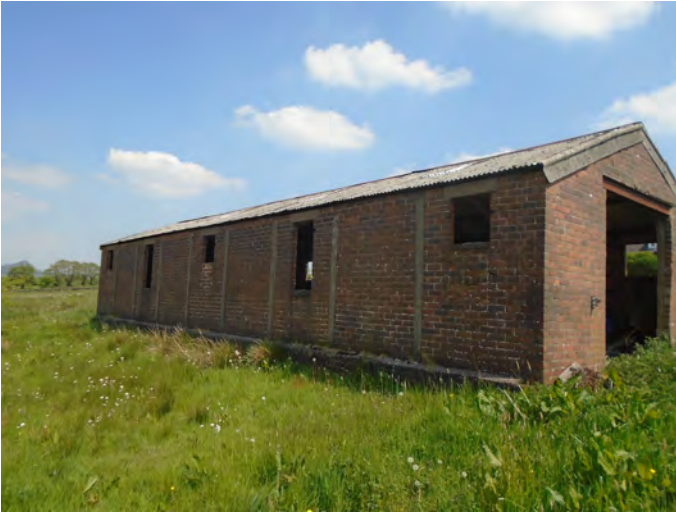
*Building D.*

27. The side elevations consist of half-brick panels between the reinforced concrete portal frame columns. The outer and inner faces of the concrete columns are exposed. There are cracks, exposed reinforcement, and reinforcement corrosion to both the outer and inner faces. Regularly spaced windows have concrete lintels. The lower parts of the windows have been in-filled with brickwork. The gable elevations are of half brick construction. There is an exposed and corroding steel lintel to the opening in the South gable elevation.

28. The elevations are plumb within normal tolerances. Horizontal lines are level within normal tolerances. There are some significant cracks to the North end of the West elevation but they do not appear to have been caused by foundation movement and they are clearly very old. The brick infill to the windows is not properly bonded to the adjoining brickwork. The lintel to the opening on the south gable is missing.

- b. **Cut-Out.** Carefully cut out the columns and then make good the brickwork. This would be a very labour intensive, difficult, and costly option, and there might be problems finding enough matching bricks for the making good. Careful sequencing of the work would be required to maintain the temporary stability of the elevations during the work. Brick piers to stabilise the brickwork might be required depending on how the inner leaf is detailed. Piers could be detailed to match those on the other buildings.

- c. **Demolish.** From a purely structural and practical perspective by far the best option would be to demolish the building and then re-build on new foundations. Existing bricks could be re-used to preserve the original appearance, or used to make matching repairs on other buildings.

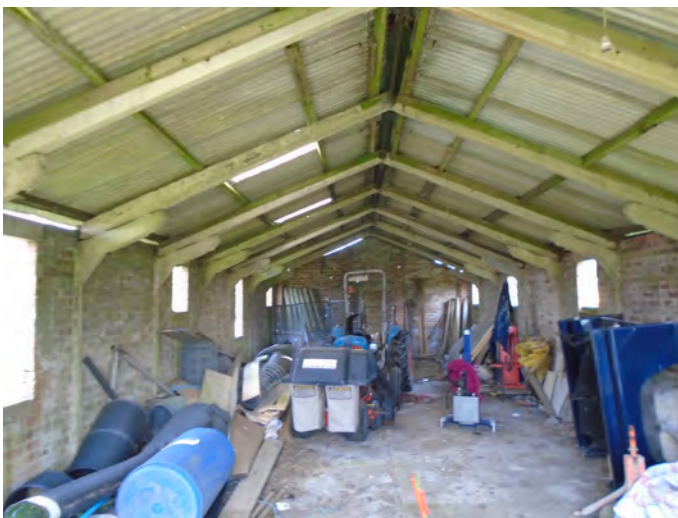
*Building D. Internal view.*
