Greenfields Farm  
**Design and Heritage Statement**  
Repairs and Upgrades to Existing House plus Extension

June 2022

**James Boon Architects**

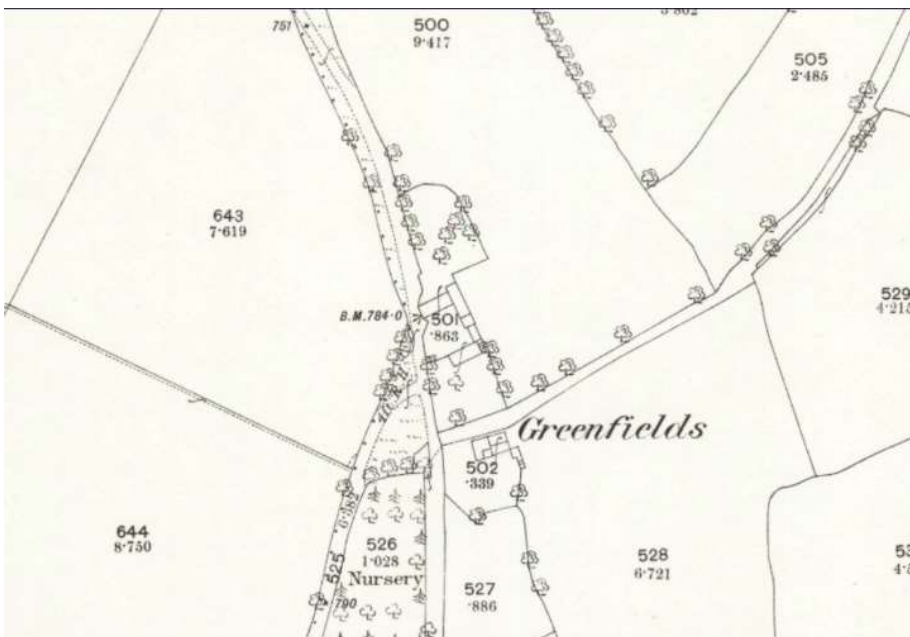
Image: OS map from 1881, showing courtyard layout of farm buildings.

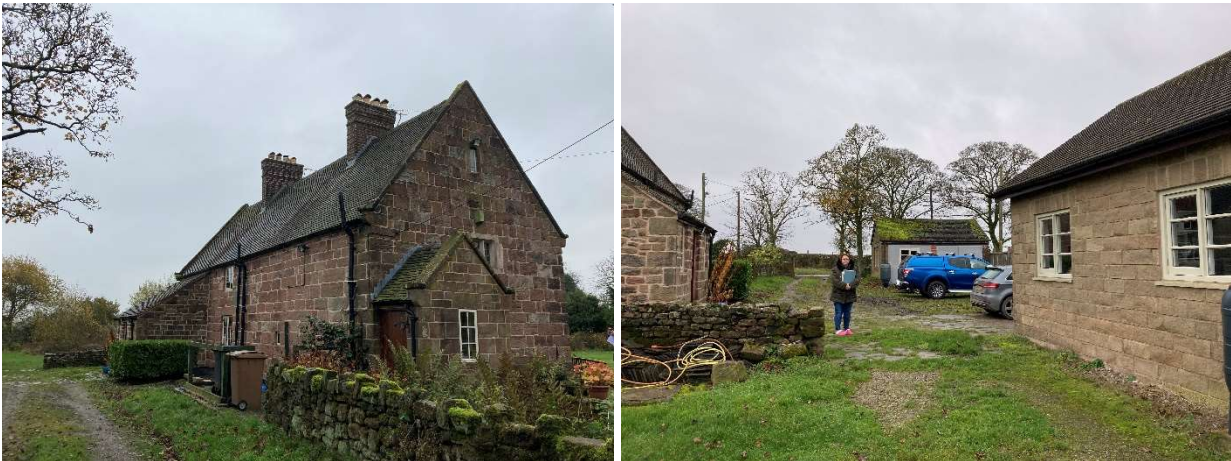
Image: (Left) Greenfields Farm seen from the NW entrance driveway, with recent porch in the foreground and extension forming utility room to the far end of the north elevation. (Right) Looking back to the west with Greenfields on the left and the two modern garage and outbuildings on the right.
