## Refurbishment Survey

Former New Inn Pub  
Denford Road  
Longsdon  
Staffordshire  
ST9 9QF

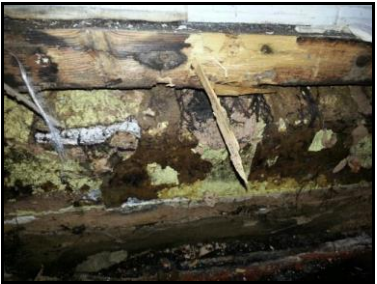
| | Sample No | Building | Floor | Analysis |
|---|---|---|---|---|
| | P-184906/006 | Former New Inn Pub | Ground Floor | No asbestos detected |

| | Product type | Condition | Surface Treatment | Asbestos type |
| | - | - | - | - |
| <b>Surveyor comments</b> | Inspection revealed the original plaster ceiling and timber beams, the sampled wall panels, solid concrete under the ceramic floor tiles, solid brickwork under the timber window boards, timber panels to the stair case where accessible. Limited inspection to the heater and chimney due to the sampled insulation board revealed MMMF insulation to a metal flue. | | | |

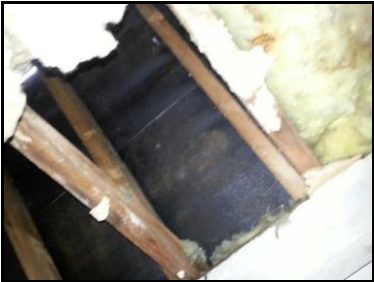
| | Sample No | Building | Floor | Analysis |
|---|---|---|---|---|
| | P-184906/009 | Former New Inn Pub | Ground Floor | No asbestos detected |

| | Product type | Condition | Surface Treatment | Asbestos type |
| | - | - | - | - |
| Surveyor comments | Inspection revealed a plaster ceiling with the sampled ceiling panels above, inspection from a previous damaged area revealed a timber ceiling above. Limited inspection to the metal ventilation ducting due to the sampled panels and metal panels which are riveted shut revealed a metal ventilation and fan. | | | |

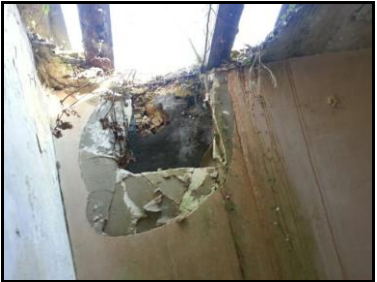
| | Sample No | Building | Floor | Analysis |
|---|---|---|---|---|
| | P-184906/015 | Former New Inn Pub | First Floor | No asbestos detected |

| | Product type | Condition | Surface Treatment | Asbestos type |
| | - | - | - | - |
| <b>Surveyor comments</b> | Inspection revealed a plasterboard ceiling with the sampled panels above, solid brick and plaster behind the ceramic wall tiles, plasterboard infills with empty cavities above the doors, solid floor below the ceramic floor tiles, ceramic cistern and plastic waste pipe. Limited inspection to the skylight due to been covered by a metal grid revealed plasterboard surroundings. Inspection within the timber boxing revealed a metal waste pipe and hessian insulated pipework. | | | |

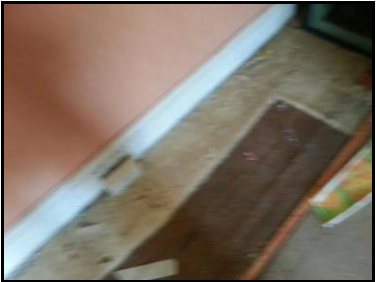
| | Sample No | Building | Floor | Analysis |
|---|---|---|---|---|
| | P-184906/017 | Former New Inn Pub | First Floor | No asbestos detected |

| | Product type | Condition | Surface Treatment | Asbestos type |
| | - | - | - | - |
| <b>Surveyor comments</b> | Ceramic cistern, plastic and metal waste pipe. | | | |

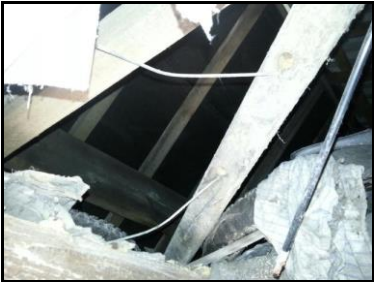
| | Sample No | Building | Floor | Analysis |
|---|---|---|---|---|
| | P-184906/031 | Former New Inn Pub | External | No asbestos detected |

| | Product type | Condition | Surface Treatment | Asbestos type |
| | - | - | - | - |
| <b>Surveyor comments</b> | The sampled was taken from different locations. The sampled textured coating is present as debris to the ground. | | | |

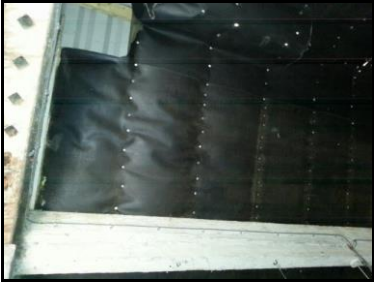
| | Sample No | Building | Floor | Analysis |
|---|---|---|---|---|
| | P-184906/034 | Former New Inn Pub | External | No asbestos detected |

| | Product type | Condition | Surface Treatment | Asbestos type |
| | - | - | - | - |
| <b>Surveyor comments</b> | Inspection revealed a metal roof, timber construction and timber beams, solid brick walls and solid concrete and brick floor. Limited inspection to stored items. | | | |

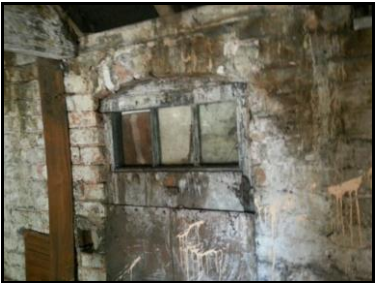
| | Sample No | Building | Floor | Analysis |
|---|---|---|---|---|
| | P-184906/037 | Former New Inn Pub | External | No asbestos detected |

| | Product type | Condition | Surface Treatment | Asbestos type |
| | - | - | - | - |
| <b>Surveyor comments</b> | The sampled insulation is in poor condition with broken debris present to the floor area. | | | |
