# GEOSHIELD Verification Report

GEO101290

Eaton Grange

AREA SURVEYED: Roadside Wing & Plant Room

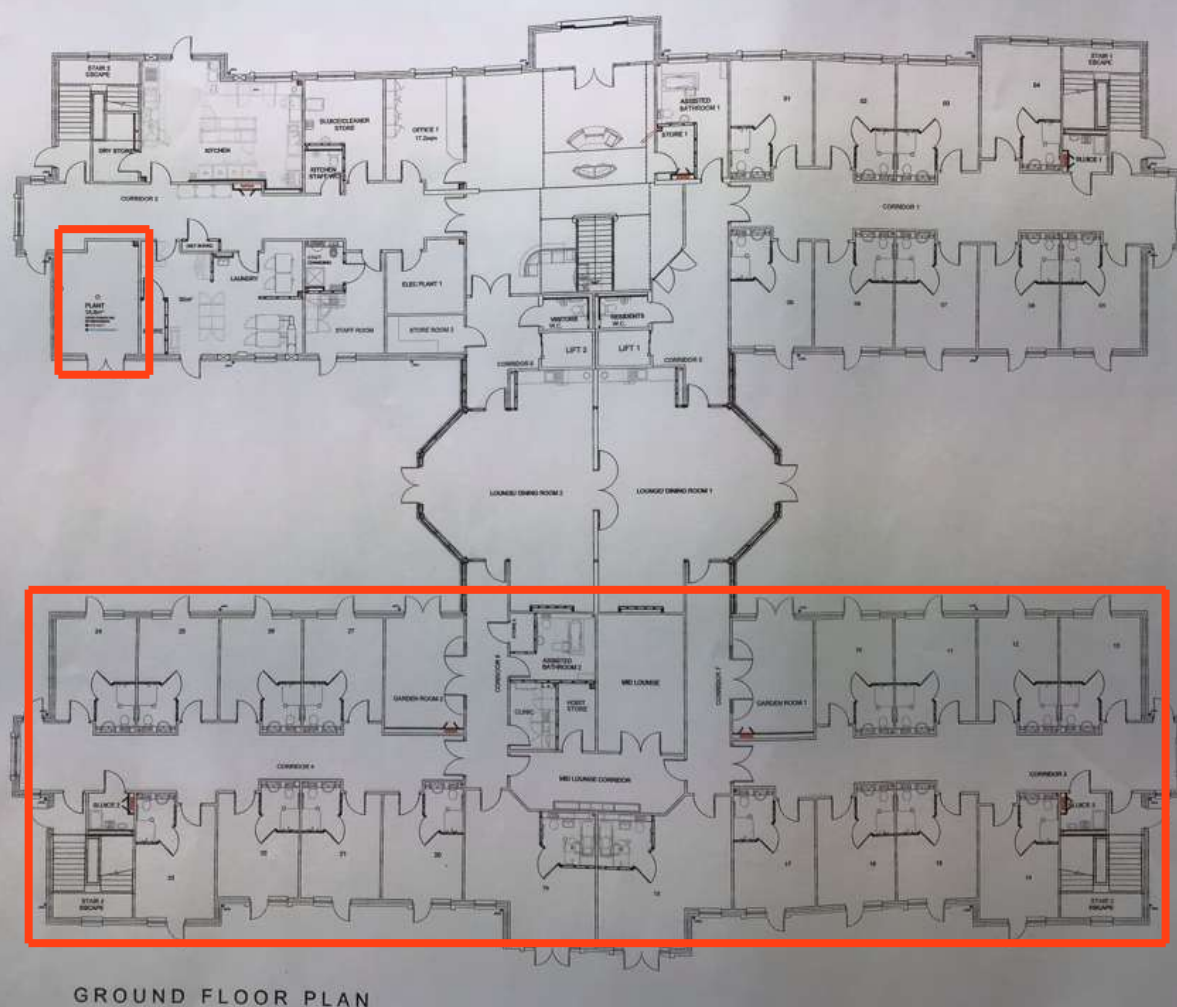
## VERIFICATION LAYOUT

Area highlighted is where verification took place for this report

roadside wing and plant room.
