| Drawing Title<br><b>TOPOGRAPHICAL SURVEY</b> | | | |

# CCTV Survey Report

**The Royal Oak  
High Street  
Dilhorne  
Stoke-on-Trent  
ST10 2PE**

## Royal Oak - CCTV Survey Report : 15/05/24

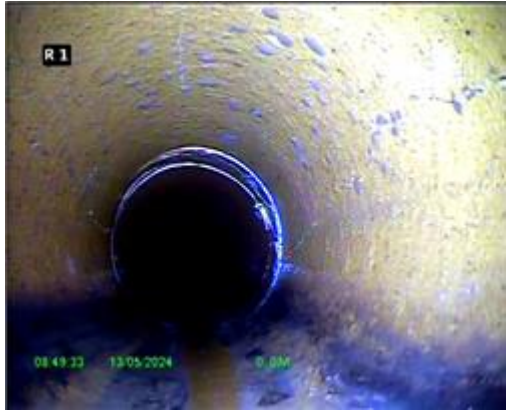
| Pos | Video Ref | Code | Description | Image |
|---|---|---|---|---|
| 00.00m | 0:00:00 | WL | Water level: 0% Height/Diameter | Image Provided - Ref: 0_1<br> |

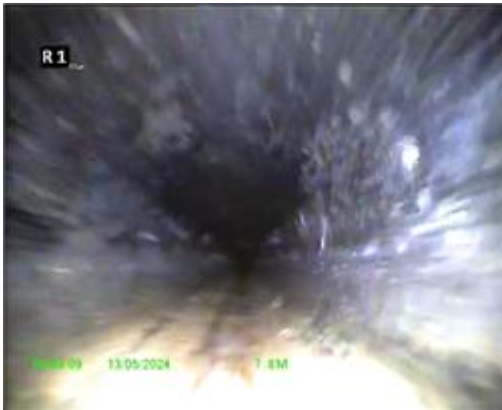
| Pos | Video Ref | Code | Description | Image |
|---|---|---|---|---|
| 07.80m | 0:00:35 | REM | General remark<br>General Condition Photo | <p>Image Provided - Ref: 0_5</p> |

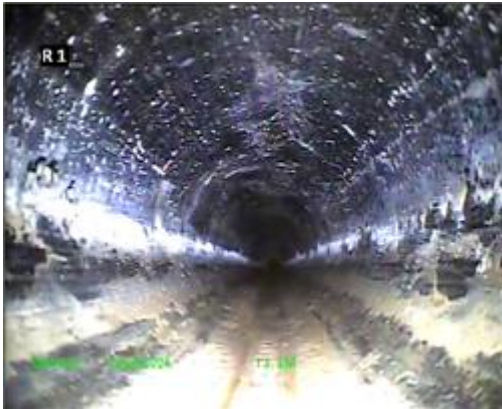
| Pos | Video Ref | Code | Description | Image |
|---|---|---|---|---|
| 13.30m | 0:00:53 | REM | General remark<br>General Condition Photo | <p>Image Provided - Ref: 0_6</p> |

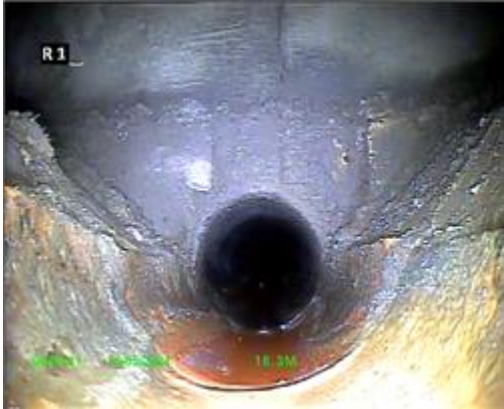
| Pos | Video Ref | Code | Description | Image |
|---|---|---|---|---|
| 16.30m | | MHF | Finish node type, manhole<br>MH 2 Reached | <p>Image Provided - Ref: 0_9999</p> |

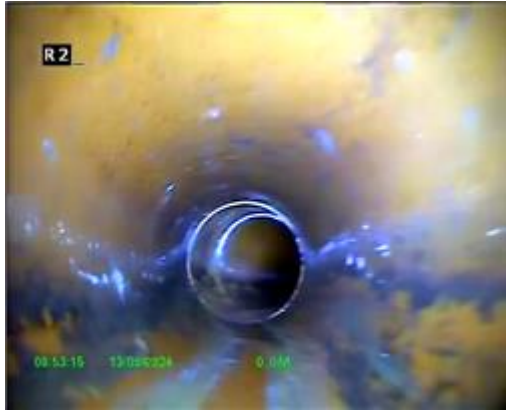
| Pos | Video Ref | Code | Description | Image |
|---|---|---|---|---|
| 00.00m | 0:00:00 | WL | Water level: 0% Height/Diameter | Image Provided - Ref: 1_1<br> |

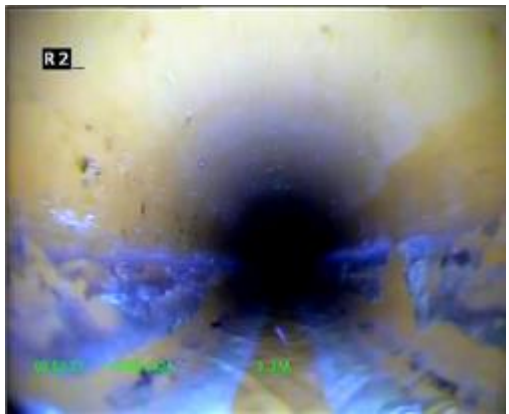
| Pos | Video Ref | Code | Description | Image |
|---|---|---|---|---|
| 03.30m | 0:00:12 | WL | Water level: 5% Height/Diameter | Image Provided - Ref: 1_4<br> |

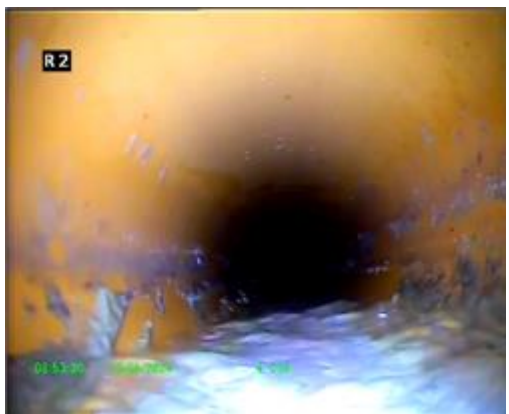
| Pos | Video Ref | Code | Description | Image |
|---|---|---|---|---|
| 03.30m | 0:00:14 | WL | Water level: 15% Height/Diameter | Image Provided - Ref: 1_5<br> |

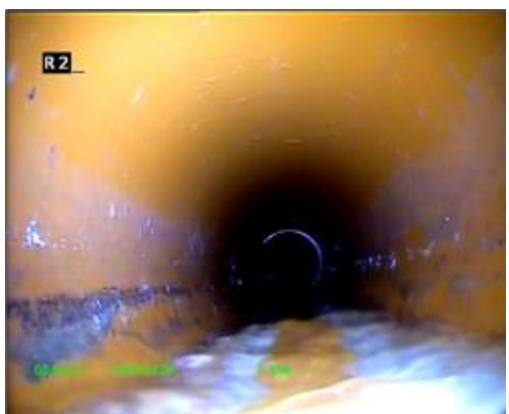
| Pos | Video Ref | Code | Description | Image |
|---|---|---|---|---|
| 07.30m | 0:00:31 | REM | General remark<br>General Condition Photo | Image Provided - Ref: 1_6<br> |

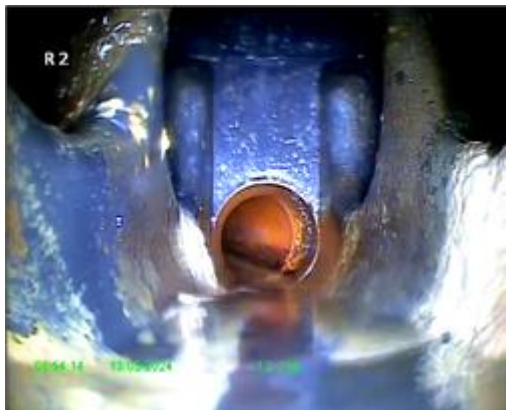
| Pos | Video Ref | Code | Description | Image |
|---|---|---|---|---|
| 12.20m | | MHF | Finish node type, manhole<br>MH 10 Reached | <p>Image Provided - Ref: 1_9999</p> |

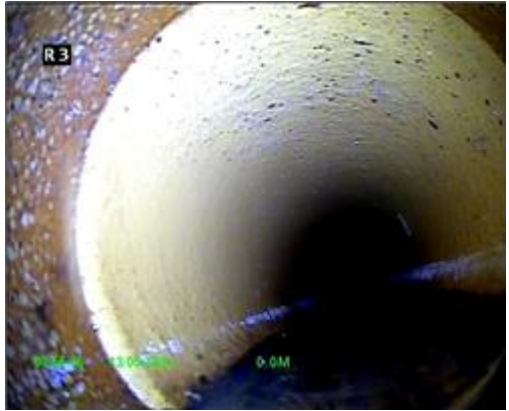
| Pos | Video Ref | Code | Description | Image |
|---|---|---|---|---|
| 00.00m | 0:00:00 | WL | Water level: 0% Height/Diameter | Image Provided - Ref: 2_1<br> |
