## Site: High Street, Dilhorne

## Section 4

## Descriptive Report with Remarks and Observation Images

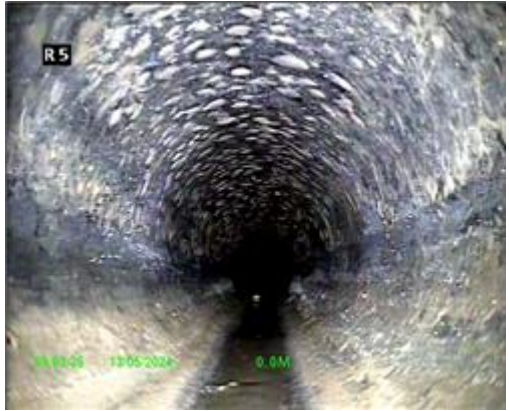
| Pos | Video Ref | Code | Description | Image |
|---|---|---|---|---|
| 00.00m | 0:00:00 | WL | Water level: 5% Height/Diameter | Image Provided - Ref: 4_1<br> |

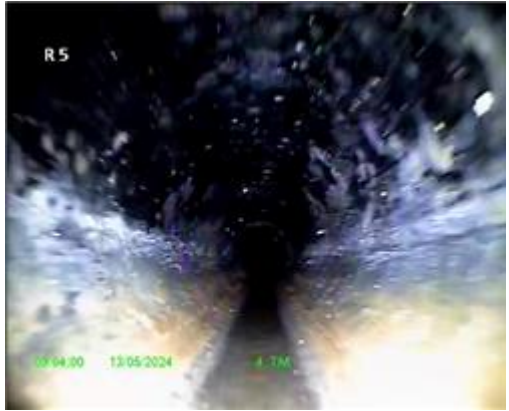
| Pos | Video Ref | Code | Description | Image |
|---|---|---|---|---|
| 04.70m | 0:00:24 | REM | General remark<br>General Condition Photo | Image Provided - Ref: 4_2<br> |

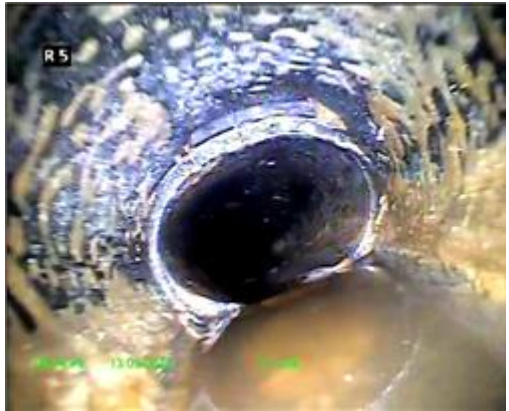
| Pos | Video Ref | Code | Description | Image |
|---|---|---|---|---|
| 12.20m | 0:01:04 | WL | Water level: 10% Height/Diameter | Image Provided - Ref: 4_5<br> |

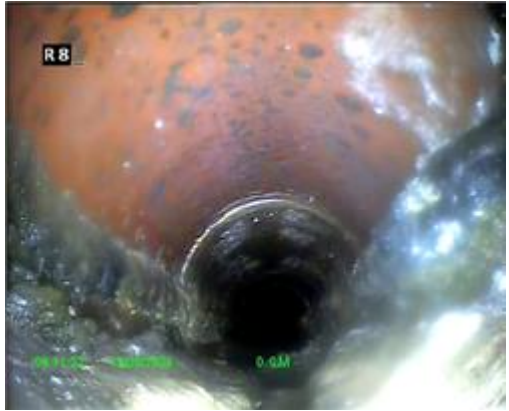
| Pos | Video Ref | Code | Description | Image |
|---|---|---|---|---|
| 00.00m | 0:00:00 | WL | Water level: 0% Height/Diameter | Image Provided - Ref: 7_1<br> |

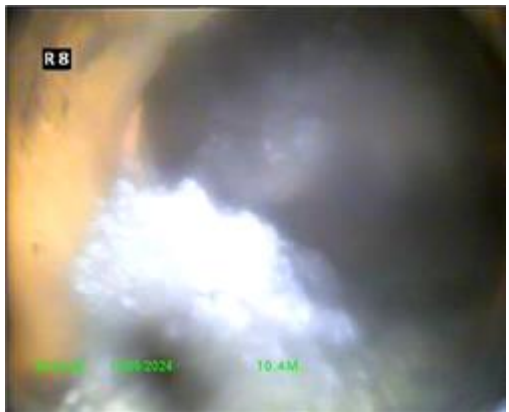
| Pos | Video Ref | Code | Description | Image |
|---|---|---|---|---|
| 10.40m | | SA | Survey abandoned<br>EOT- Unable to Camera<br>Further, Unknown End<br>Reached | <p>Image Provided - Ref: 7_9999</p> |
