## Descriptive Report with Remarks and Observation Images

## Site: High Street, Dilhorne

## Section 11

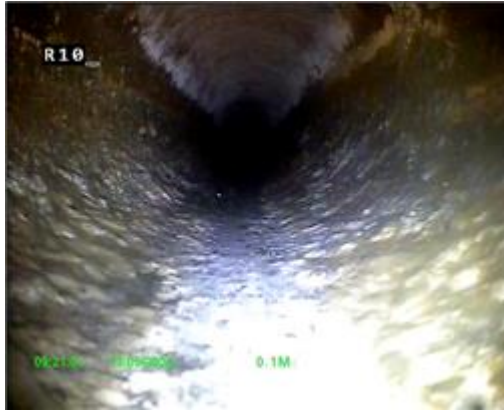
| Pos | Video Ref | Code | Description | Image |
|---|---|---|---|---|
| 00.00m | 0:00:00 | WL | Water level: 5% Height/Diameter | Image Provided - Ref: 9_1<br> |

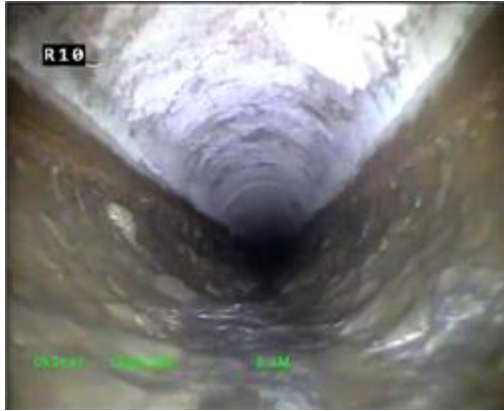
| Pos | Video Ref | Code | Description | Image |
|---|---|---|---|---|
| 08.30m | 0:00:46 | REM | General remark<br>General Condition Photo | Image Provided - Ref: 9_3<br> |

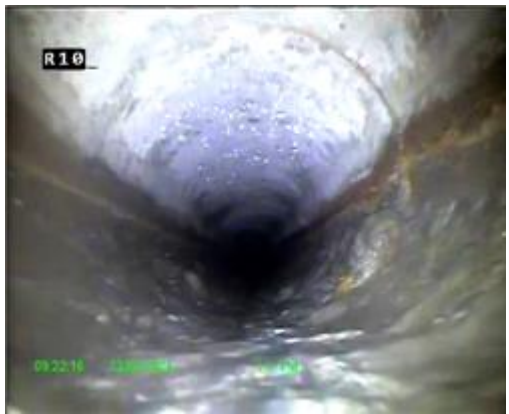
| Pos | Video Ref | Code | Description | Image |
|---|---|---|---|---|
| 14.30m | 0:01:14 | REM | General remark<br>General Condition Photo | <p>Image Provided - Ref: 9_4</p> |

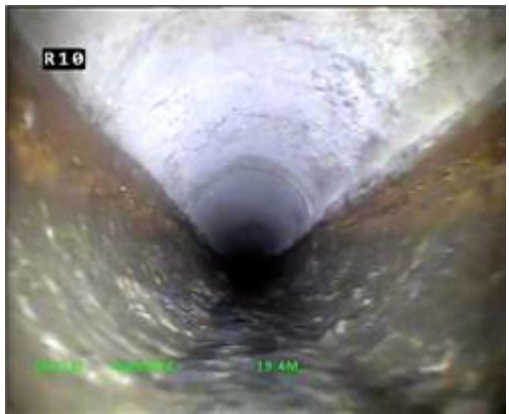
| Pos | Video Ref | Code | Description | Image |
|---|---|---|---|---|
| 19.40m | 0:01:36 | REM | General remark<br>General Condition Photo | <p>Image Provided - Ref: 9_5</p> |

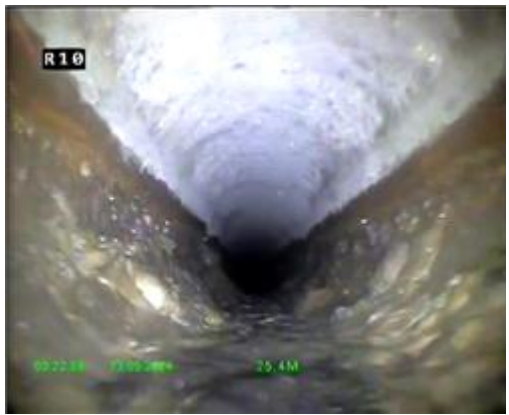
| Pos | Video Ref | Code | Description | Image |
|---|---|---|---|---|
| 25.40m | 0:01:57 | REM | General remark<br>General Condition Photo | <p>Image Provided - Ref: 9_6</p> |

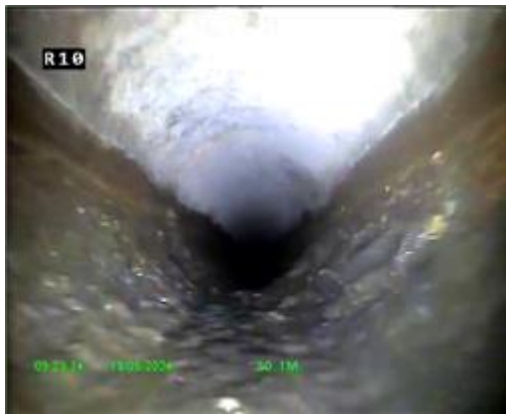
| Pos | Video Ref | Code | Description | Image |
|---|---|---|---|---|
| 30.10m | 0:02:12 | REM | General remark<br>General Condition Photo | Image Provided - Ref: 9_7<br> |

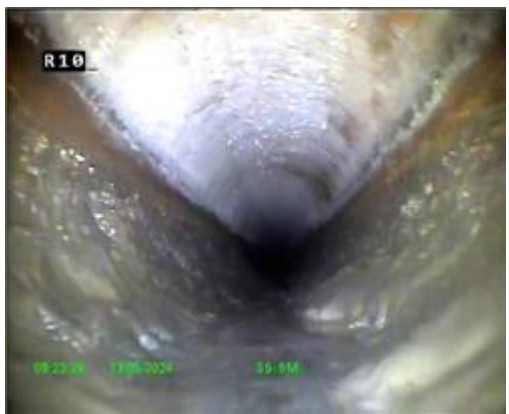
| Pos | Video Ref | Code | Description | Image |
|---|---|---|---|---|
| 35.90m | 0:02:27 | REM | General remark<br>General Condition Photo | Image Provided - Ref: 9_8<br> |

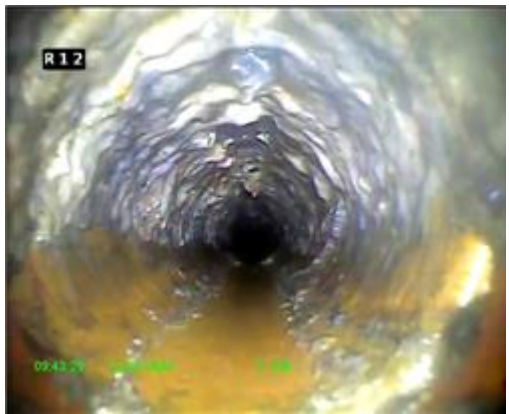
| Pos | Video Ref | Code | Description | Image |
|---|---|---|---|---|
| 02.70m | 0:00:21 | MCVC | Material of pipe changes to Vitrified Clay (i.e. all clayware) | Image Provided - Ref: 11_4<br> |

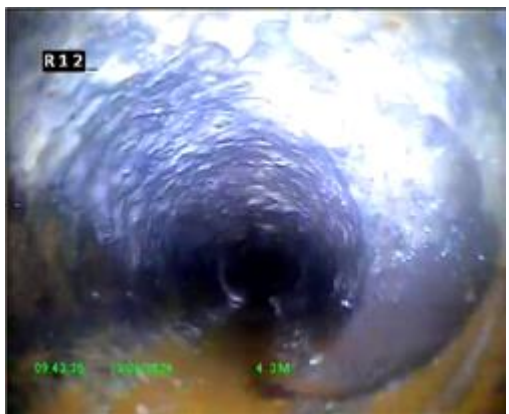
| Pos | Video Ref | Code | Description | Image |
|---|---|---|---|---|
| 04.30m | 0:00:27 | JN | Junction at 03 o'clock: 100mm Diameter | Image Provided - Ref: 11_5<br> |

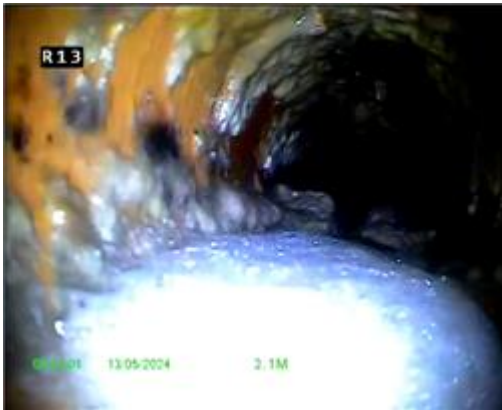
| Pos | Video Ref | Code | Description | Image |
|---|---|---|---|---|
| 02.10m | 0:00:13 | REM | General remark<br>General Condition Photo | Image Provided - Ref: 12_5<br> |

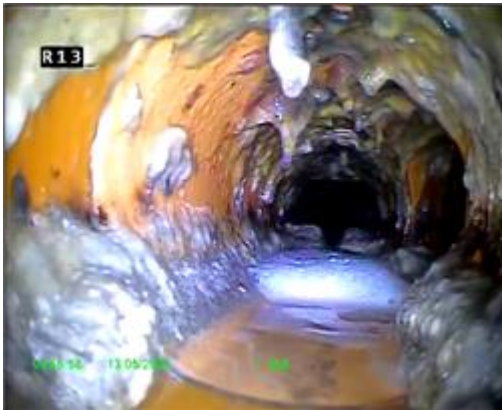
| Pos | Video Ref | Code | Description | Image |
|---|---|---|---|---|
| 02.20m | 0:00:11 | JN | Junction at 03 o'clock: 100mm Diameter | Image Provided - Ref: 12_4<br> |

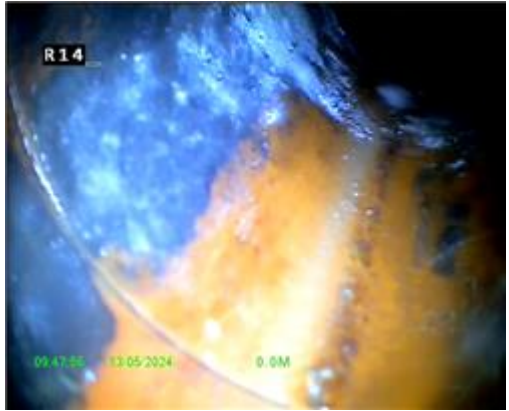
| Pos | Video Ref | Code | Description | Image |
|---|---|---|---|---|
| 00.00m | 0:00:00 | WL | Water level: 0% Height/Diameter | Image Provided - Ref: 13_1<br> |

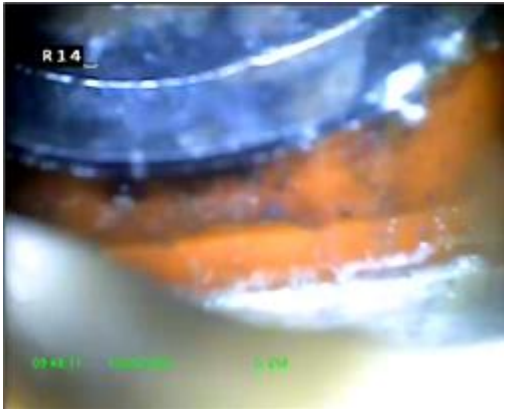
| Pos | Video Ref | Code | Description | Image |
|---|---|---|---|---|
| 00.80m | | GYF | Finish node type Gully Gully Reached | <p>Image Provided - Ref: 13_9999</p> |

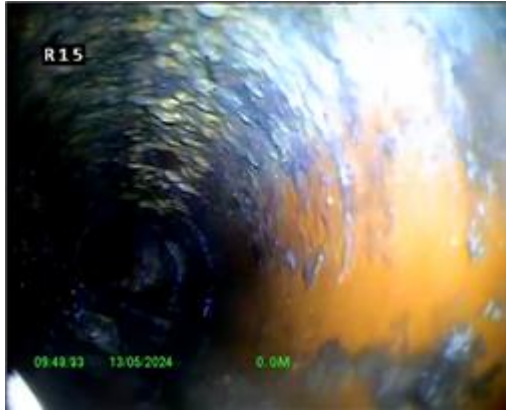
| Pos | Video Ref | Code | Description | Image |
|---|---|---|---|---|
| 00.00m | 0:00:00 | WL | Water level: 0% Height/Diameter | Image Provided - Ref: 14_1<br> |
