Gate Farm, Foxt, ST10 2HN  
HERITAGE STATEMENT & IMPACT ASSESSMENT

Produced for Mr and Mrs Wilbraham

24<sup>th</sup> October 2025

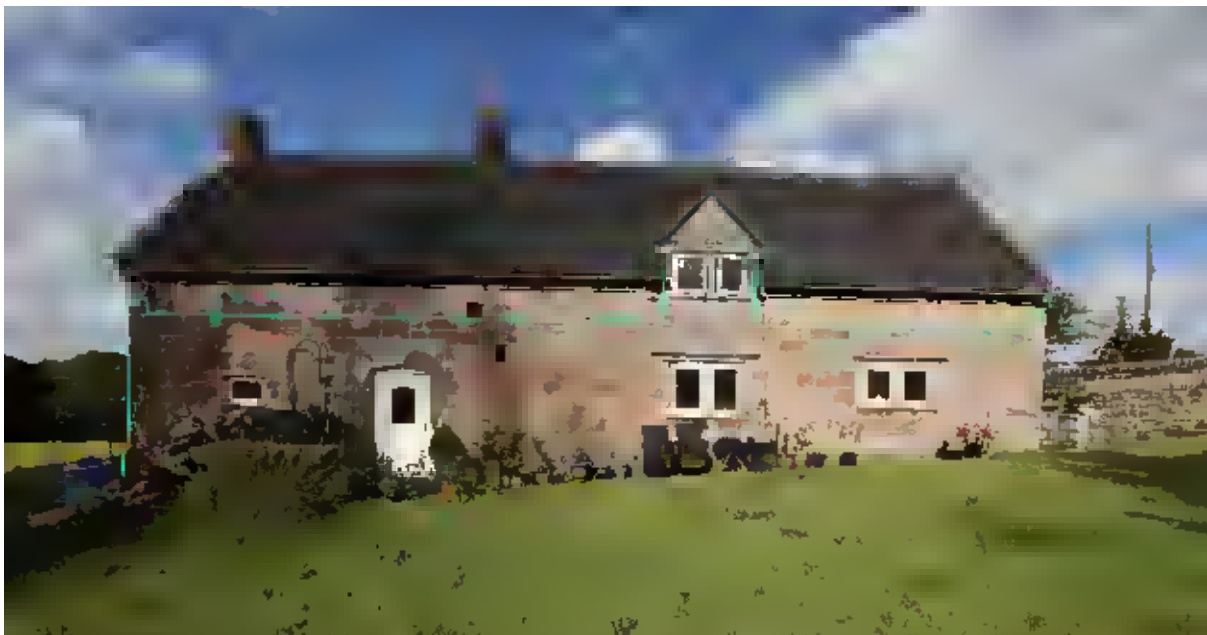
Fig. 7 Front elevation with phasing represented by turquoise lines. The original elevation of 1624 had a lower eaves. The eaves were raised by two courses of ashlar and a sawtooth brick eaves, probably ca. 1743, when the roof is likely to have been changed from thatch to Staffordshire blue clay tiles.

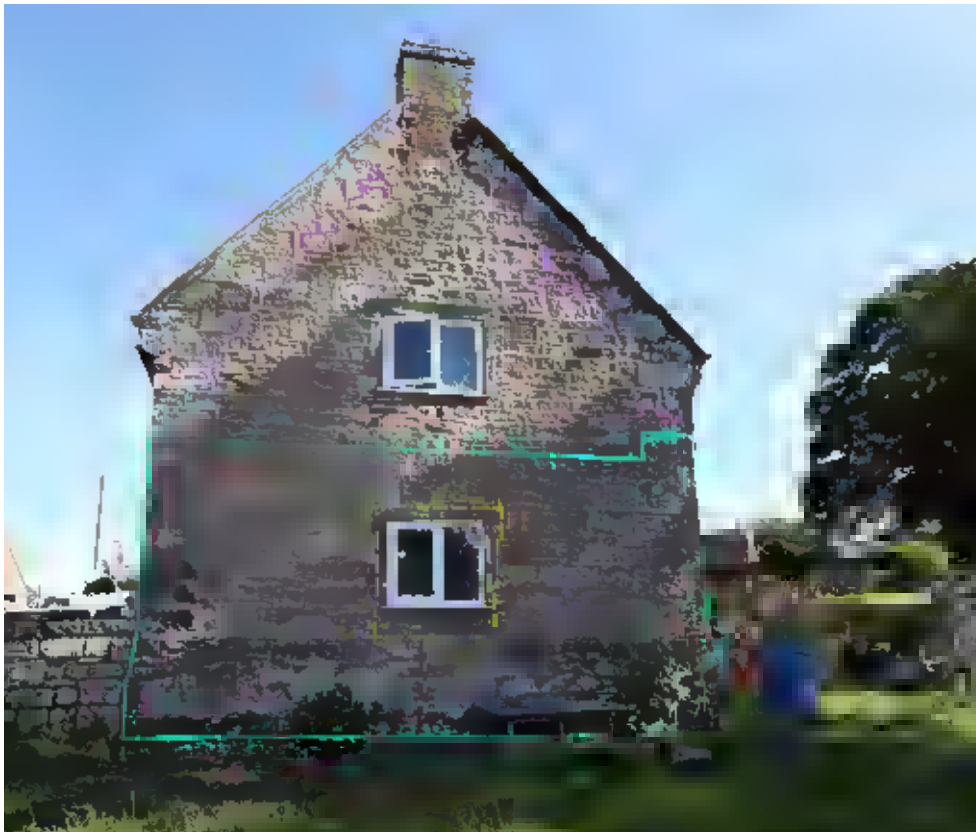
Fig. 10 South gable elevation with 1624 phase represented by turquoise lines, with later remodelling to add a flue ca. 1680 (pink area reconstructed) and ground floor window remodelled (yellow) and the eaves and gable reconstructed ca. 1743.

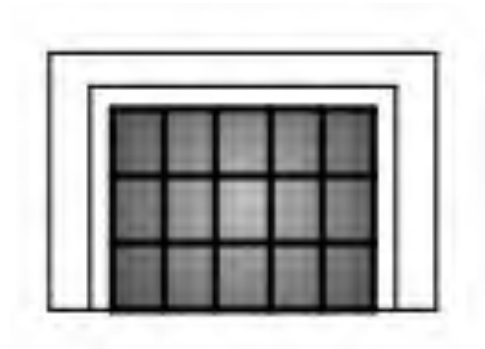
#### GFW9

The original window has been modified by cutting out the chamfer on the lintel and by removing the deep chamfer on the cill. This window is so small that it is unlikely it ever had a mullion. As this window will serve a WC and it is close in size to the original window, a true leaded light window with true lead comes is proposed for this opening and as it will not have a metal sub-frame the distribution of comes in a rectangular pattern will be bespoke for this window, rather than standardised to match others. The cill will be dressed in Code 4 lead.

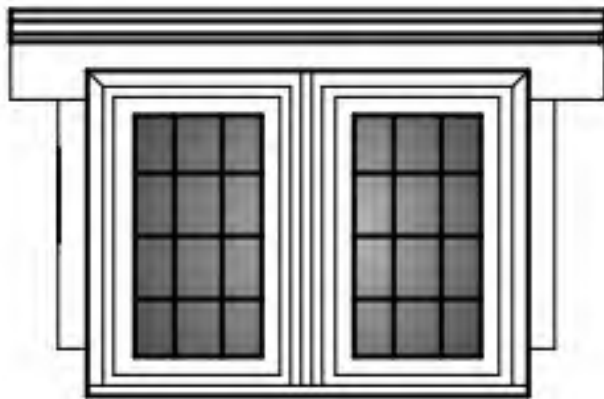
## GFW1

This window to the Houseplace has been altered with the removal of the deep chamfer to the cill and the cutting out of the secondary chamfer to the lintels and jambs, and the introduction of a new mullion. As a result, the white uPVC frames sit further forward than the historic leaded lights. The proposed windows are a pair of metal side-hinged casements with black-painted finish (or similar), retaining the mullion in-situ, but inserting a new Code 4 lead flashing to the cill. Windows will be double-glazed with applied faux lead. This is an enhancement and more sympathetic than white uPVC, whilst reducing the impact of the white uPVC frames, increasing the amount of light with slim metal frames, and adopting a rectangular form of leading as a nod to 18<sup>th</sup> century changes.

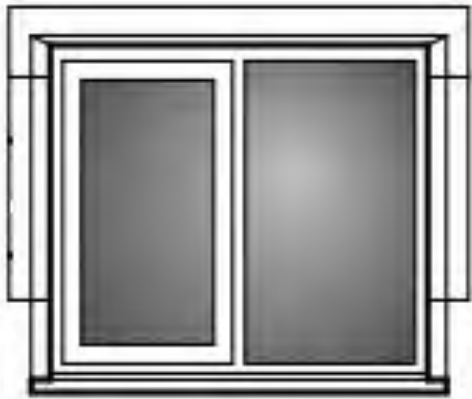
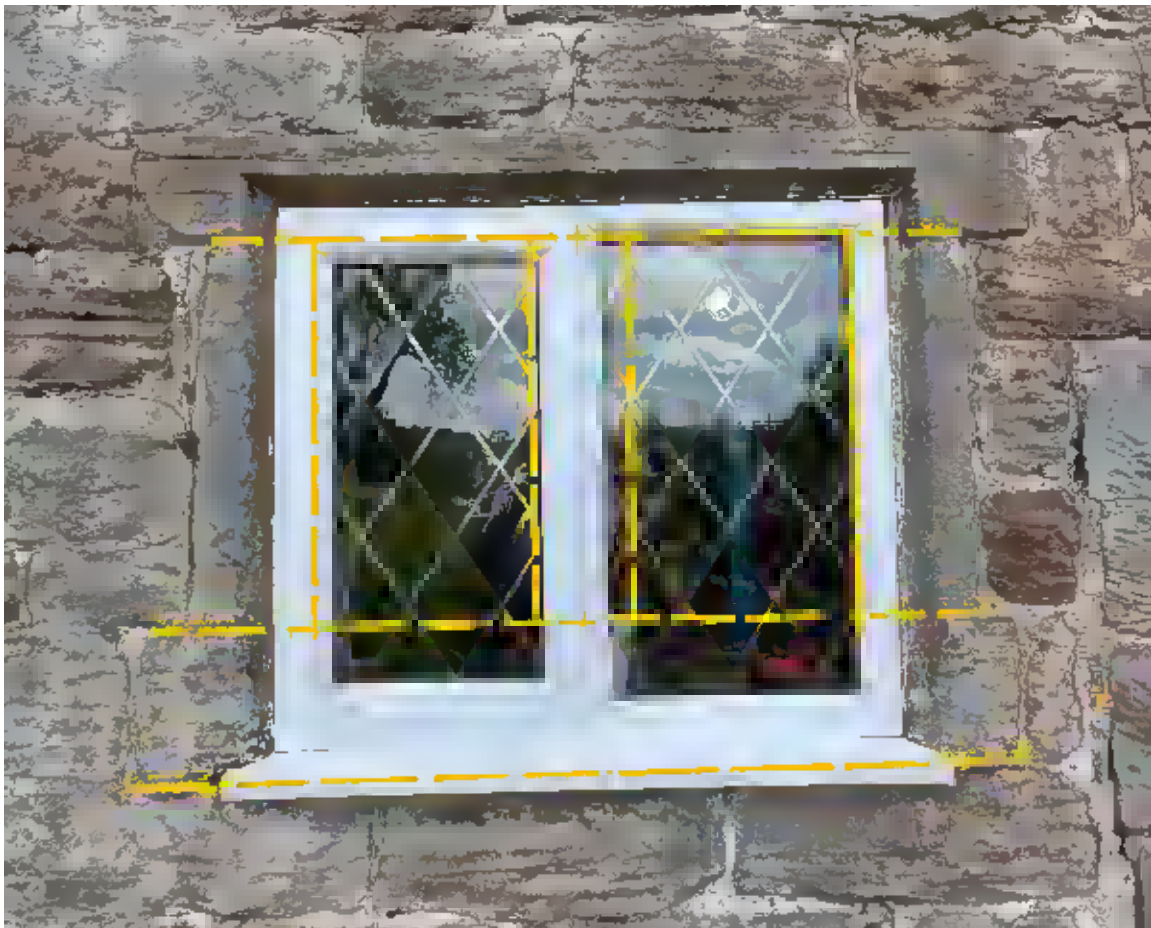
## GFW5

This window to the rear elevation of the Houseplace has been altered with the removal of the deep chamfer to the original stone cill and the cutting out of the secondary stone chamfer to the lintels and jambs and the removal of the central mullion. The proposed window is a metal window with a fixed direct-glazed panel, and a single, side-hinged metal casement, all with a putty finish, and painted black (or similar), inserting a new Code 4 lead flashing to the cill. Paired casement windows will be double-glazed without applied lead. This is an enhancement and more sympathetic than white uPVC, whilst reducing the impact of the white uPVC frames, increasing the amount of light with slim metal frames.

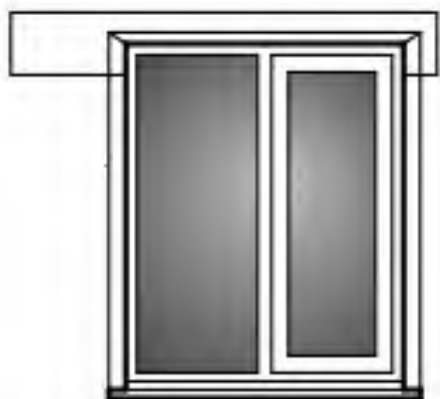
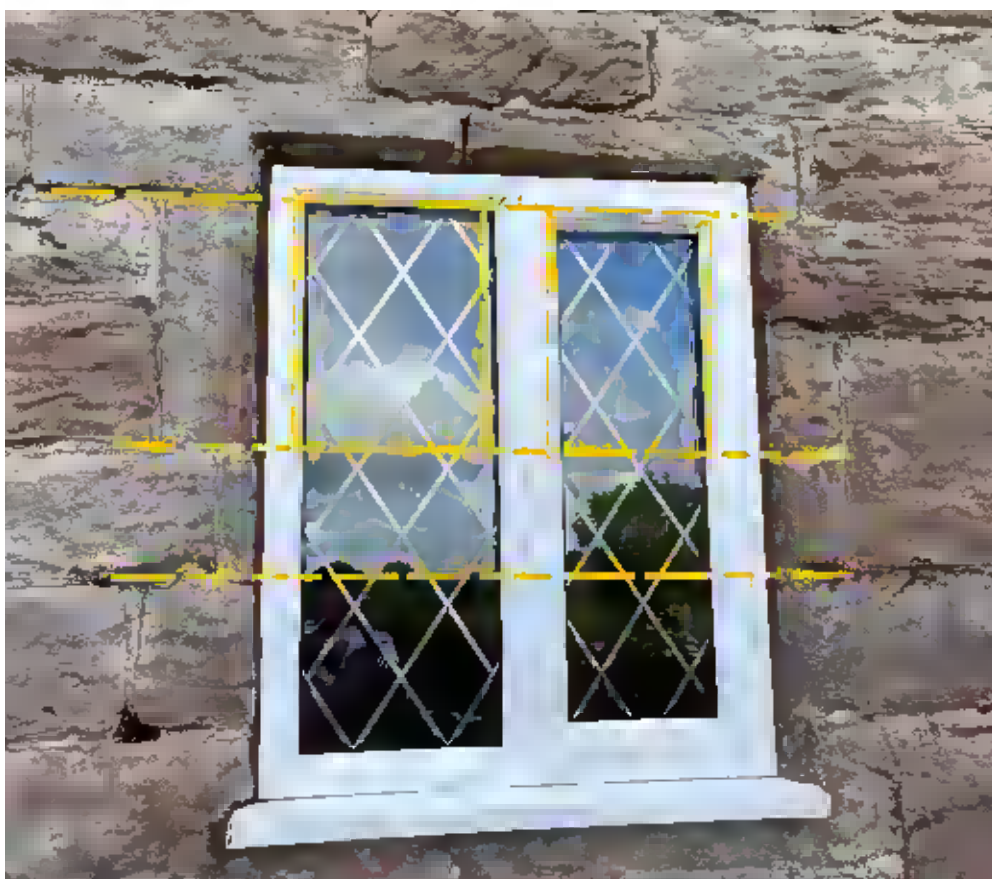
GFW6

The 'fire window' was a small mullioned window set into the smokehood. Fire windows were typically smaller than the other windows. The window cill has been significantly lowered, but the lintel and the left jamb is still evident. The window has also been cut back to remove the double chamfer and the central mullion and widened. The vertical joint is on the line of the original mullion. The proposed window is a metal window with a fixed direct-glazed panel, and a single, side-hinged metal casement, all with a putty finish, and painted black (or similar), inserting a new Code 4 lead flashing to the cill. Paired casement windows will be double-glazed without applied lead. A simple and sympathetic replacement is a metal frame, painted black, so visually recessive, with plain double-glazed sealed unit.

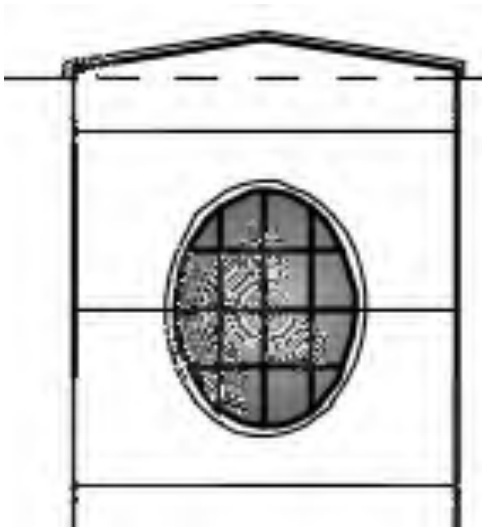
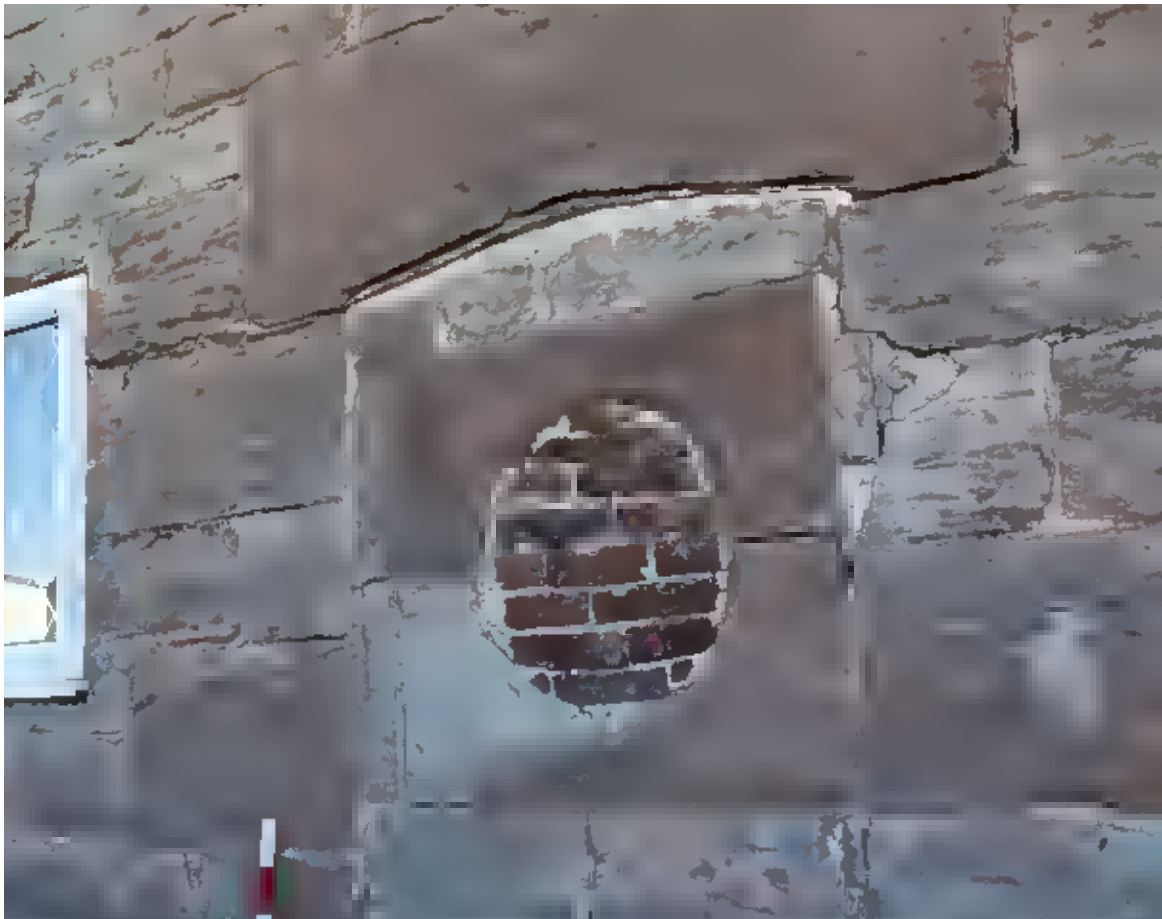
## GFW7

This is a former oeil-de-boeuf window from the late 17<sup>th</sup> century. The proposal is to restore a true leaded-light window to this opening with true lead came and as it will not have a metal sub-frame the distribution of comes in a rectangular pattern will be bespoke for this window, rather than standardised to match others. It does not need a separate cill detail as the whole surround is chamfered and unaltered. This provides some restoration but does not restore the door opening, so two primary phases of development will still be evident.

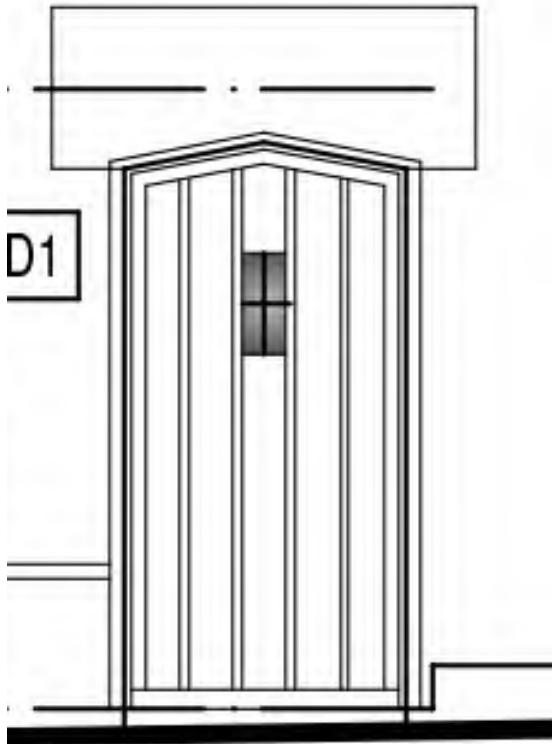
### GFD1

The original front door opening remains in-situ but has been altered with a uPVC door in the reveal. The original door was located in a rebate behind the masonry. The proposed alteration will restore an oak boarded door with moulded cover fillets to the original location, as in the example below, with a weatherboard which is typical of the 17<sup>th</sup> century (see photo of similar 17<sup>th</sup> century door in Endon), and very small genuine 'leaded light'. This proposal is a very positive enhancement.

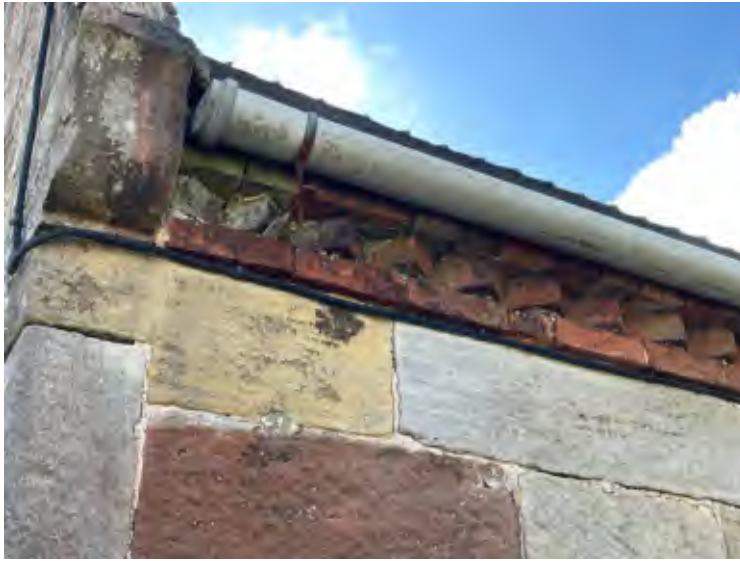
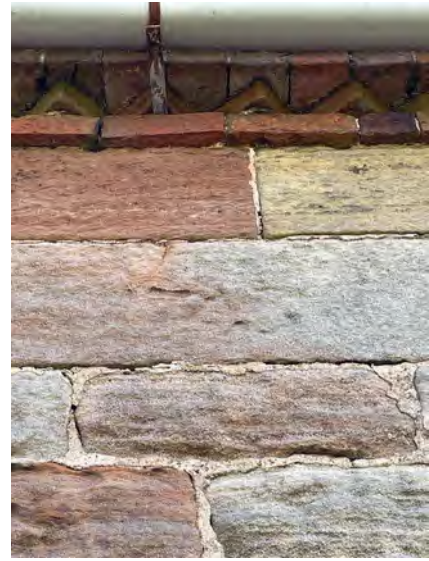
1 and 2. Above left and right – sawtooth brick eaves and datestone of 1743 in the top two courses.

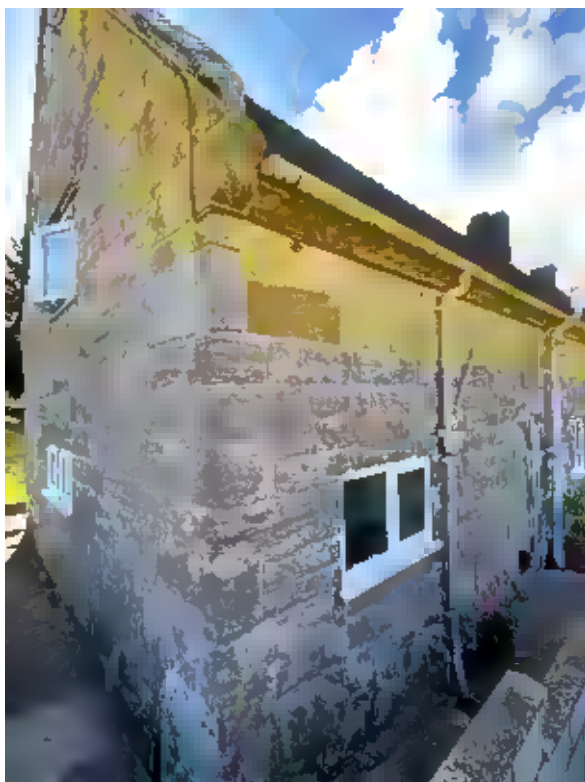
5. Left – rear elevation showing in yellow highlight the 1743 raising of the eaves. The 1624 gable was raised with a coped gable which sat higher than the eaves. The original eaves were probably stone, with a moulded band, which was removed in 1743.

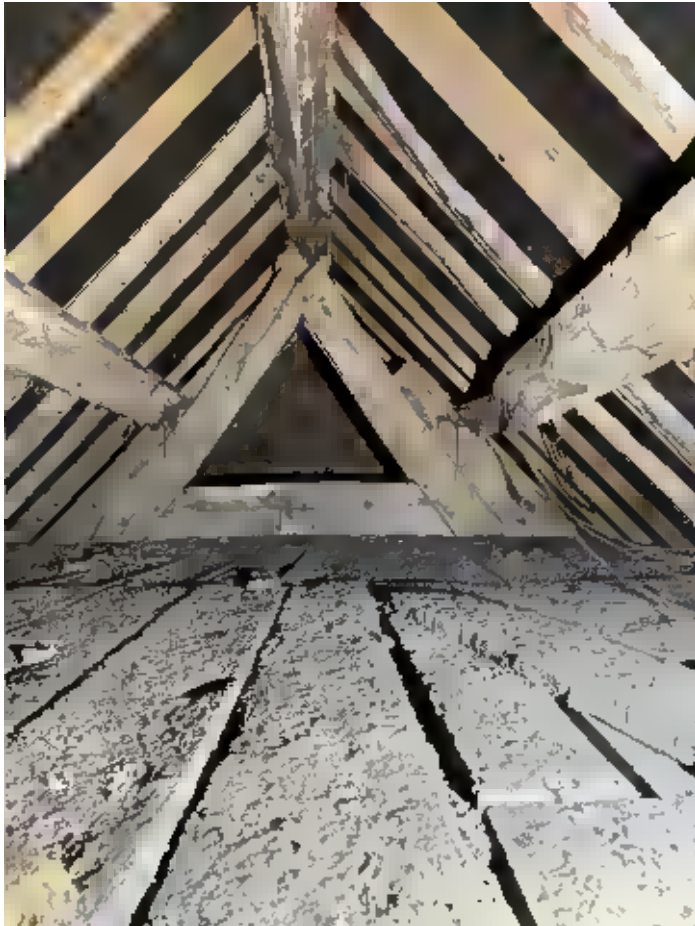
8. Attic space with apex of closed truss of 1624; at this point it is likely that it was always open for access between the two 'garret' spaces. The original ridge beam of 1624 has been cut-off, with a small amount retained and a new ridge beam added ca. 1743. The additional principal rafters terminate before the ridge and support secondary trenched purlins, which makes the roof a double purlin roof to both slopes, and strong. Rafters are a mixture of modern and 1743.

Oak floorboards may have been added to new ceiling joists ca. 1743.

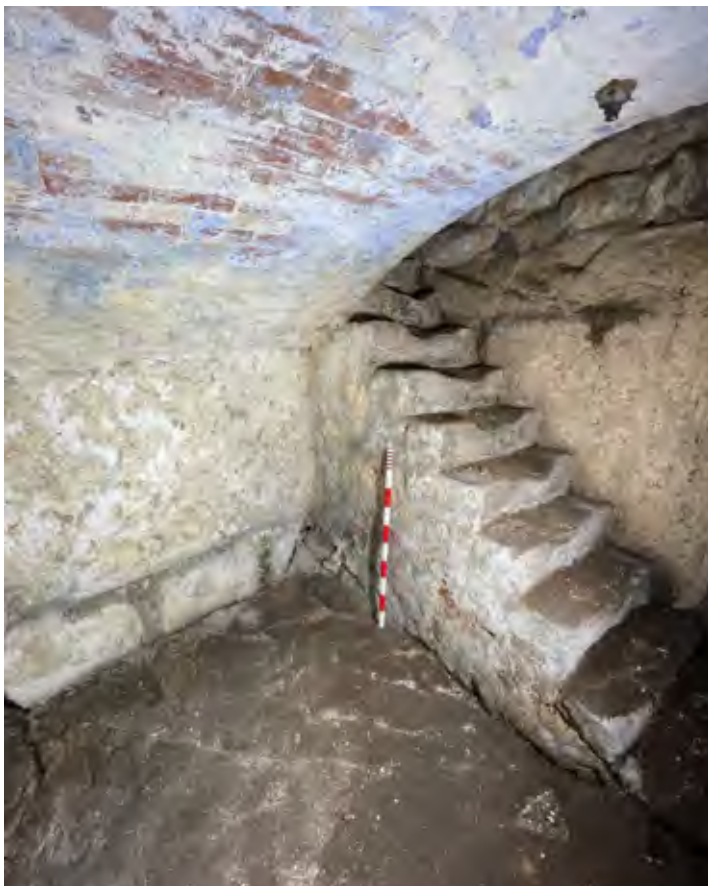
9. Cellar with barrel-arched brick vault and stone steps cut into the bedrock. Bedrock to the floor and walls.

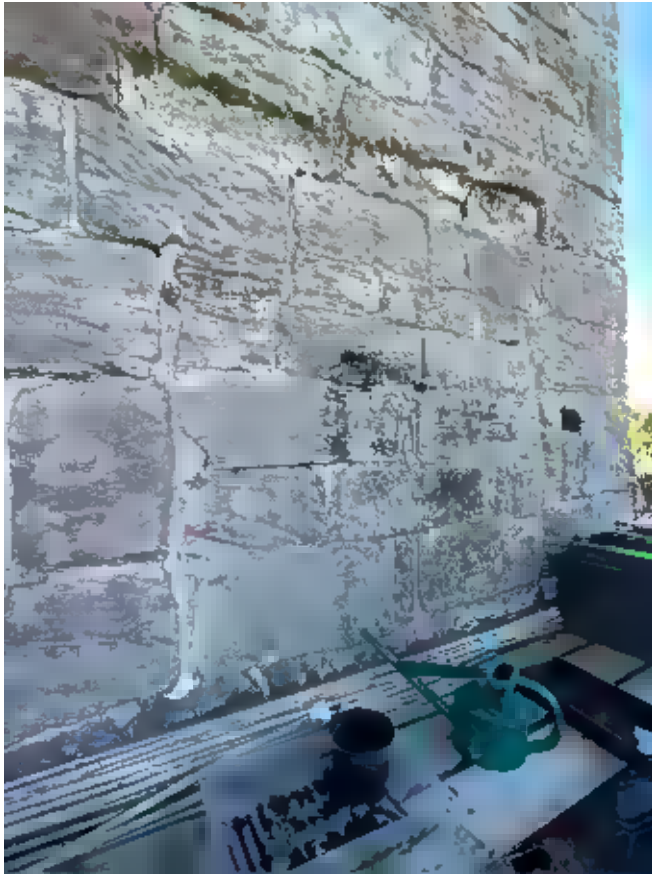
10. Southern bay corner with former window to 1624 phase, stoned up probably ca. 1680.

The slot in the masonry is likely to be a later modification to support a small outhouse with oak rail and monopitch roof.

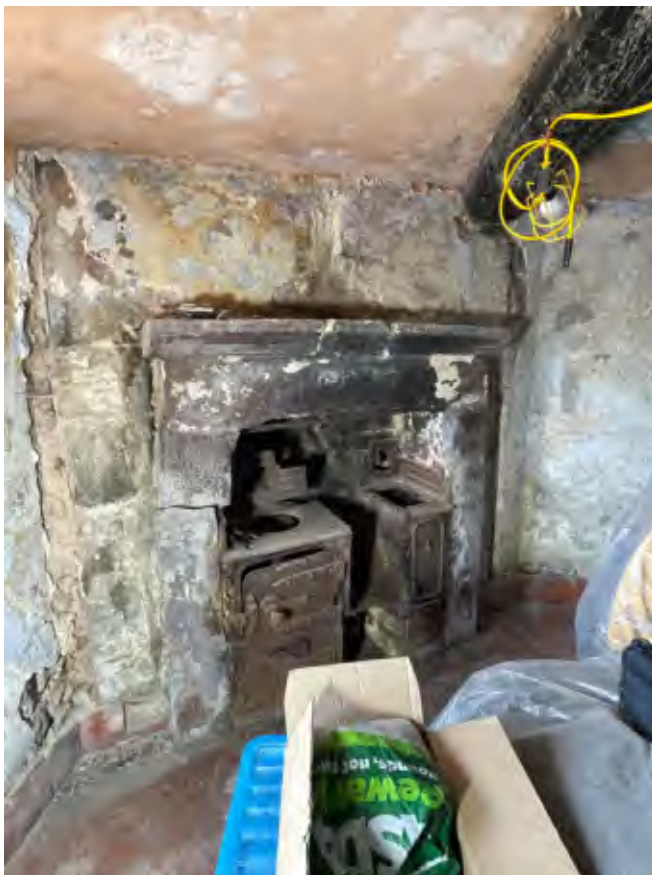
11. Corner fireplace to Parlour in southern bay of ca. 1680., with two phases of stone surround and cast-iron range of the 19<sup>th</sup> century. Lath-and-plaster ceiling, with gypsum skim in places.

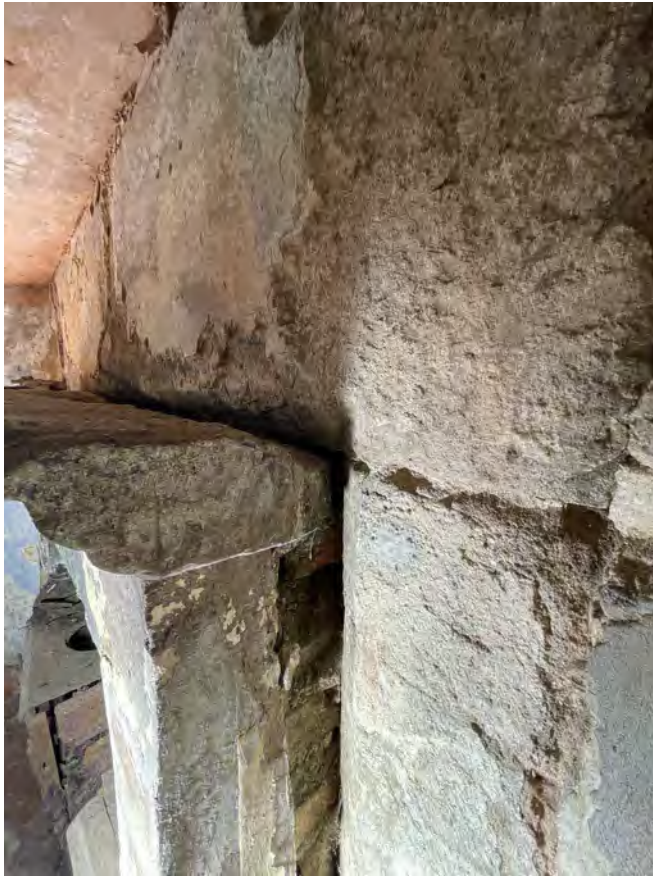
12. Corner fireplace with stone masonry chamfered surround to the full-height of the ceiling of ca. 1680 in-situ, and later inserted stone fireplace of the early 19<sup>th</sup> century with moulded lintel.

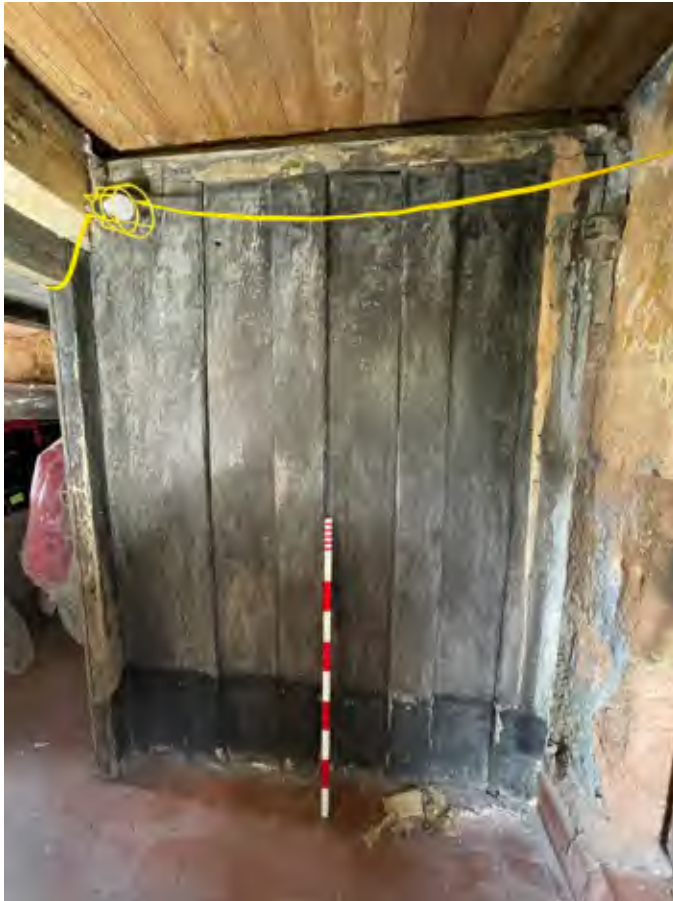
14. Plank-and-muntin screen to southern Parlour, of 17<sup>th</sup> century construction, with section of boarded floor to soffit of bedroom. The screen is pegged construction and similar to that in the main Living Room. Careful investigation is needed of the floor to establish if there is a hidden sole plate.

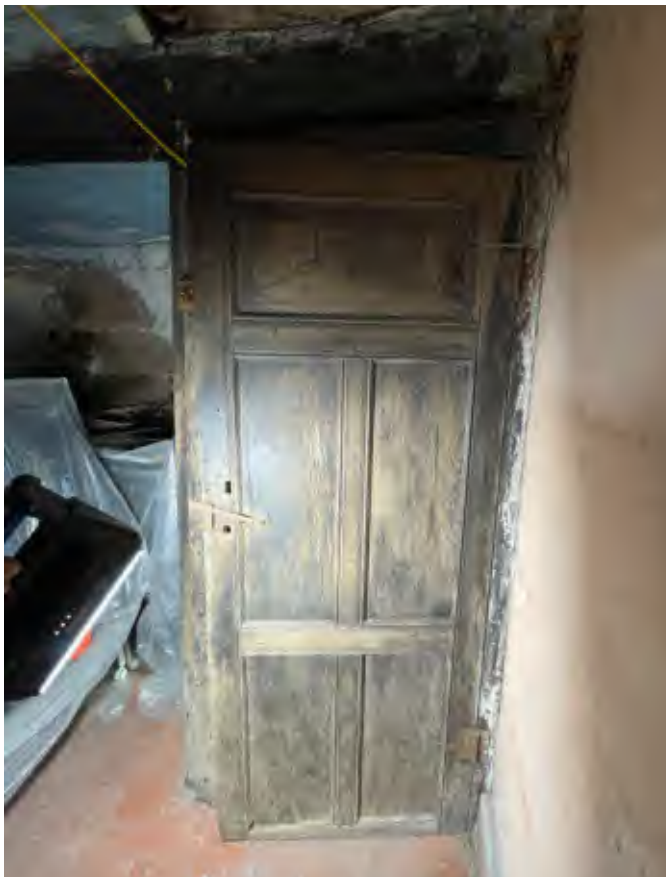
15. Late 17<sup>th</sup> century oak door in-situ to Parlour, with panelled form and ghosted remnants of contemporary door furniture – escutcheon, decorative h-hinges (now butt-hinges). The form of the door, with raised-and-fielded top panel and chamfered bottom leading edge of each rail, is typical of a room which has been fully panelled.

The floor may have been raised and the bottom of the door trimmed.

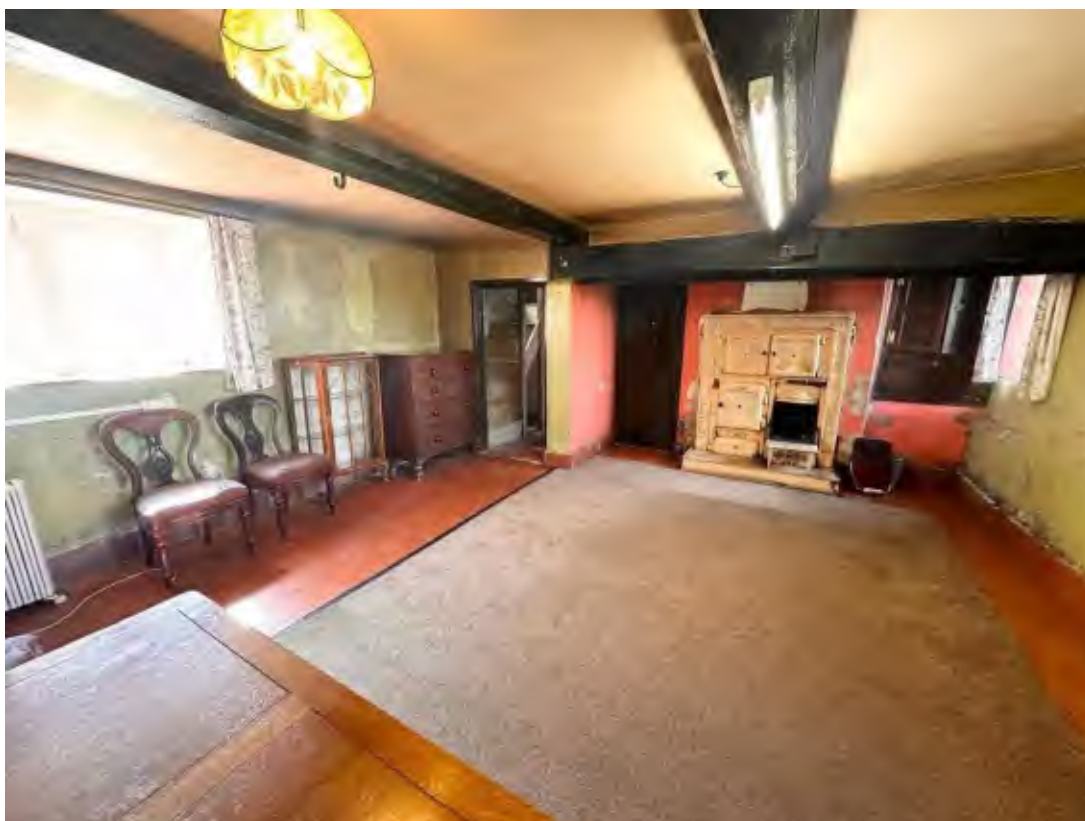
18. View of the interior of the Living Room from the sale particulars. Ceilings are plasterboard and have been removed to inspect the condition of the oak joists.

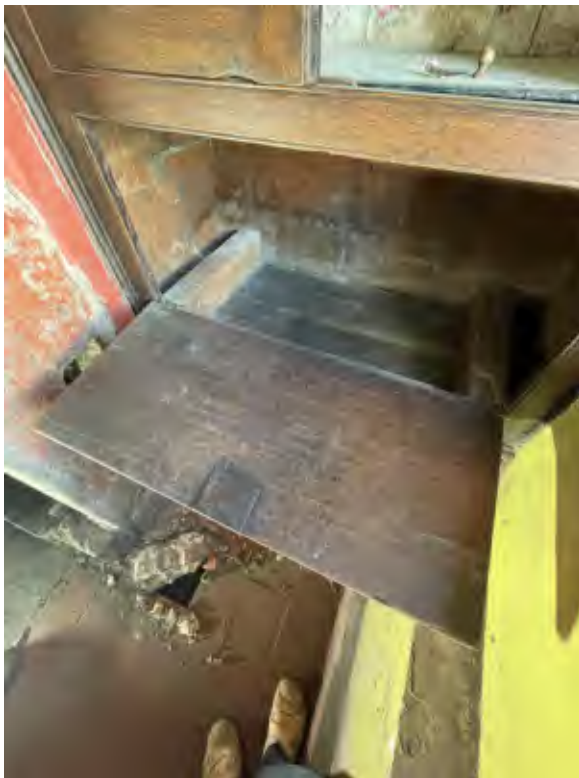
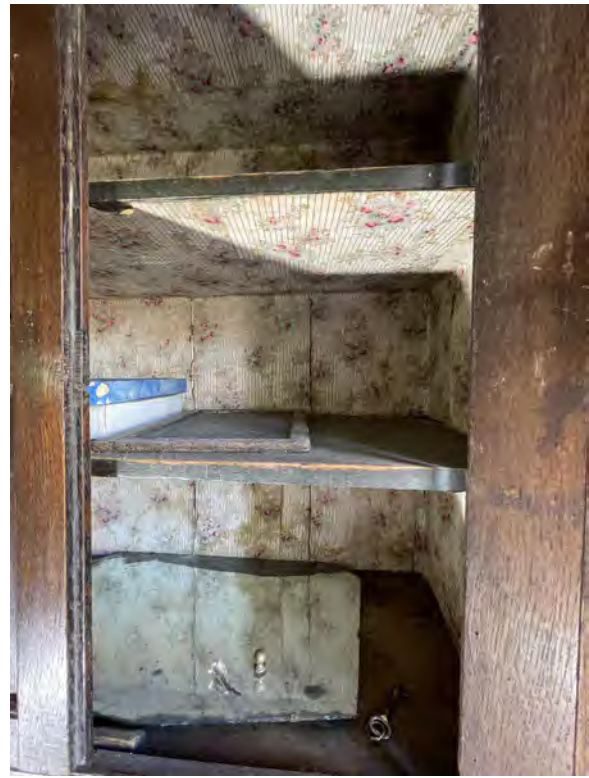
23. 18<sup>th</sup> century china corner cupboard with writing desk and altered fire window. Soffit needs local reinstatement of plasterboard and plaster skim.

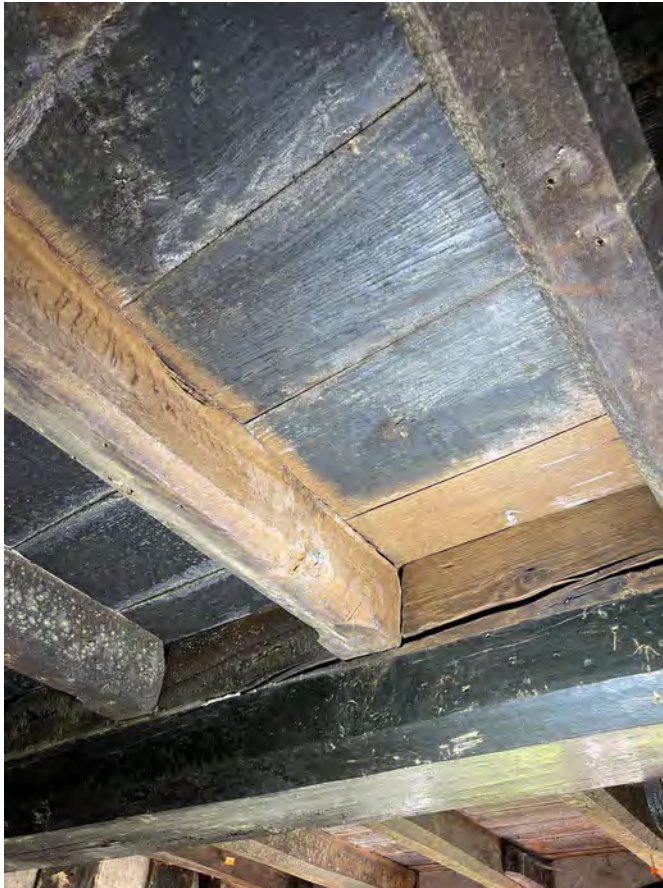
32. Main Living Room – area of test steam cleaning to soffit where plasterboard has been removed and revealed stop-chamfered oak joists and boarded ceiling.

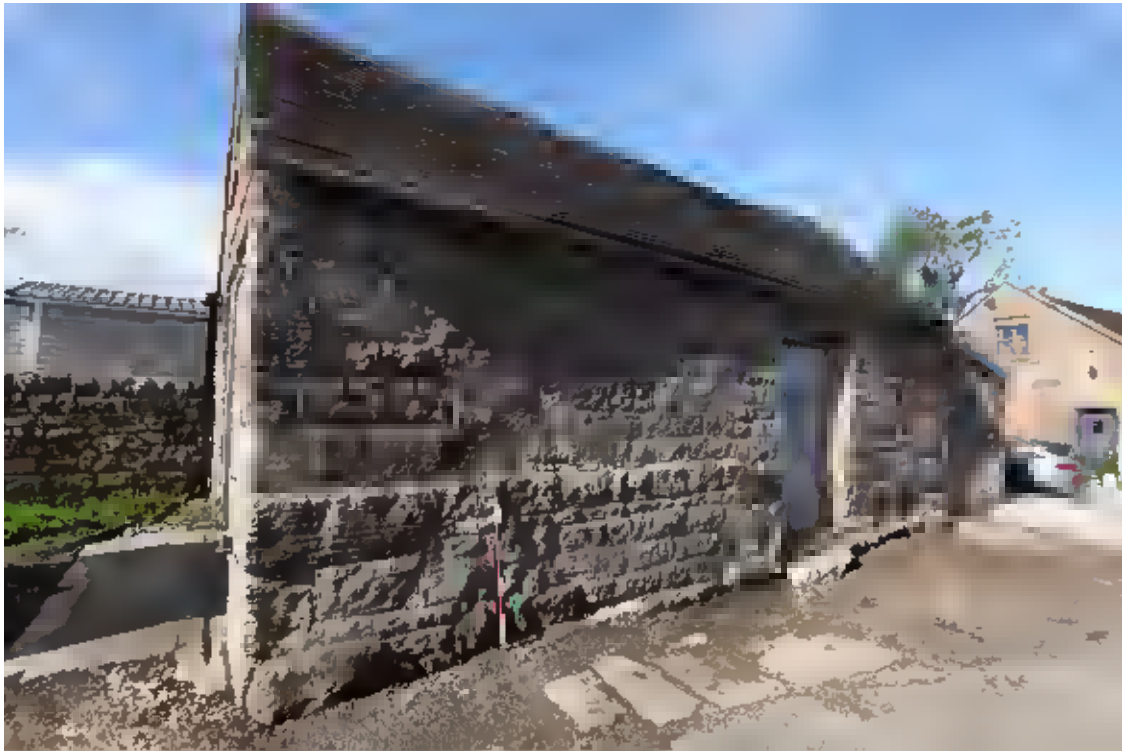
36. Stable – 17<sup>th</sup> century form with deep plinth and large blocks of masonry, altered and extended at the end of the 19<sup>th</sup> century.

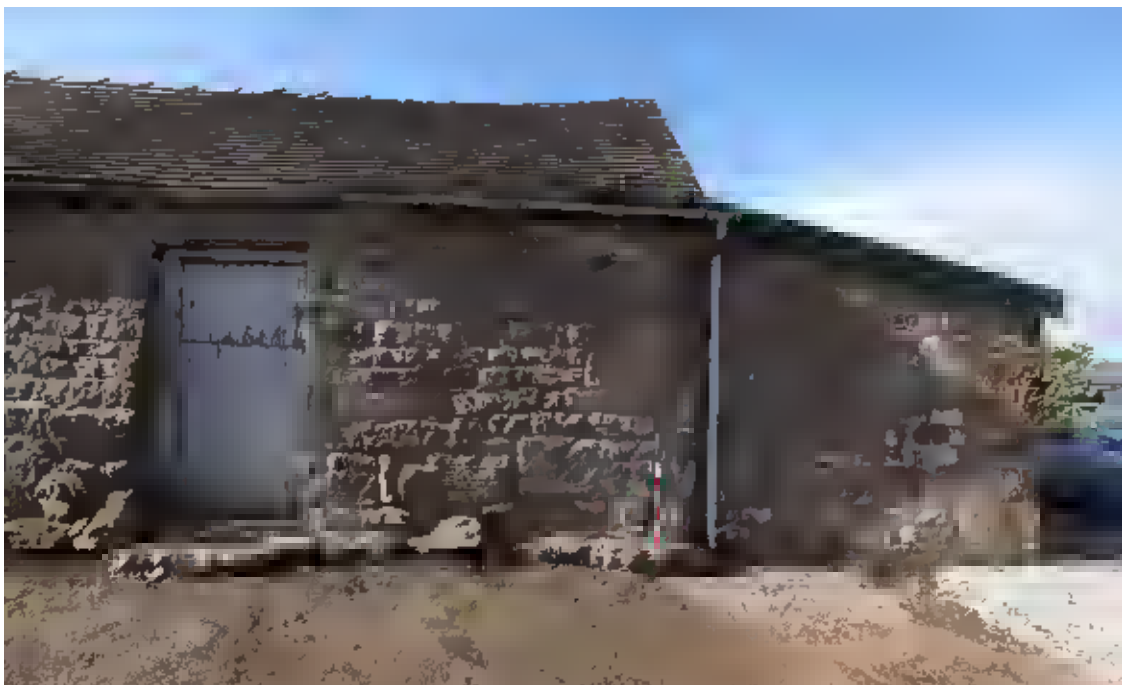
37. Stable – 17<sup>th</sup> century with later alterations and large blocks of masonry. Lean-to addition of the late 19<sup>th</sup> century in stone.

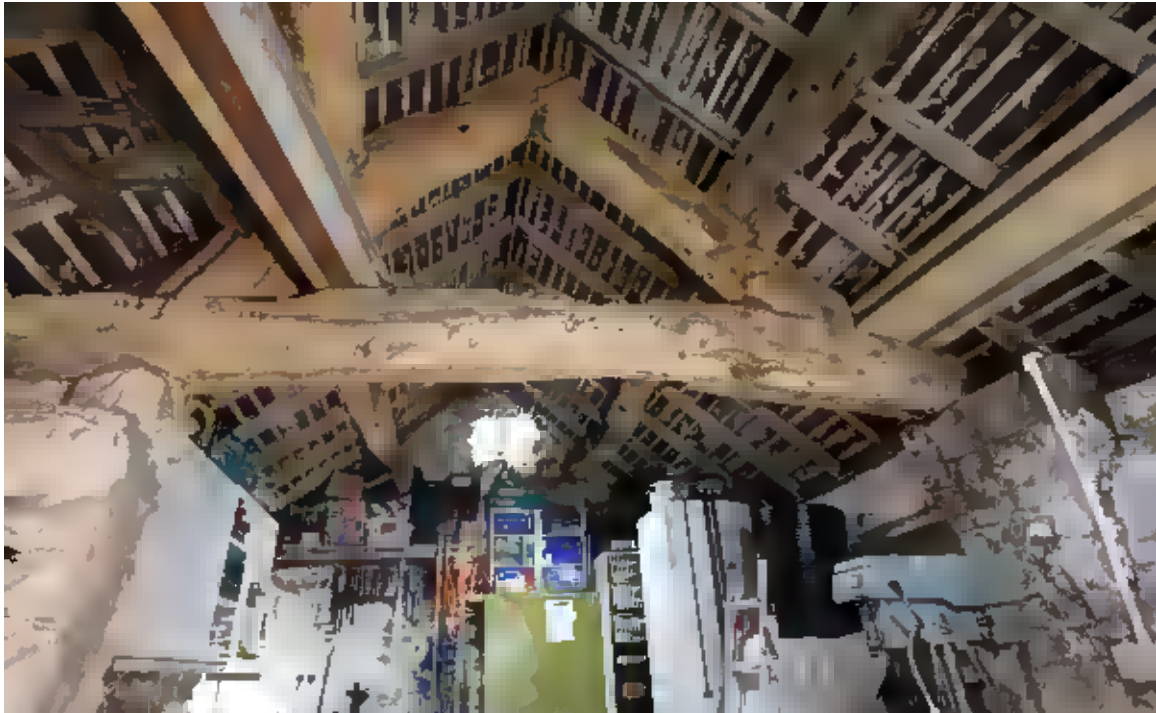
38. 17<sup>th</sup> century truss inserted into centre of stable roof over cross wall, which has been part demolished.

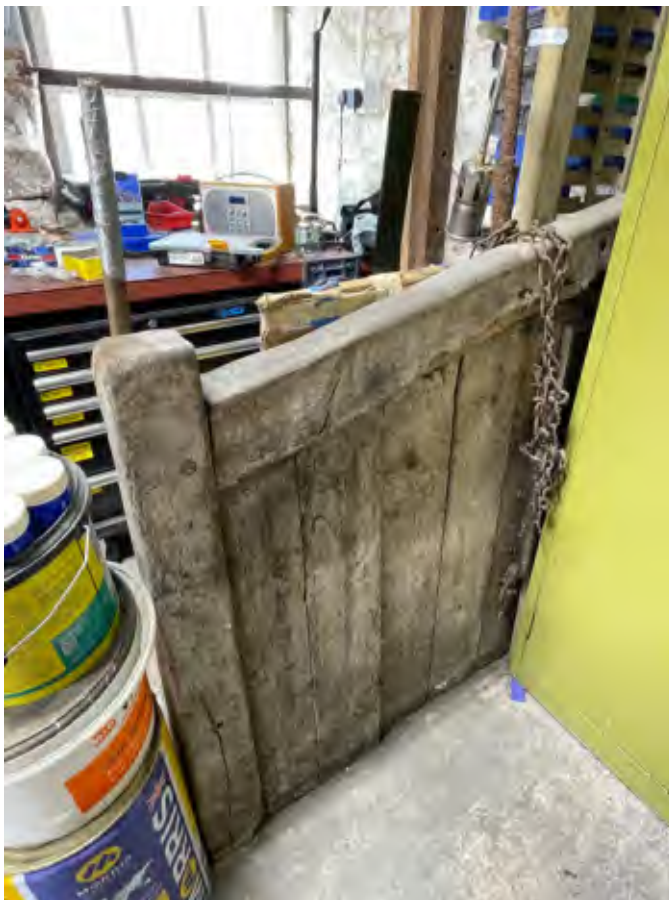
39. Stable with later inserted oak stall dividing two bays for a pair of horses.
