# Design and Heritage Statement

Location: 1, High Street, Alton, ST10 4AQ

## Application Title: Chimney and Roofing Repair Works - Listed Building Consent Phase 1

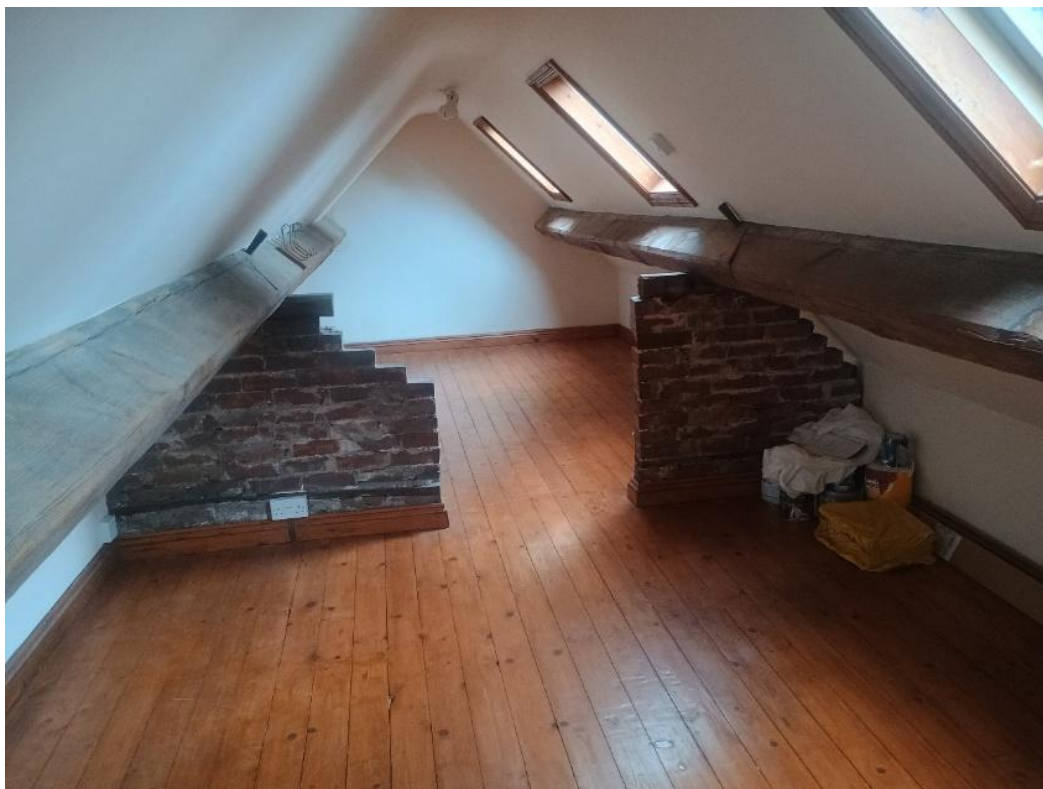
There is evidence of water ingress from the chimney stack in the attic. Water staining is evident on the attic internal wall (dry-lined) and wooden purlins where the purlins meet the gable end wall.

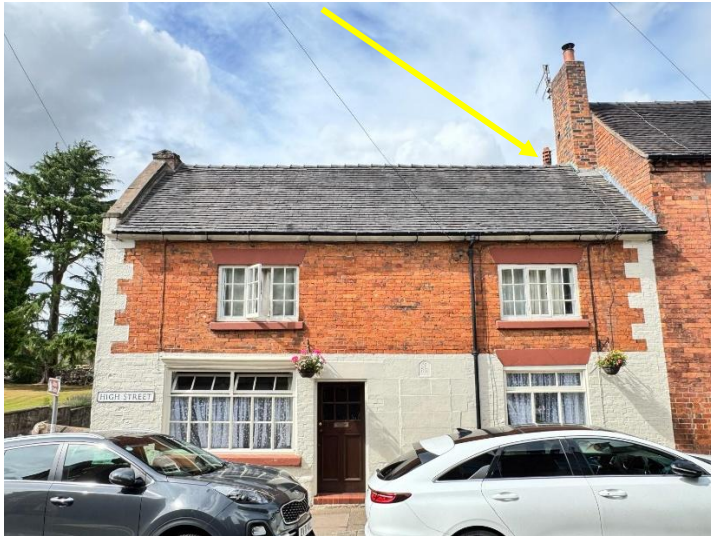
The top of the chimney pot and cowl is visible from the street frontage at street level.

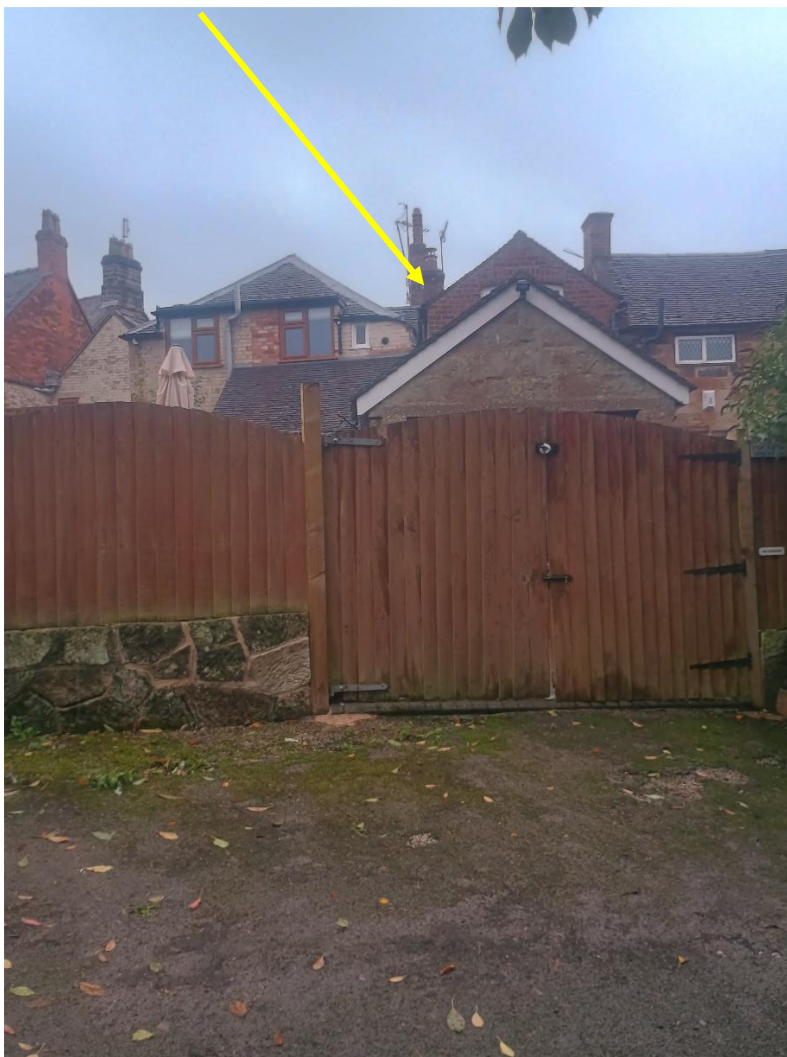
The chimney stack is visible from the rear of the property.

The roofer's recommendation is to remove the rear chimney stack as the stack is redundant and there is significant water ingress down the stack. The roof will be re-instated with new rafters and plain blue Staffordshire roof tiles to prevent any further water ingress, improve future roof performance and negate the requirement for continued maintenance of the chimney stack.
