**D20-ONE**  
STRUCTURAL DESIGN

# **Structural Report for Proposed Conversion**

**Barn at Dilhorne House**

| | Project<br><br>Structural Survey Report – Barn at Dilhorne House, ST10 2PH | Sheet no./rev.<br><br>2 | Job Ref.<br><br>0625-01 |

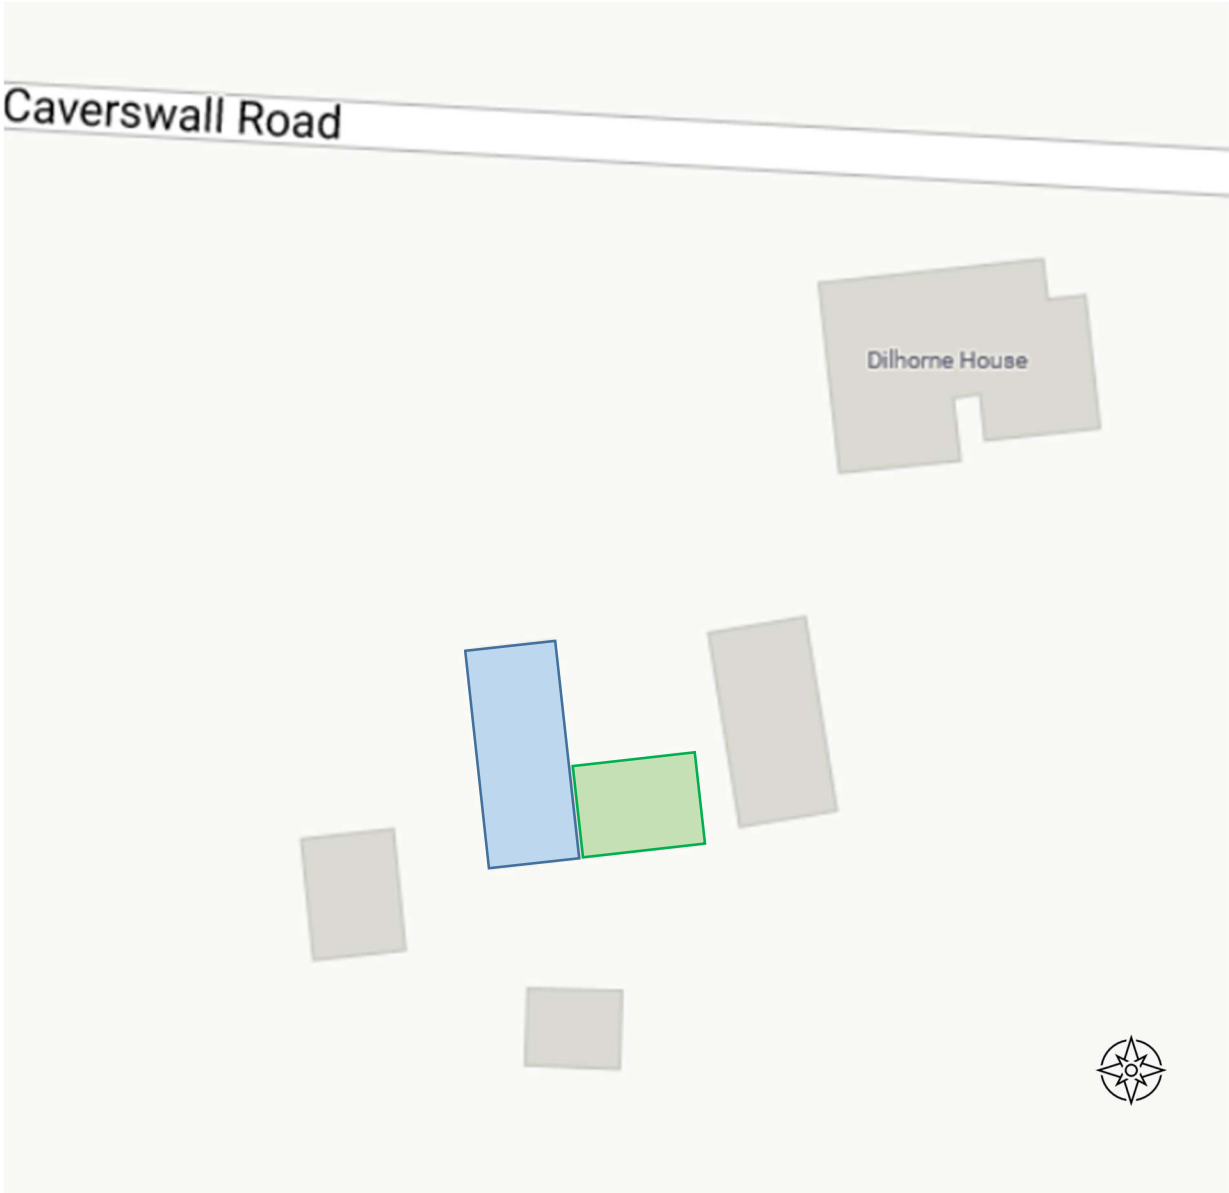
Figure 1 - Plan indicating building extents and orientated North

- 2.1 The site is a mixture of agricultural buildings and a main house. As indicated in figure 1 above. This report only covers the building indicated, which is a single L shaped brick-built structure with a single storey section in green and a two-storey section noted in blue.

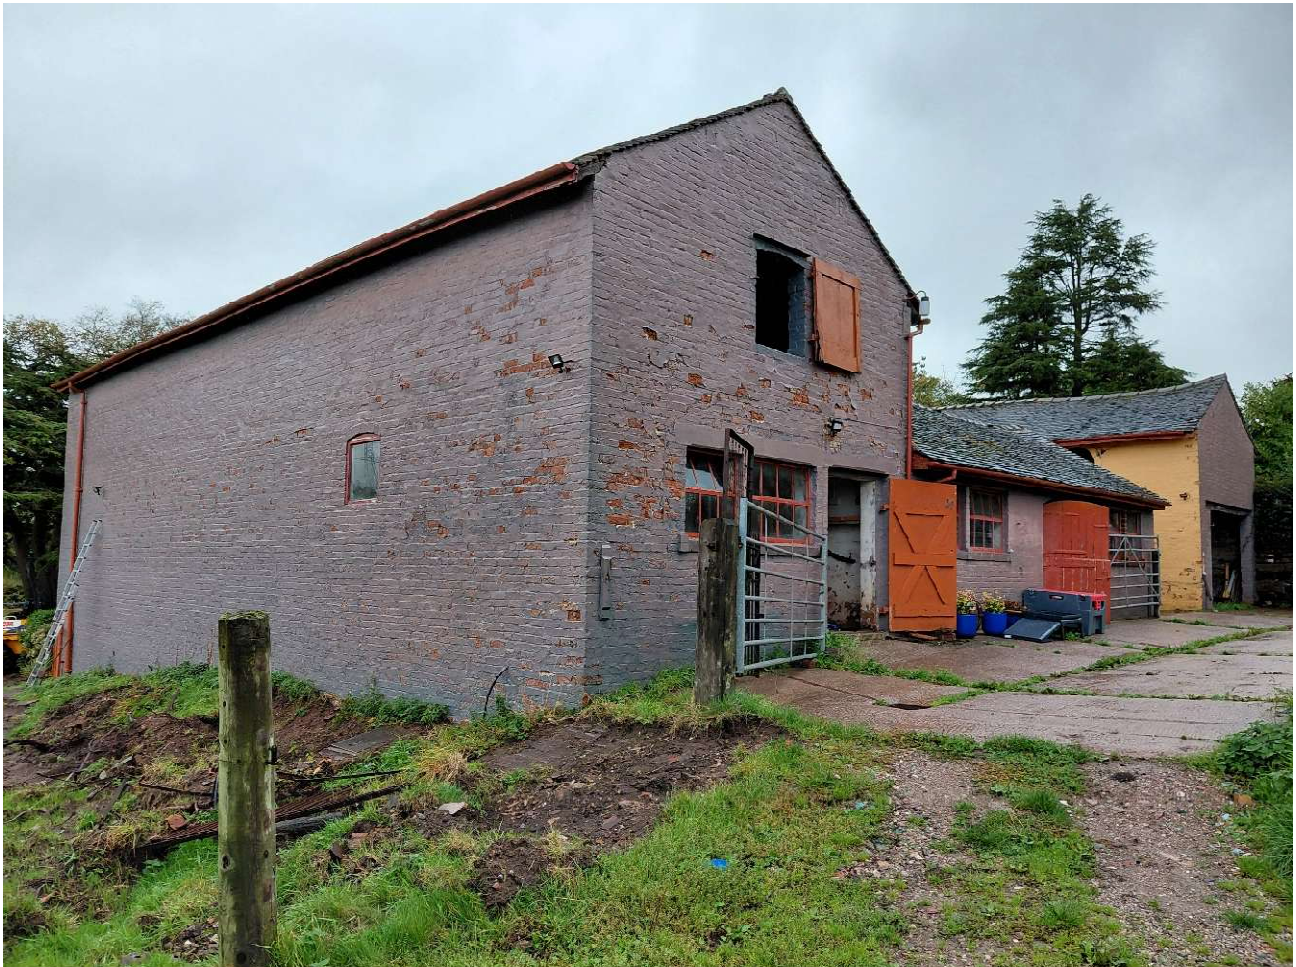
South West Elevation

- 3.1.1.5 Slight bulge at eaves on the right hand part of the Western elevation.
- 3.1.2 Roof structure appears appropriate for type of structure and in fair condition.

- 3.1.2.1 Access to fully inspect the two-storey roof was restricted due to safety concerns.
  - 3.1.2.2 Dip in the ridge line to the Southern extent of the ridge that aligns with bulge as noted previously.

- 4.3 The cause of the rotational movement at eaves, combined with the ridge dip, suggests a failure or long-term creep deflection of timber roof supports that will require further investigation and repair or replacement as agreed with a suitably qualified Structural Engineer.
