Structural Appraisal Report on

**The Cottage Building at
Fole Dairy
Uttoxeter Road
Uttoxeter
Staffordshire ST14 5EH**

July 2011

Report No. R11-1860

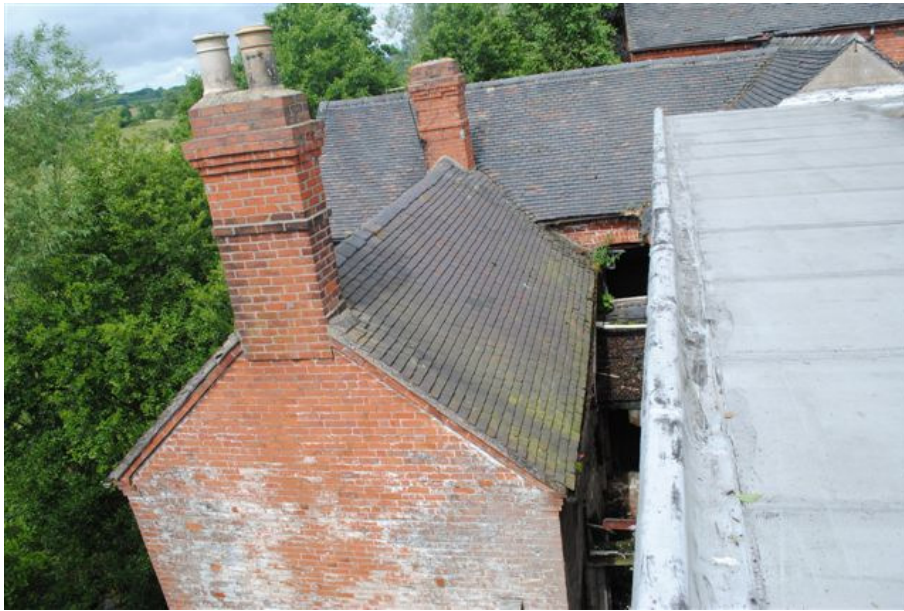
Photograph No. 6: Part View along South Elevation (Upper Level)

- 3.4 **South Elevation Facing The River Tean:** There is a considerable amount of settlement affecting the wall. The window openings are distorted and the cill brickwork slopes. Parts of the wall bulge outwards and there was stepped cracking at the short corner return and below the ground floor windows. The first floor window lintel has been re-pointed in the past.
