LIGHTOAKS, OAKAMOOR

HERITAGE STATEMENT & IMPACT ASSESSMENT

Prepared on behalf of Purple Circle Homes Ltd.

LIGHTOAKS - STATEMENT OF SIGNIFICANCE

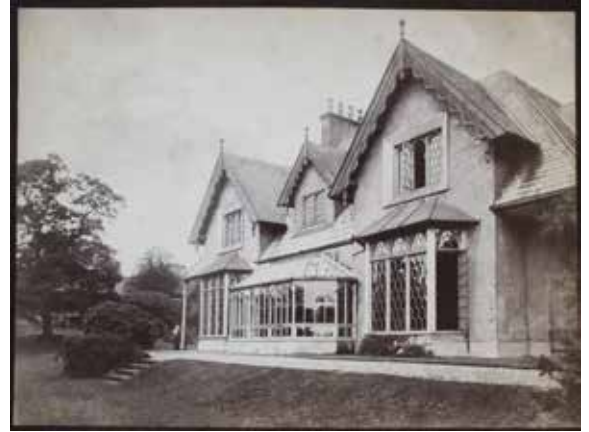
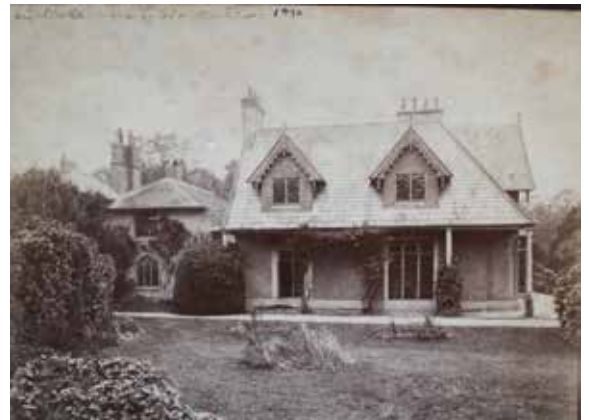
On the service ranges there was no attempt to disguise the new brickwork and the details are a little clumsy with a harder and more mottled brick flettons chosen for the attic floor. The bond is the same with three courses of stretchers to one of headers on the northern courtyard elevations and other bonds matching the coursing elsewhere. The attic dormer windows introduced as part of this refurbishment are a uniform pattern with cast-iron lozenge-shaped lattice casements, some of which are flat-headed and some of which incorporate pointed arched tracery. Each dormer has decorative scalloped bargeboards to match those on the original 1820s building.

The rear service buildings were also built from brickwork, with large overhanging, hipped, slate roofs, but this brick may have been originally limewashed rather than rendered and the evidence suggest that this was applied uniformly to all elevations without render. The later remodelling of the building of ca. 1895 incorporated a variety of different bricks, according to location and on the formal elevations this was covered up with new render and the whole building was re-rendered. Unfortunately, some of this render has been painted a very strong red colour, which is inappropriate in its use of bold colour, as it was designed to be rustic, mellow and have an air of rustic simplicity and authenticity. Later remodelling of windows involved creating large stone architraves (or panels) around the windows, to match those on the south-east garden elevation, and removing the timber posts, truncating the eaves slightly and supporting the first floor on decorative timber braces. Many of the original cast iron windows are still in-situ or re-used but there are also very good copies in the new cast-iron windows. There are subtle differences in the fixings and fittings, such as closing mechanisms.

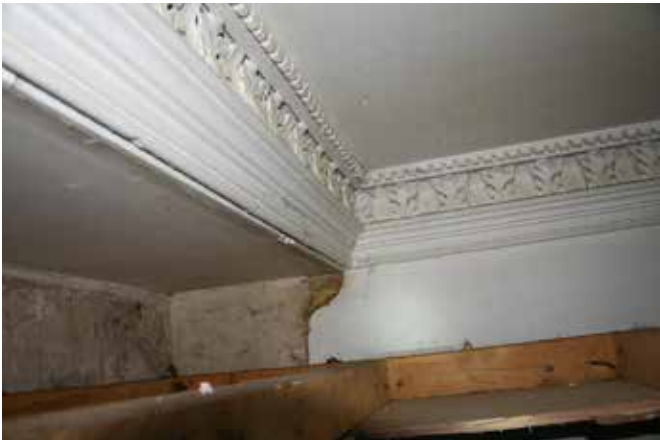
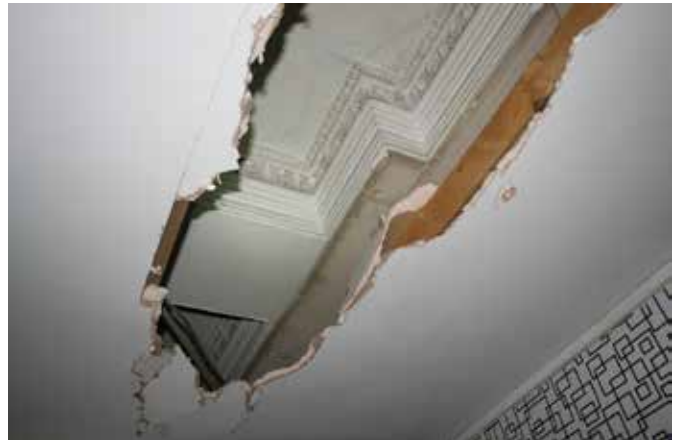
Ornate plasterwork and evidence of former library built-in bookshelves to the Billiard Room

The investigation of the Billiard Room has found that the ornate plastered and ribbed ceiling remains completely intact. The southern end of the room contains evidence within the plasterwork that the whole of this wall was fitted with shelving, designed in conjunction with the plasterwork. The shelving has been removed in its entirety but there are curved console brackets surviving in the plasterwork at either end of the wall. The shelving broke forward in

the centre of the wall and the cornice within the plasterwork repeats this detail, creating an articulated design. This formal arrangement was probably designed to provide fixed bookshelves and cupboards underneath. There are no indications that this room was approach via another doorway off the central hallway. The original entrance doorway from the Gun Room lobby still survives intact.

The floor of the Billiard Room is also largely complete with an oak parquet floor but has been damaged by the later alterations to create a kitchen and shower room. The original fireplace has been removed but within the parquet floor the position of the fireplace and the hearth can be clearly seen (pictured right). It will be feasible to reinstate a fireplace at some point in the future, but whether it can be made a working fireplace needs further investigation and is uncertain.

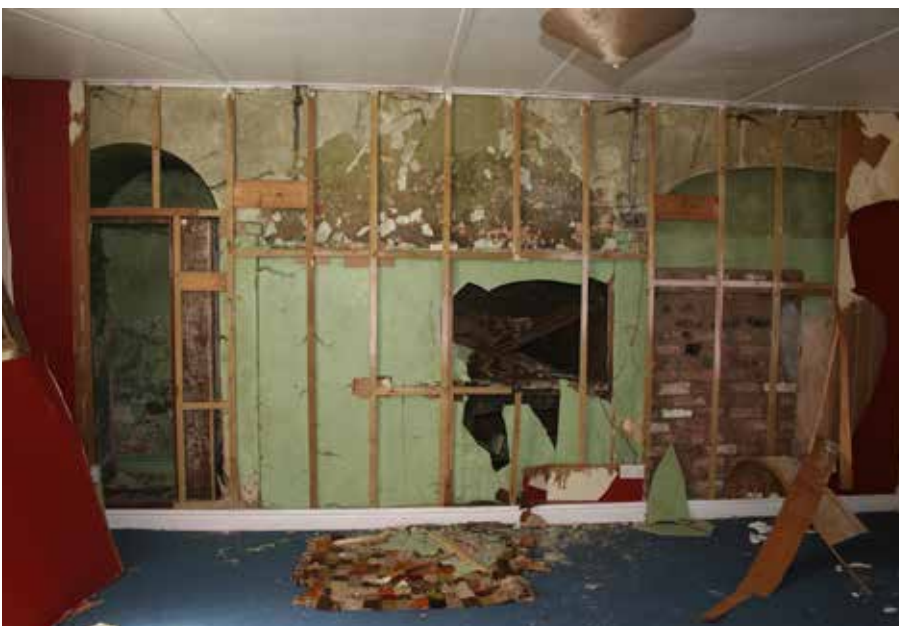
The kitchen flue wall was divided into three plastered bays divided by four sandstone pilasters with plain impost bands, which survive across the whole wall.

The investigation of the former Kitchen has found that the west wall contains a complete sequence of arched openings, flues and fixtures which are typical of high quality Georgian kitchens. This includes a central fireplace with very large cast-iron range and a previous arched opening connecting the kitchen with the coach-house; the fixtures survive largely in their form of the 1890s. This is of very high significance.

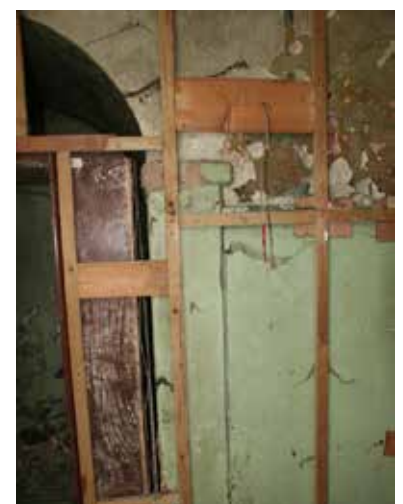
Arches spring from the impost bands and there are three different type of arch:

- the central hearth has a large segmental-arched brick opening, which was plastered over and the arch infilled at the time that a cast-iron range was installed, which survives in a poor condition, with partially collapsed register plate and plate warming rack, but the remainder of the fittings largely intact,

- the arch to the right is a shallow basket arch and this is decorative, as the plasterwork creates a shallow recess which is part of the design and does not represent an infilled arch; there is a later infilled section of brickwork, which was inserted when the original copper or warming oven was removed. The presence of a flue behind this brickwork cannot be discounted. This rebated recess with a basket arch is typically Georgian.

- The third arch to the left is a semi-circular masonry arch which supports the large flue and masonry above, deeply set. The straight joint in the brickwork within the garage reveals that this was once a vaulted doorway connecting the kitchen with the room / coach-house beyond.

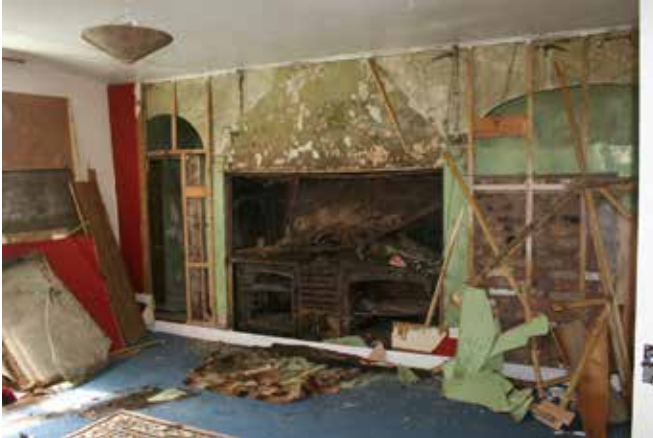
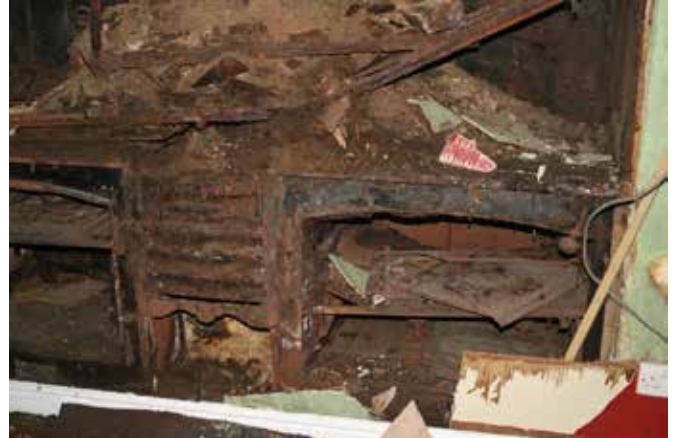
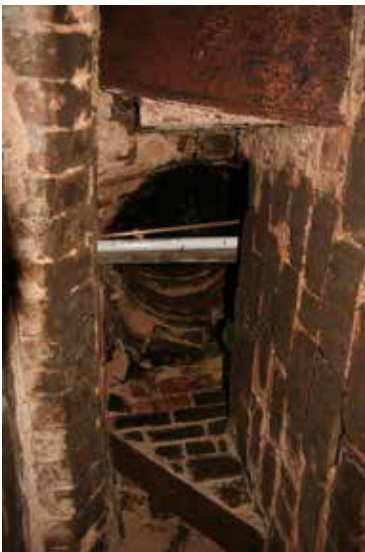
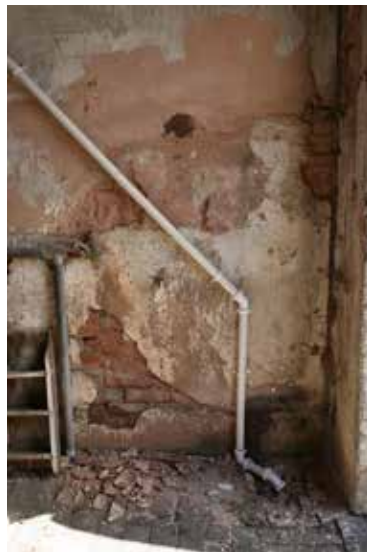
Details of the cast-iron range: Above - double ovens. Below left - chimney flue with iron bands lining large circular flue. Below centre - the wall to the rear of the former doorway, with straight joints. Below right - collapsed plate warming rack

The date of the range is not possible to identify at present but, following renovation, it may be feasible to find name plaques and date the fittings. It is a 'closed range' with cast-iron plates over the ovens and separate rack for warming pans or plates, and may date from the 1890s refurbishment. The presence of cast back panels with reeding seem to indicate late Georgian fittings but common styles of casting were adopted throughout the 19th century. To either side of the central open fire basket are ovens.
