LISTED BUILDING HERITAGE STATEMENT

Barns at Bradley Lane Bradley Alton Stoke on Trent

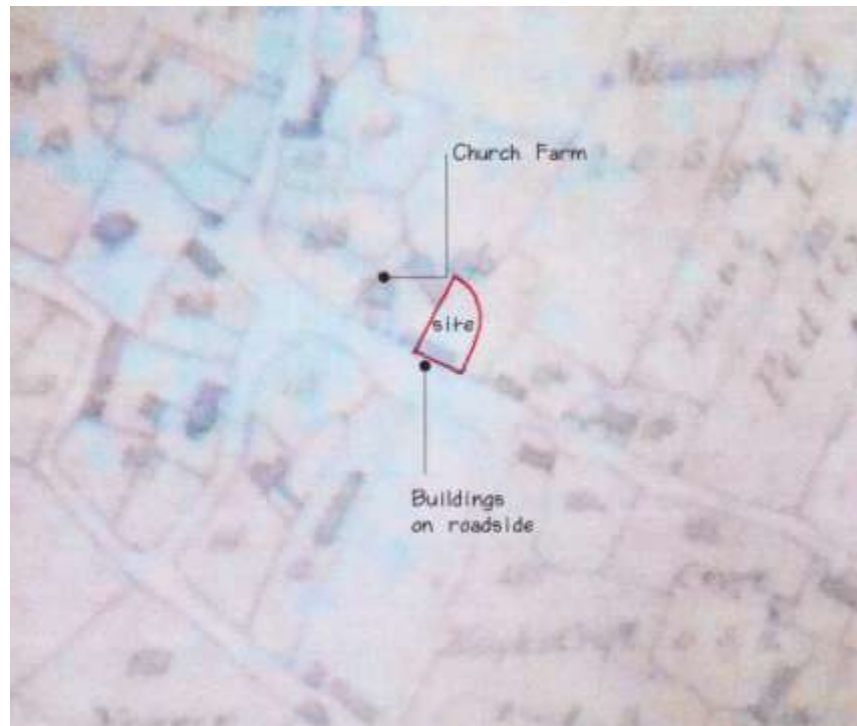
1.2.1- Examination of old mapping reveals that the main block fronting the road was probably built in about 1650. This is indicated on the old map shown below which is thought to date from the mid seventeenth century.

The building is of solid coursed local sandstone ('Ashlar') with a hand-made clay tiled roof supported by timber rafters and purlins with a Queen Post Truss with dropped ceiling tie near to the eastern division where the buildings were separated many years ago.

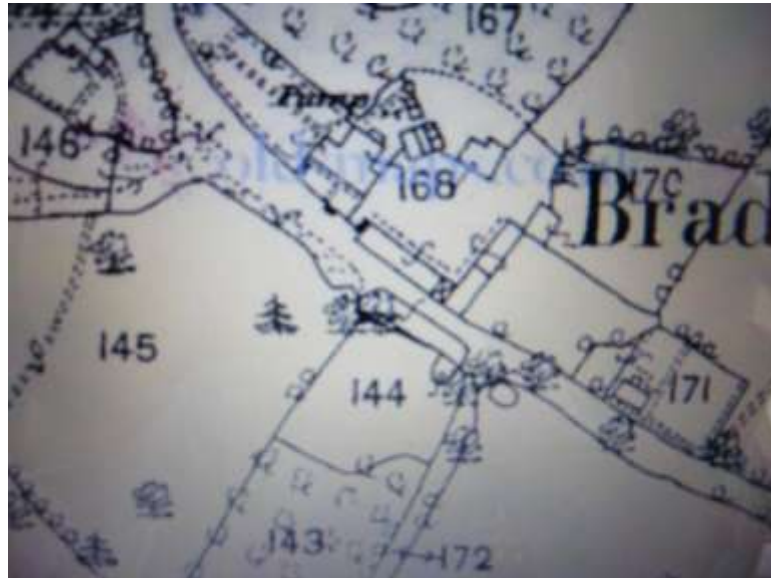
1.2.2- The linking roof and block at right angles was then added later, probably in about 1750. The map below is an extract from the 1881 Ordnance Survey:

This shows the opening and the later building running at right angles from the road. The main 2 storey section by the road is again is of Ashlar sandstone with a tiled roof. It is in 3 bays with a loft area to the 2 sections by the road. The gables here are finished with tabled stone parapets and kneelers at each end.

The roofs are tiled and again supported by timber rafters and purlins which are carried by the gable walls, a King Post truss and 1 internal wall. Valleys are formed where the linking roof over the roadside opening meets at right angles.

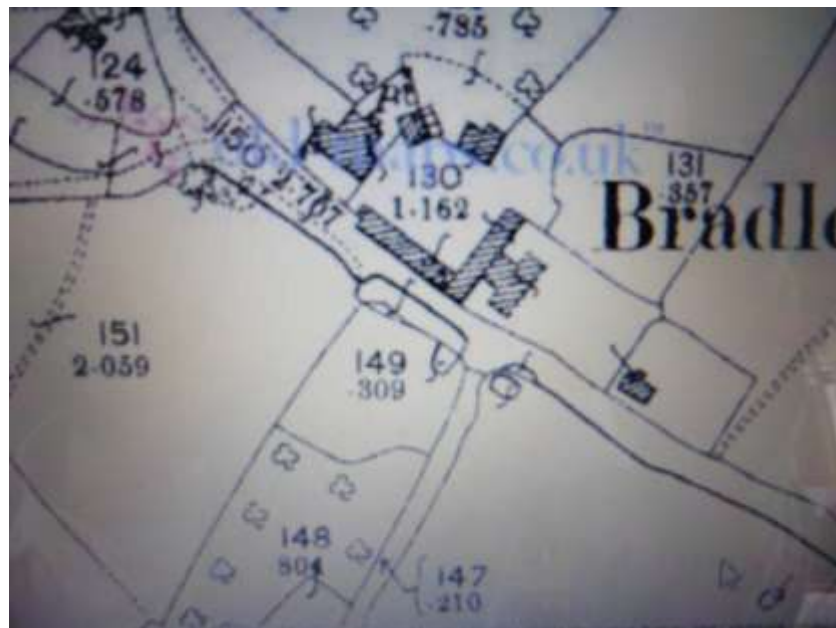
1.2.3-The open barn and link are visible on the 1900 edition which dates that part to the late 1890's fairly precisely. An extract is shown below:

The main support for the barn is from 10 substantial brick columns with plinths at about 1.20 metres above ground level. The roof is of corrugated asbestos sheeting on timber boarding with timber rafters beneath carried by purlins and supported on Queen Post timber trusses at each column.

The linking section is supported by a brick column off the lower stone barn and brick support off the higher gable and a matching corrugated asbestos roof.

The open barn has been extended on the roadside with a matching corrugated asbestos roof supported by 2 timber columns and a King Post truss. This is the most recent part of the structure and probably dates from the 1930's.

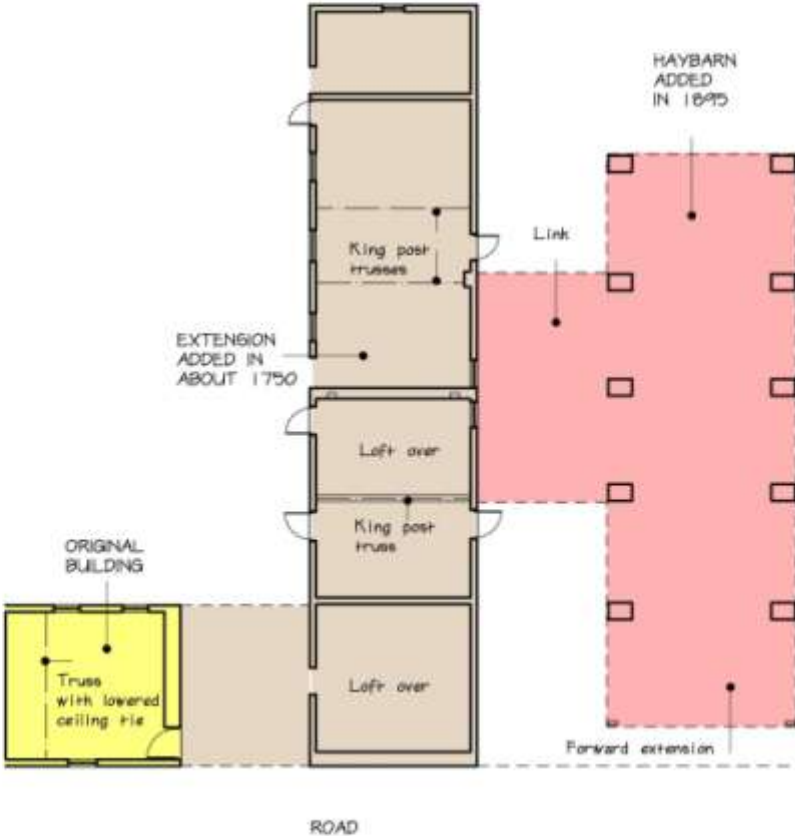
Plan 1-200

APPENDIX

1.2- History and sequence of development (see also plan at the end of this report attached as an Appendix):
