## DESIGN, ACCESS AND HERITAGE STATEMENT

31 High Street, Upper Tean, Staffordshire, ST10 4DY

**Conversion of existing store to non-habitable ancillary domestic accommodation and replacement windows to rear elevation first floor.**

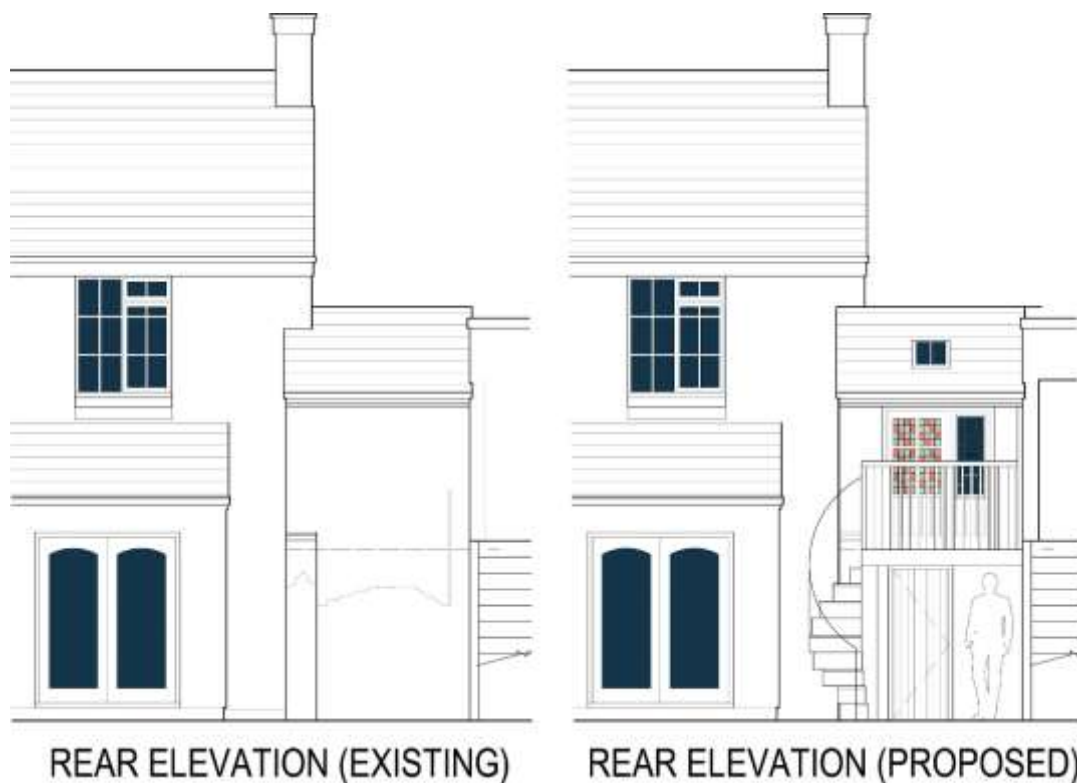
This will include the creation of a new external opening to the Rear elevation at first floor through the existing rendered masonry wall, accessed by new metal spiral staircase and balcony. At ground floor, it is proposed to create a new external opening to the rear elevation rendered masonry wall and block up the existing opening to the east elevation.

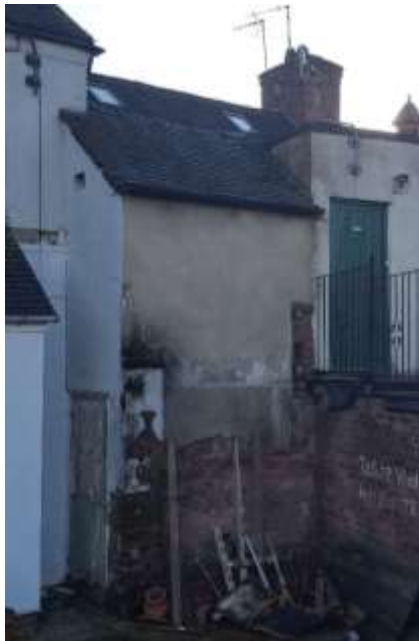
Fig H01: External lime render in poor condition

The store walls are constructed from solid brick masonry (2leafs) with traditional lime render to the external leaf and lime plaster to the interior: the internal and external finishes are in poor condition with evidence of failure (see images H01 & H02) The store roof is constructed from Staffordshire blue tiles on timber battens on timber rafters with a lath and lime plaster ceiling (torching/ underlay not determined at this time): the roof appears sound, however the ceiling is in poor condition with evidence of failure (see Image H03). Floor: The first floor is constructed from timber boards on timber rafters with a lath and lime plaster ceiling below: all components appear to be in good condition. At ground floor the alley way is partitioned from the small store by a timber framed vertical boarded partition wall with ledge and brace boarded door and crittal window; the door is sound condition but the wall boarding and window requires like-for-like reparations (see image H04). The ground floor alleyway and store are constructed from contemporary concrete.

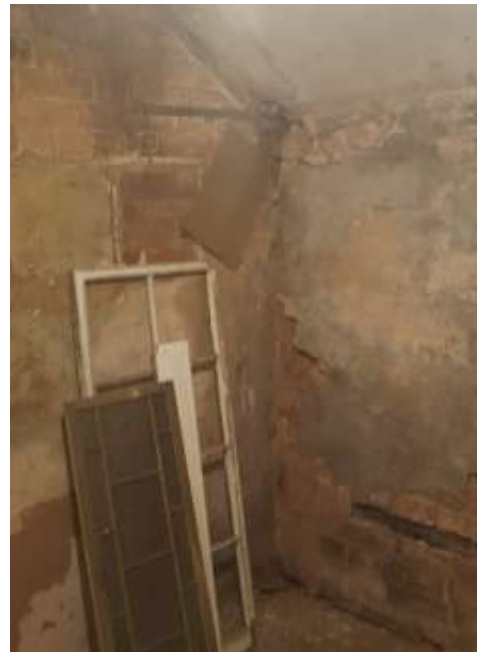
Fig H02: Internal lime plaster in poor condition

Walls: Existing blown lime plaster removed from surface and common brick work made good with 3:1 lime mortar. Where lime plaster is in sound condition it shall be retained and walls made good with scratch coat of lime plaster. 50mm woodfibre insulation board fully bonded to internal face and finished with Solo one-coat lime plaster and painted with water-based heritage paint.

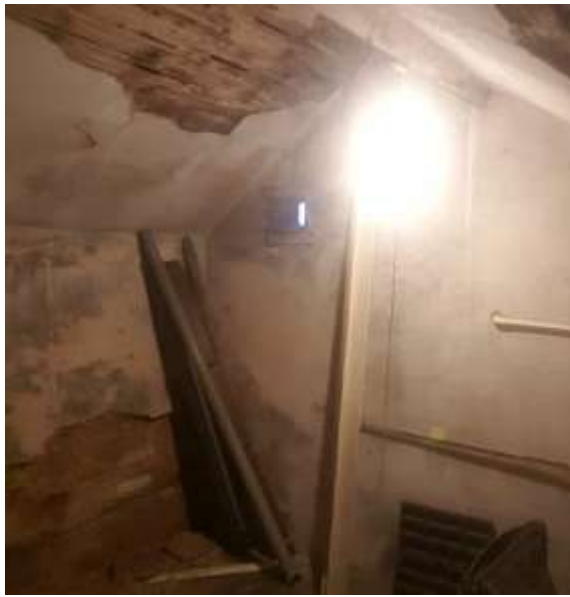
Fig H03: External lath and plaster ceiling in poor condition

Ceiling: Existing blown lath and plaster ceiling carefully removed and rafters cleaned and prepared to take new ceiling construction: 50mm woodfibre insulation board mechanically fixed to rafters and finished with Solo one-coat lime plaster and painted with water-based heritage paint.

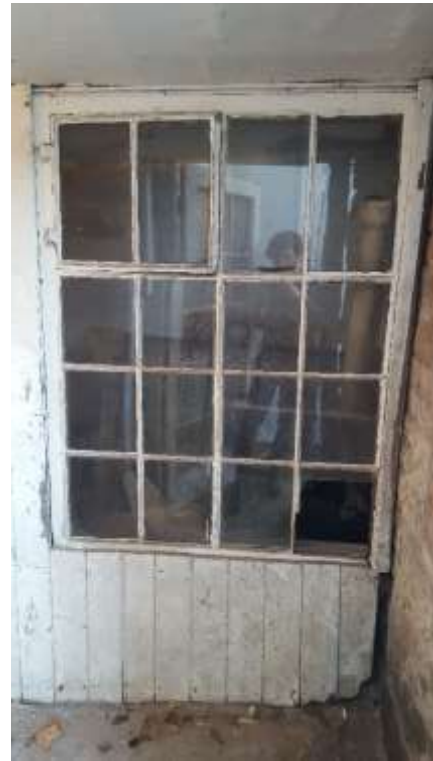
Fig H04: Internal partition wall requiring repairs

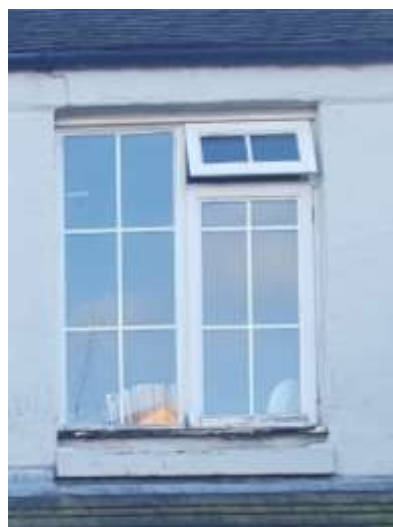
Fig H05: Existing windows ; single glazed storm casements with planted glazing bars

Single glazing in painted timber storm casement frames (top and side hung as shown) with planted glazing bars. Frames and stub sills in poor condition with evidence of rot externally and internally (see Fig H05): casement construction and planted glazing bars would suggest the windows are modern interventions and not original.

W01 & W02 (replacements): New timber framed flush casement windows with structural timber glazing bars and slim-line (14mm) double glazing: casement configuration to match existing All timbers painted white in water-based heritage paint.

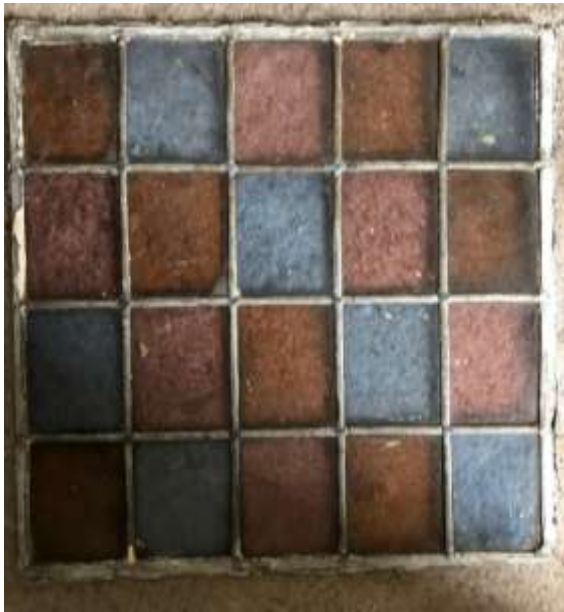
Fig H06: Handmade coloured leaded glass to be used in new door

W04: (first floor door) New timber framed external vertical boarded half glazed door and sidelight: It is proposed to re-use coloured glass panes found in storage at the property (see fig H06) in the creation of the new timber framed external door, and re-use art-deco style casements -again found in storage at the property- (see fig H07) for the side vision light: secondary glazing installed to the internal leaf of the glazing. All frames, casement timbers and tongue and groove panelling to be painted in water-based paint in heritage colours.

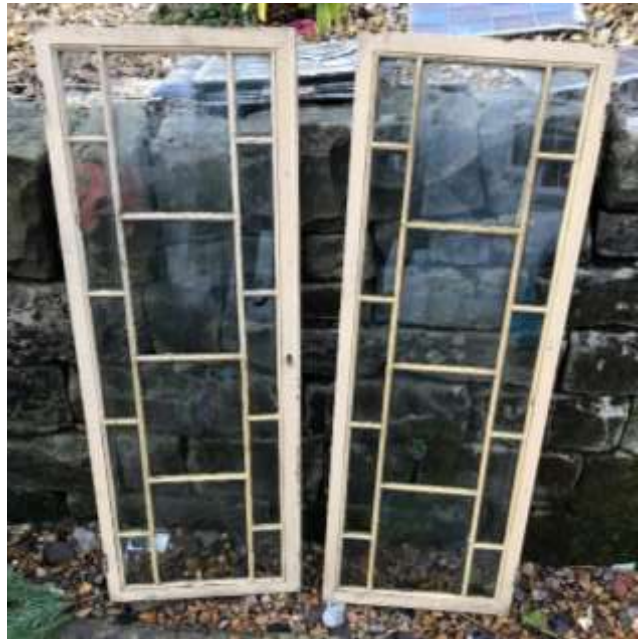
Fig H07: single glazed casements to be used in side vision panel
