**Subject:** Further objections arising from the Quarry 3 instability and dangers / the lagoon and safety regulations in respect of SMD/2019/0646 and SMD/2022/0014

**Further objections arising from the Quarry 3 instability and dangers / the lagoon and safety regulations in respect of SMD/2019/0646 and SMD/2022/0014**

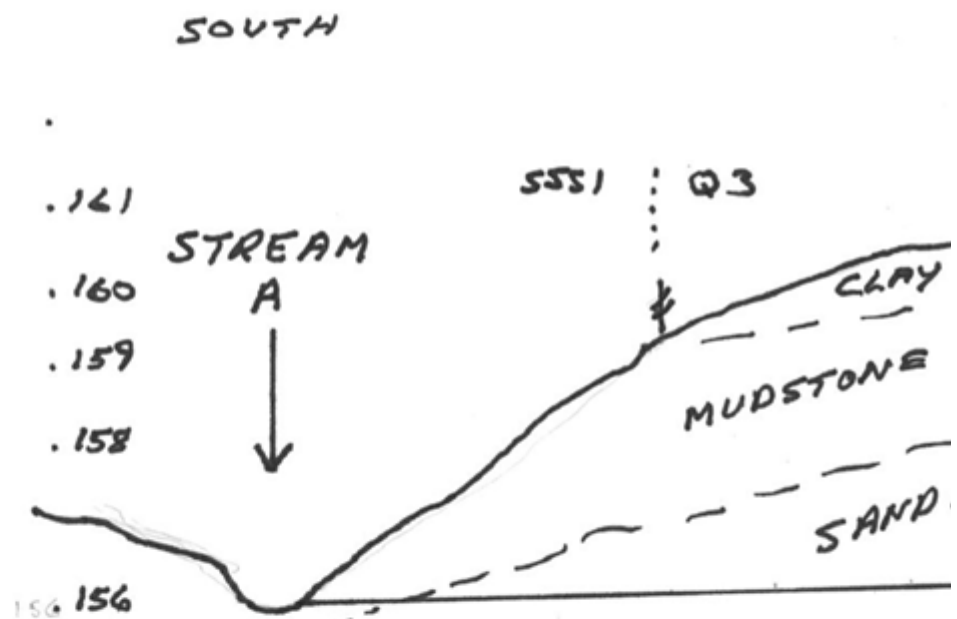
**Long Section Fig**

location shown in Fig 1. The cutting base/cut deep through the land bridge to match the lake level of 156m AOD the channel base sl length.

This quality of drawing or illustration is just not acceptable.

However that response will require further submissions as those geotechnical assessments submitted so far are not sufficient to pass muster lacking as they do for example in SMD/2022/0014 where the problem is derived from the inadequate quality of information provided by Abbeydale BEC, and its suitability for purpose as exemplified by comparing the required technical information profile and quality of cartographic draughtsmanship under regulation 33 of the HSE guidance, to that in the submission as a support document for the proposed new outfall spillway (ref application SMD/2022/0014) also provided by the same company, Abbeydale. and shown in the extract below :-
