## 2.0 Roof - Rafter Plan & Proposed

## 2.0 Roof - Existing & Proposed

## 1.0 First Floor - Existing & Proposed

## 0.0 Ground Floor - Existing & Proposed

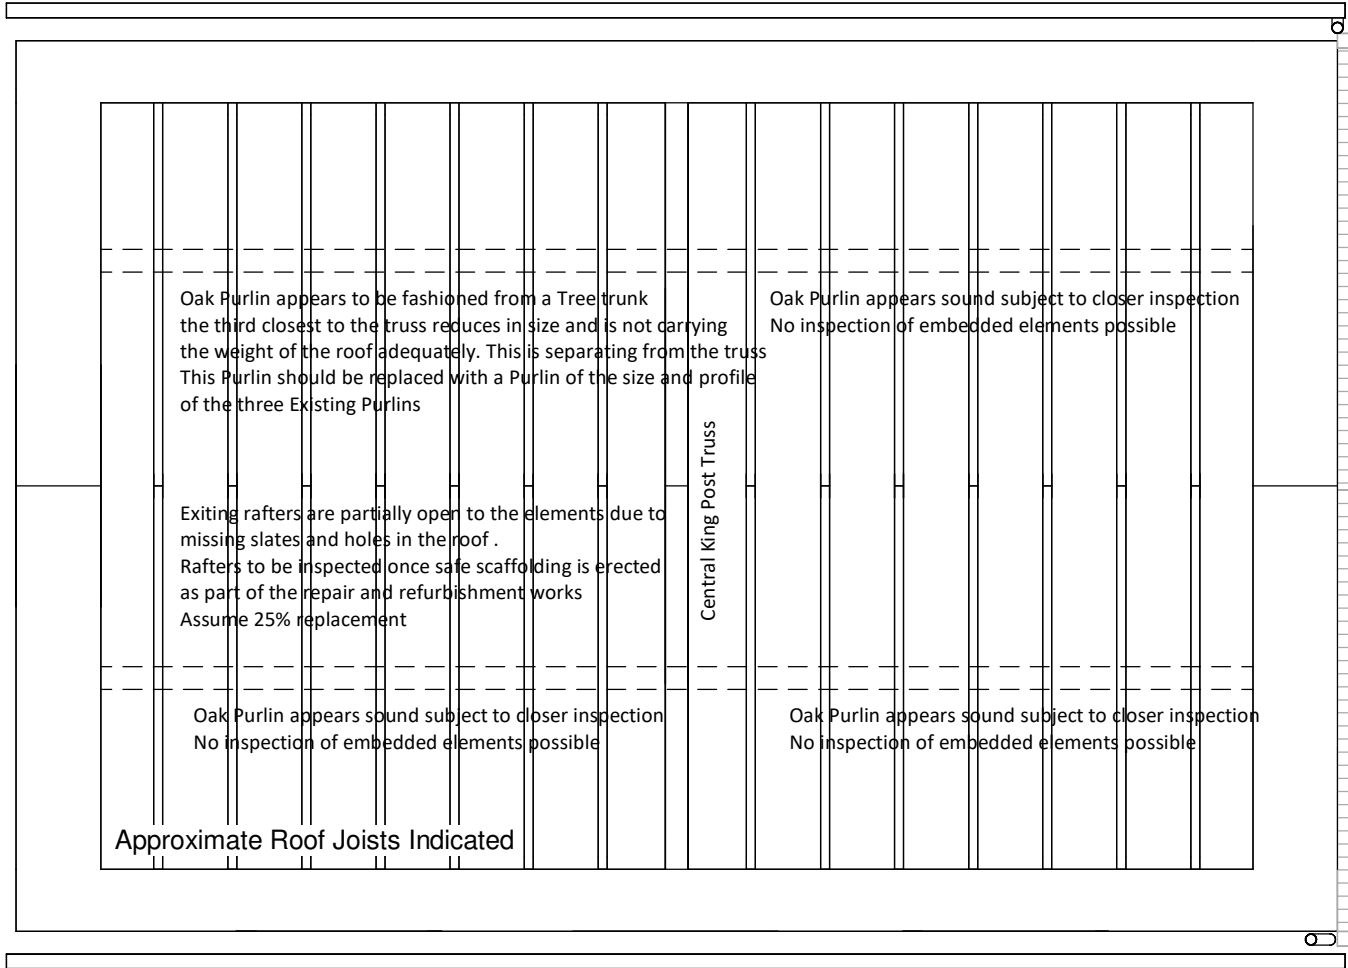
**Roof timbers**  
Allow for replacement of the Ridge Board due to decay  
Allow for replacement of tiling battens due to water ingress  
Existing Rafters to be set aside for reuse. Replace rotten rafters refer to Condition Survey for full extent of works

Allow for replacement of One Oak Purlin. Inspection of the ends of the three remaining purlins to determine whether any further rot is present  
Allow for 2no black fitch plates to be bolted to Purlin joints over the King Post truss  
Fit new treated timber wall plate to head of wall prior to installation of rafters.

Fit a type W1 breather membrane to roof removing the damaged felt.

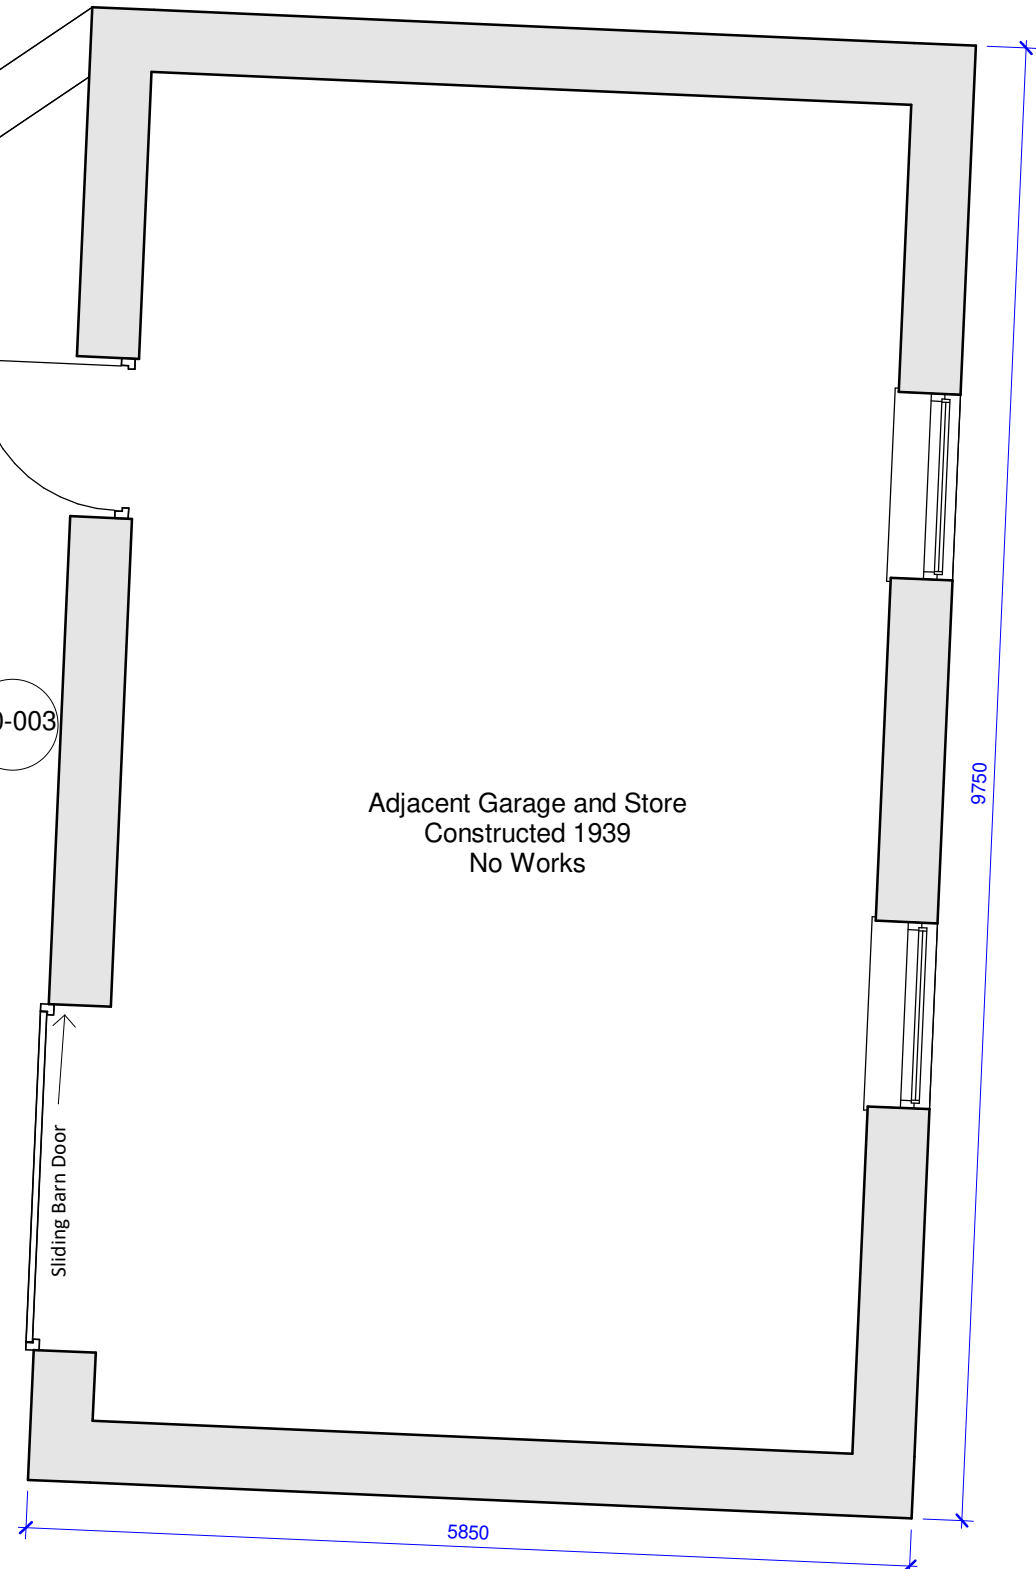
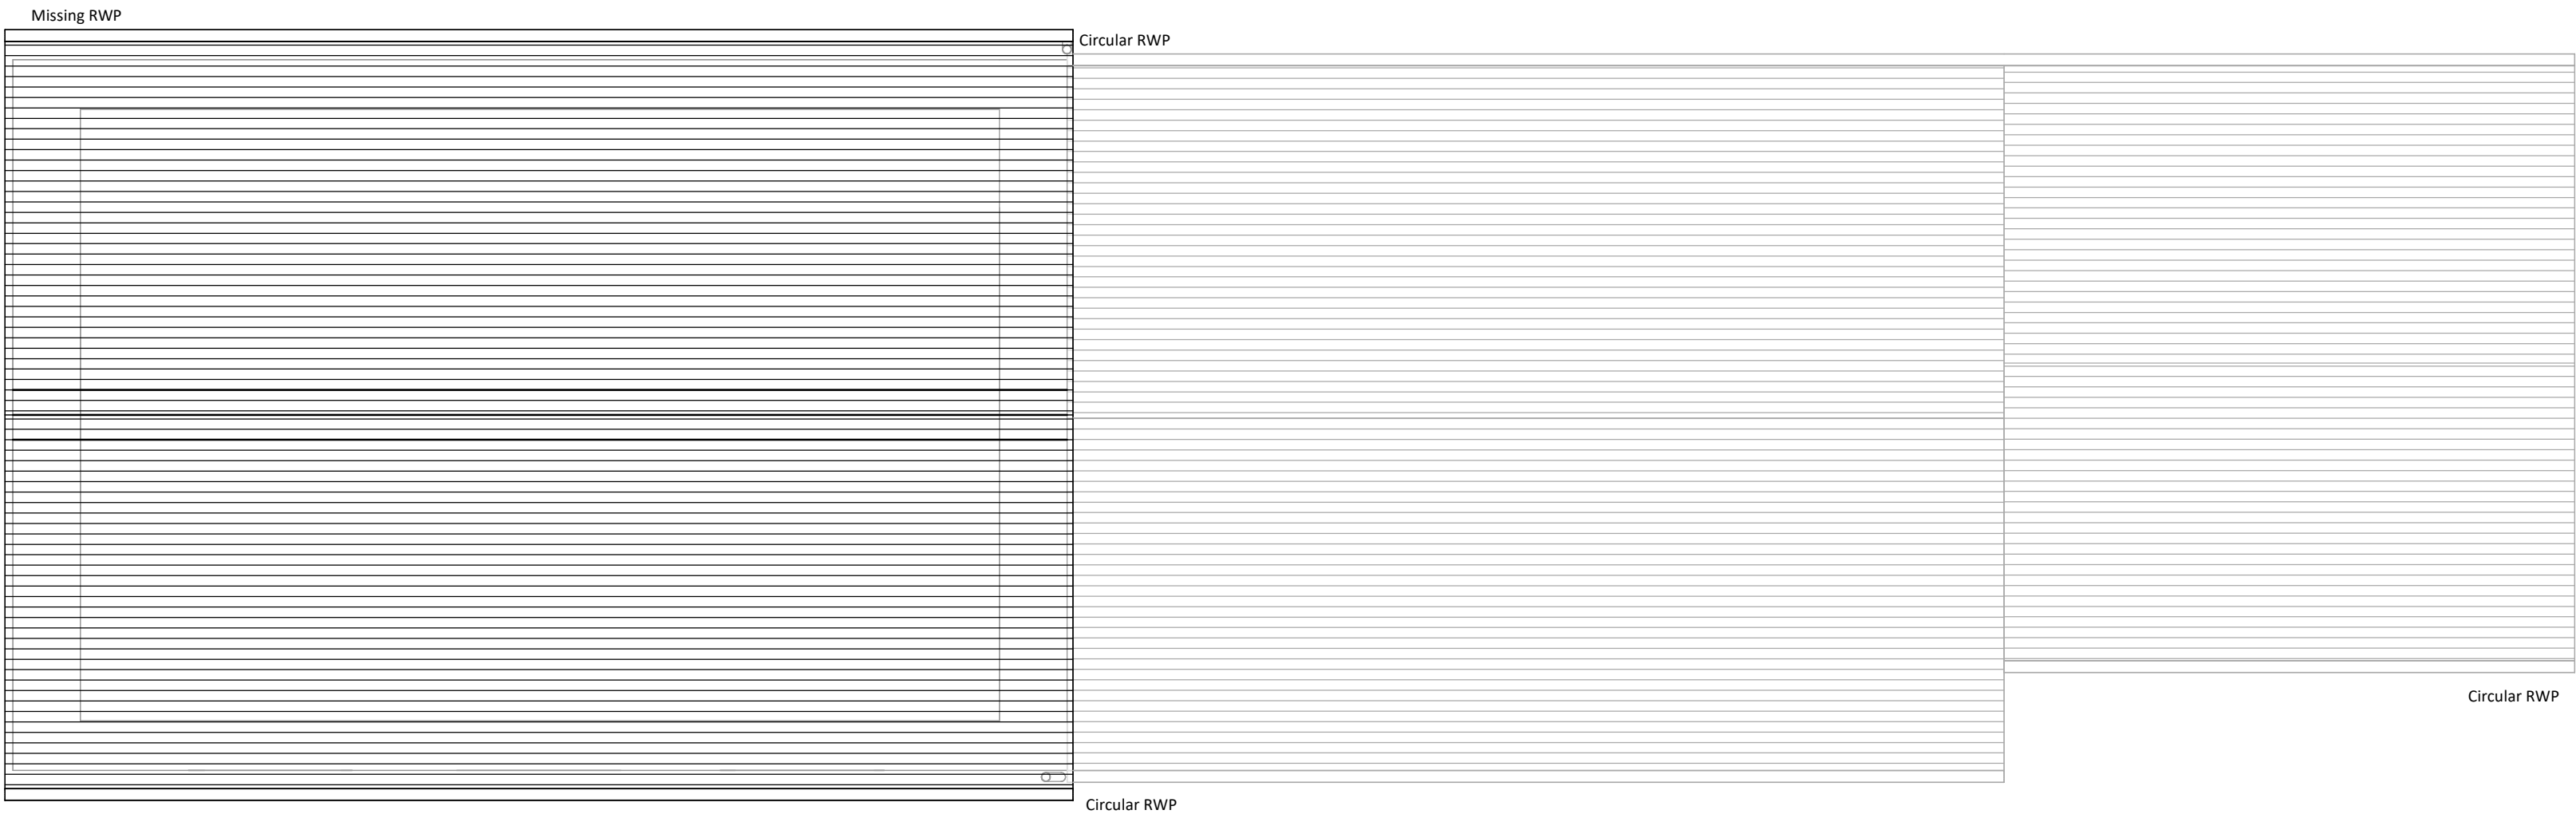
**Materials**  
**For detailed Scope of works refer to Condition Survey**  
**Roof:**  
Existing: Slate roofing with Clay capped angled slate ridge tiles, set over a central King Post truss with Oak Purlins either side supporting rafters.  
Proposed: Roof tiles are to be set aside for reuse, roof to be rebuilt due to partial collapse
