Project: Moneystone Park  
 Job No: 418055  
 Client: Laver Leisure

Project: Moneystone Activity Park SI

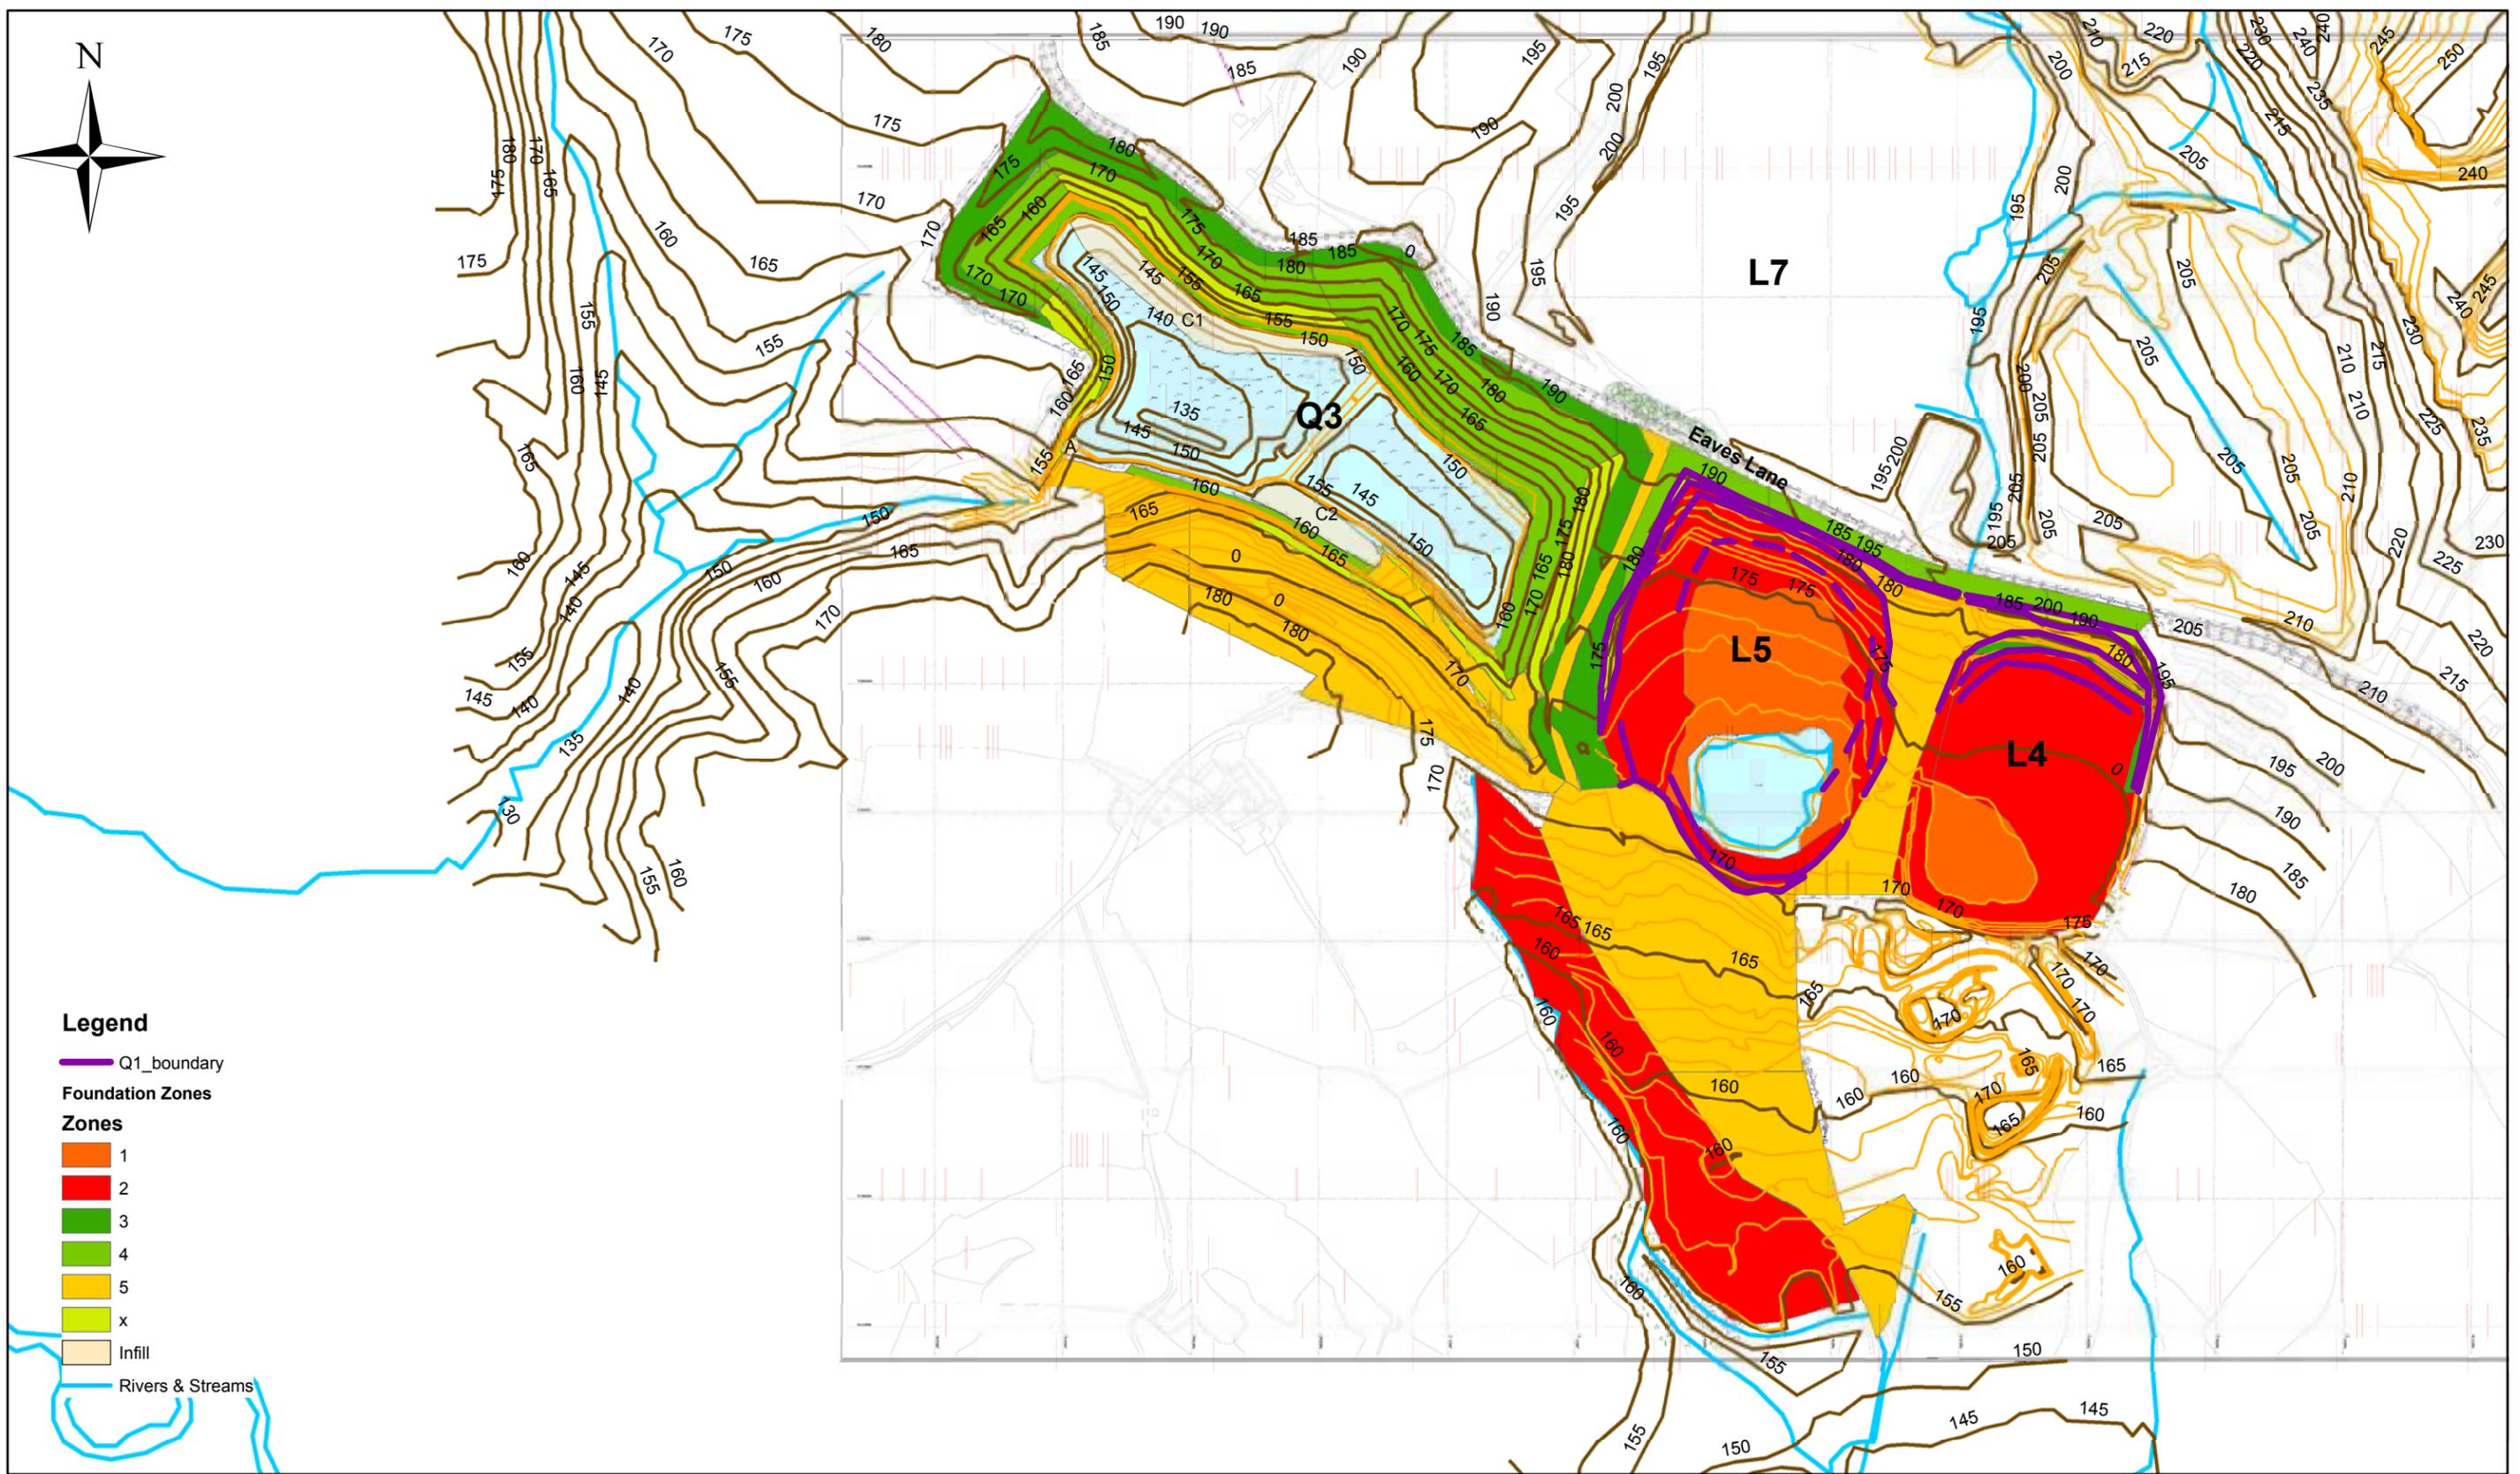
**Fig**

## 2018 FOUNDATION ZONE PLAN

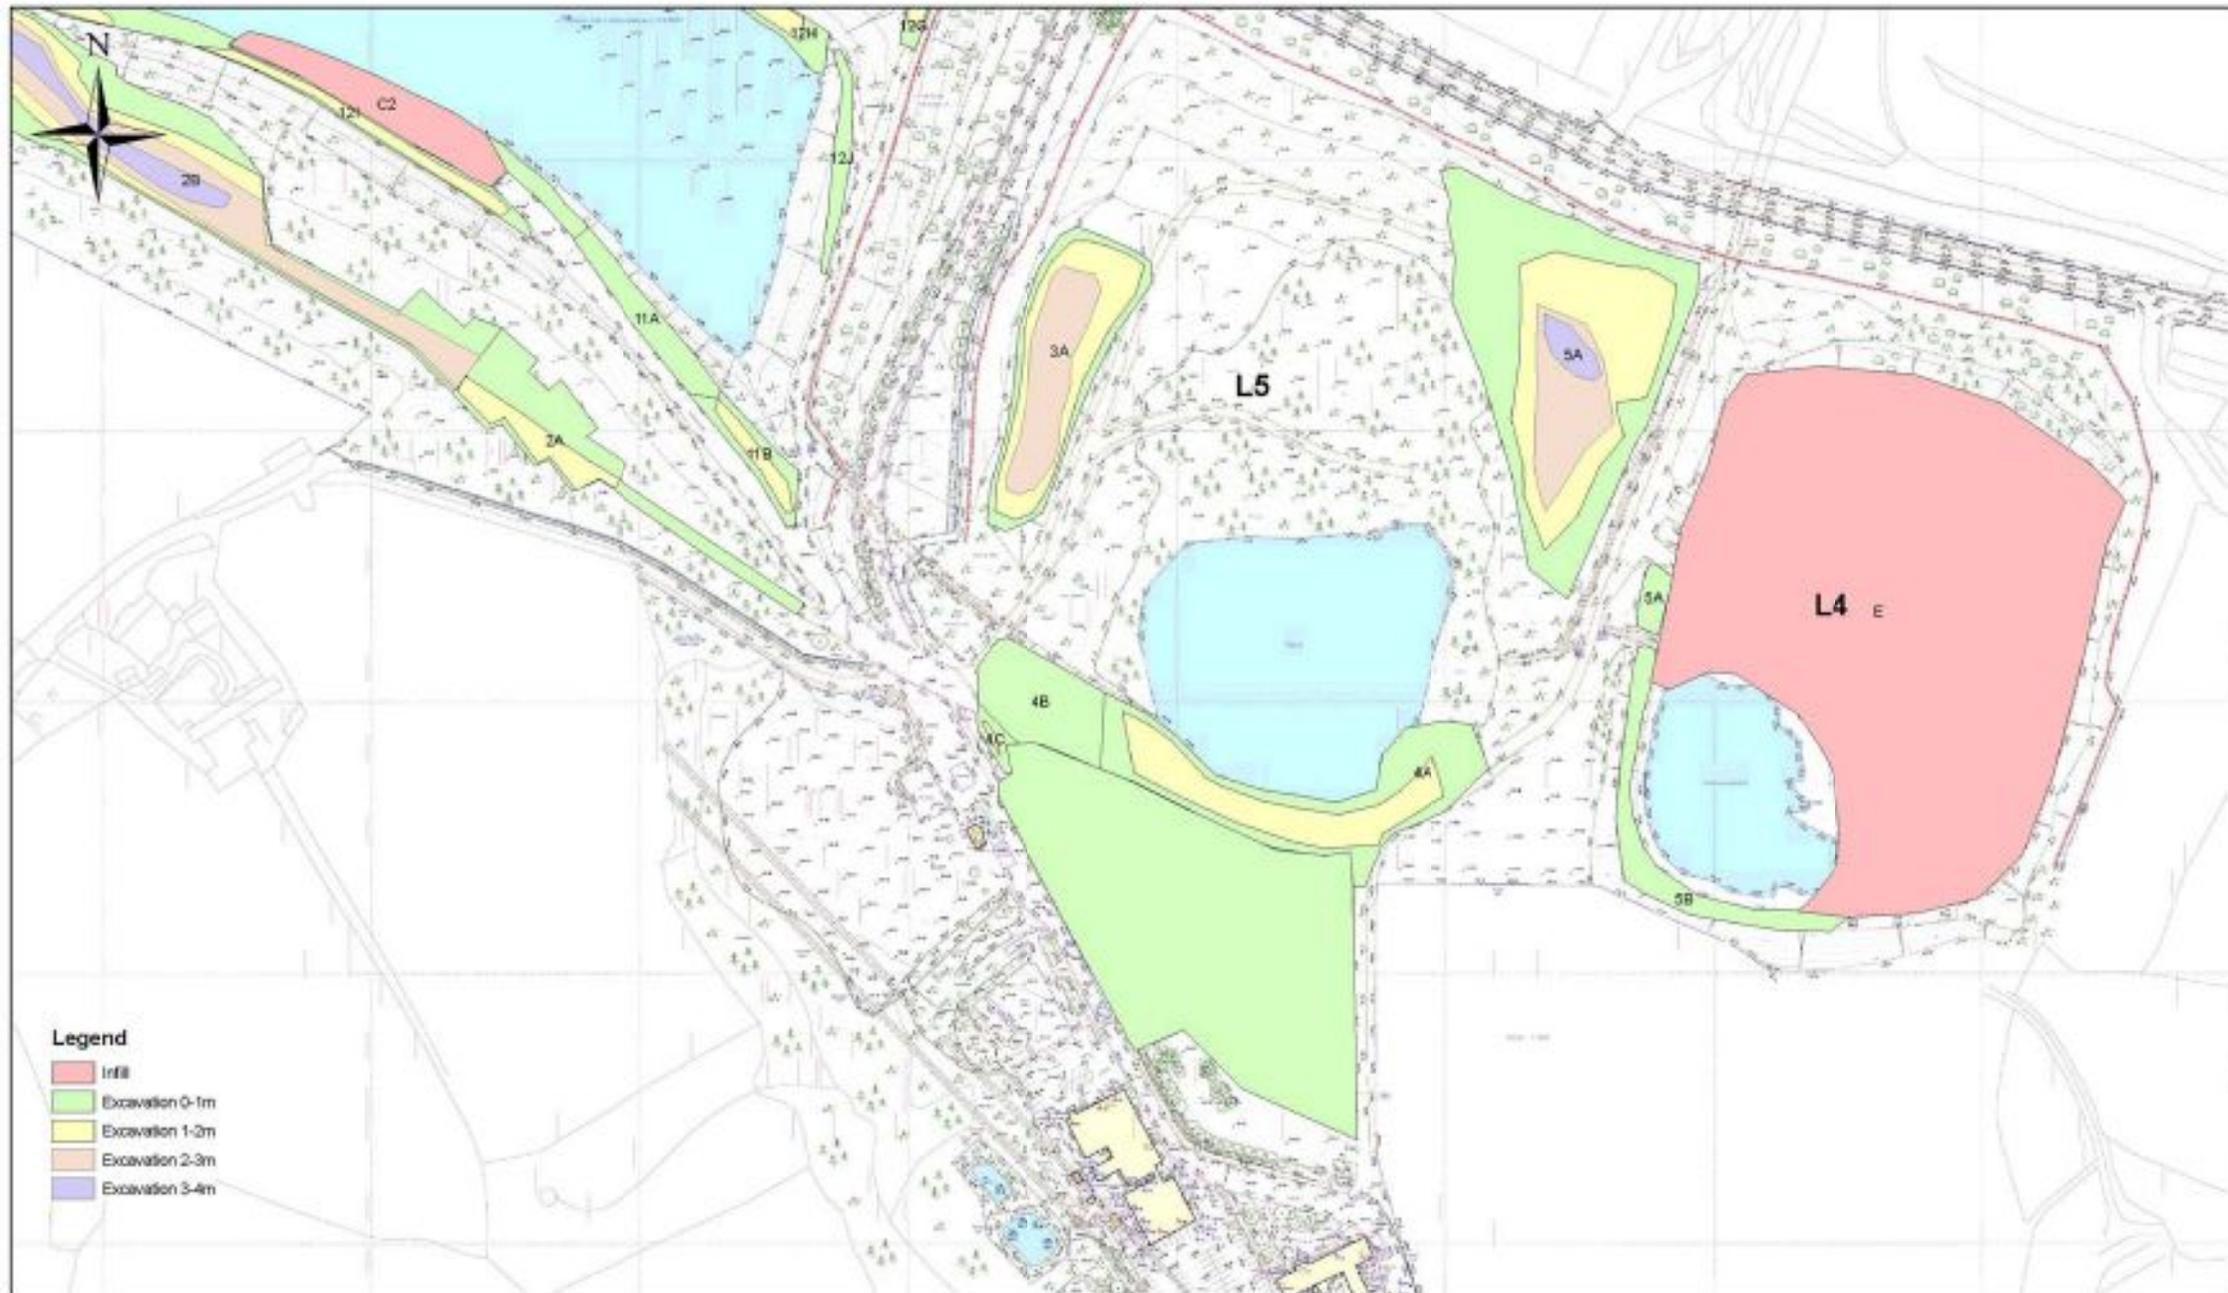
**Fig 2H1**

- Legend**
- Infill
  - Excavation 0-1m
  - Excavation 1-2m
  - Excavation 2-3m
  - Excavation 3-4m

**2018 EARTHWORKS HEATMAP Q1**

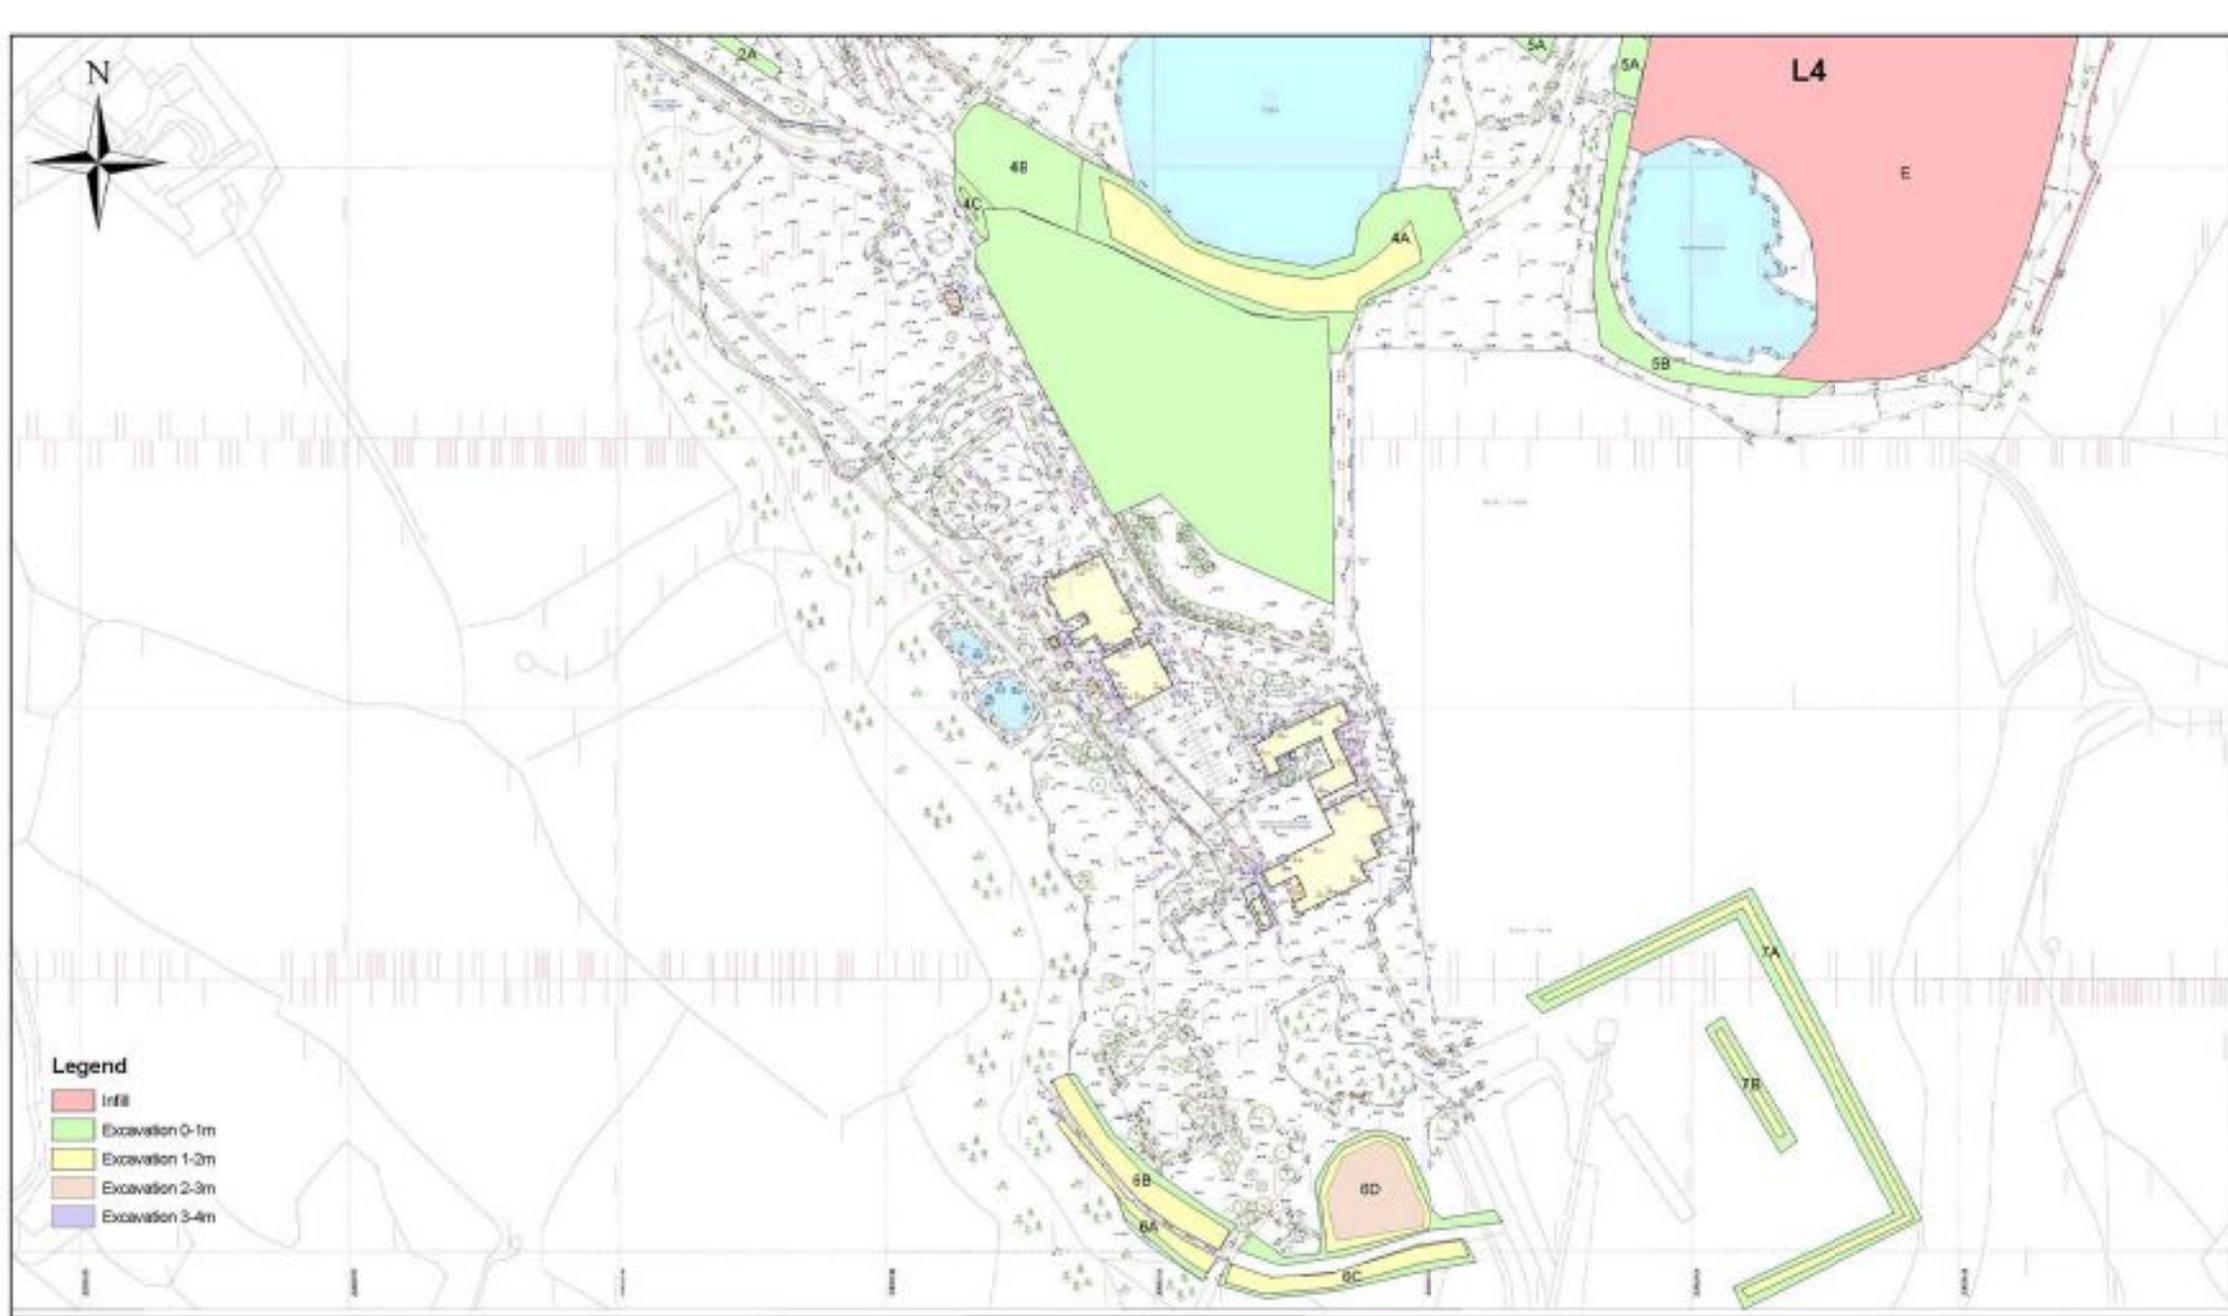
**Fig 2H2**

**2018 EARTHWORKS HEATMAP Q1**

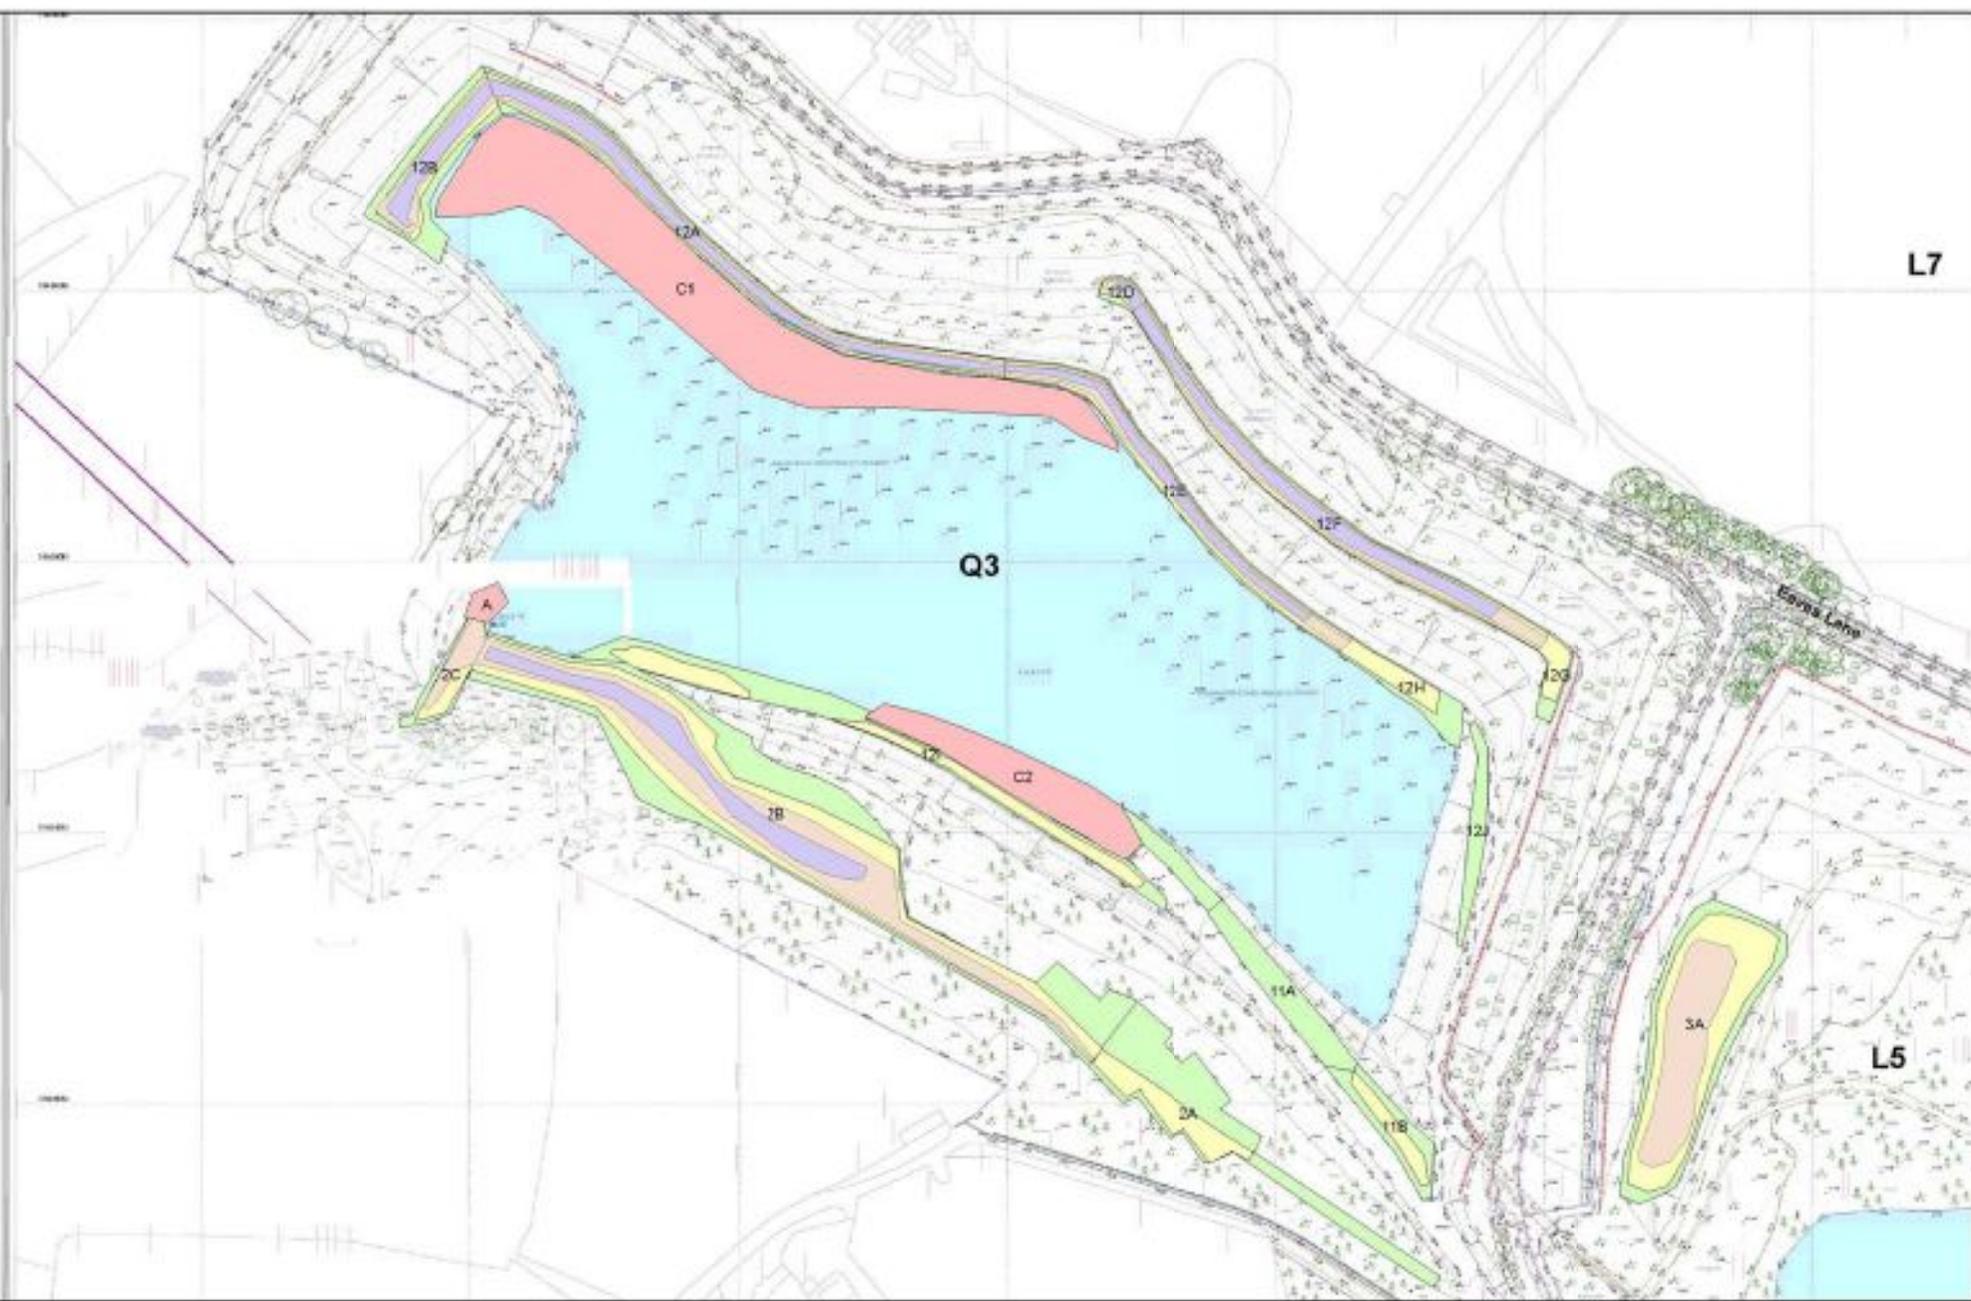
**Fig 2H3**

**2018 EARTHWORKS HEATMAP Q3**

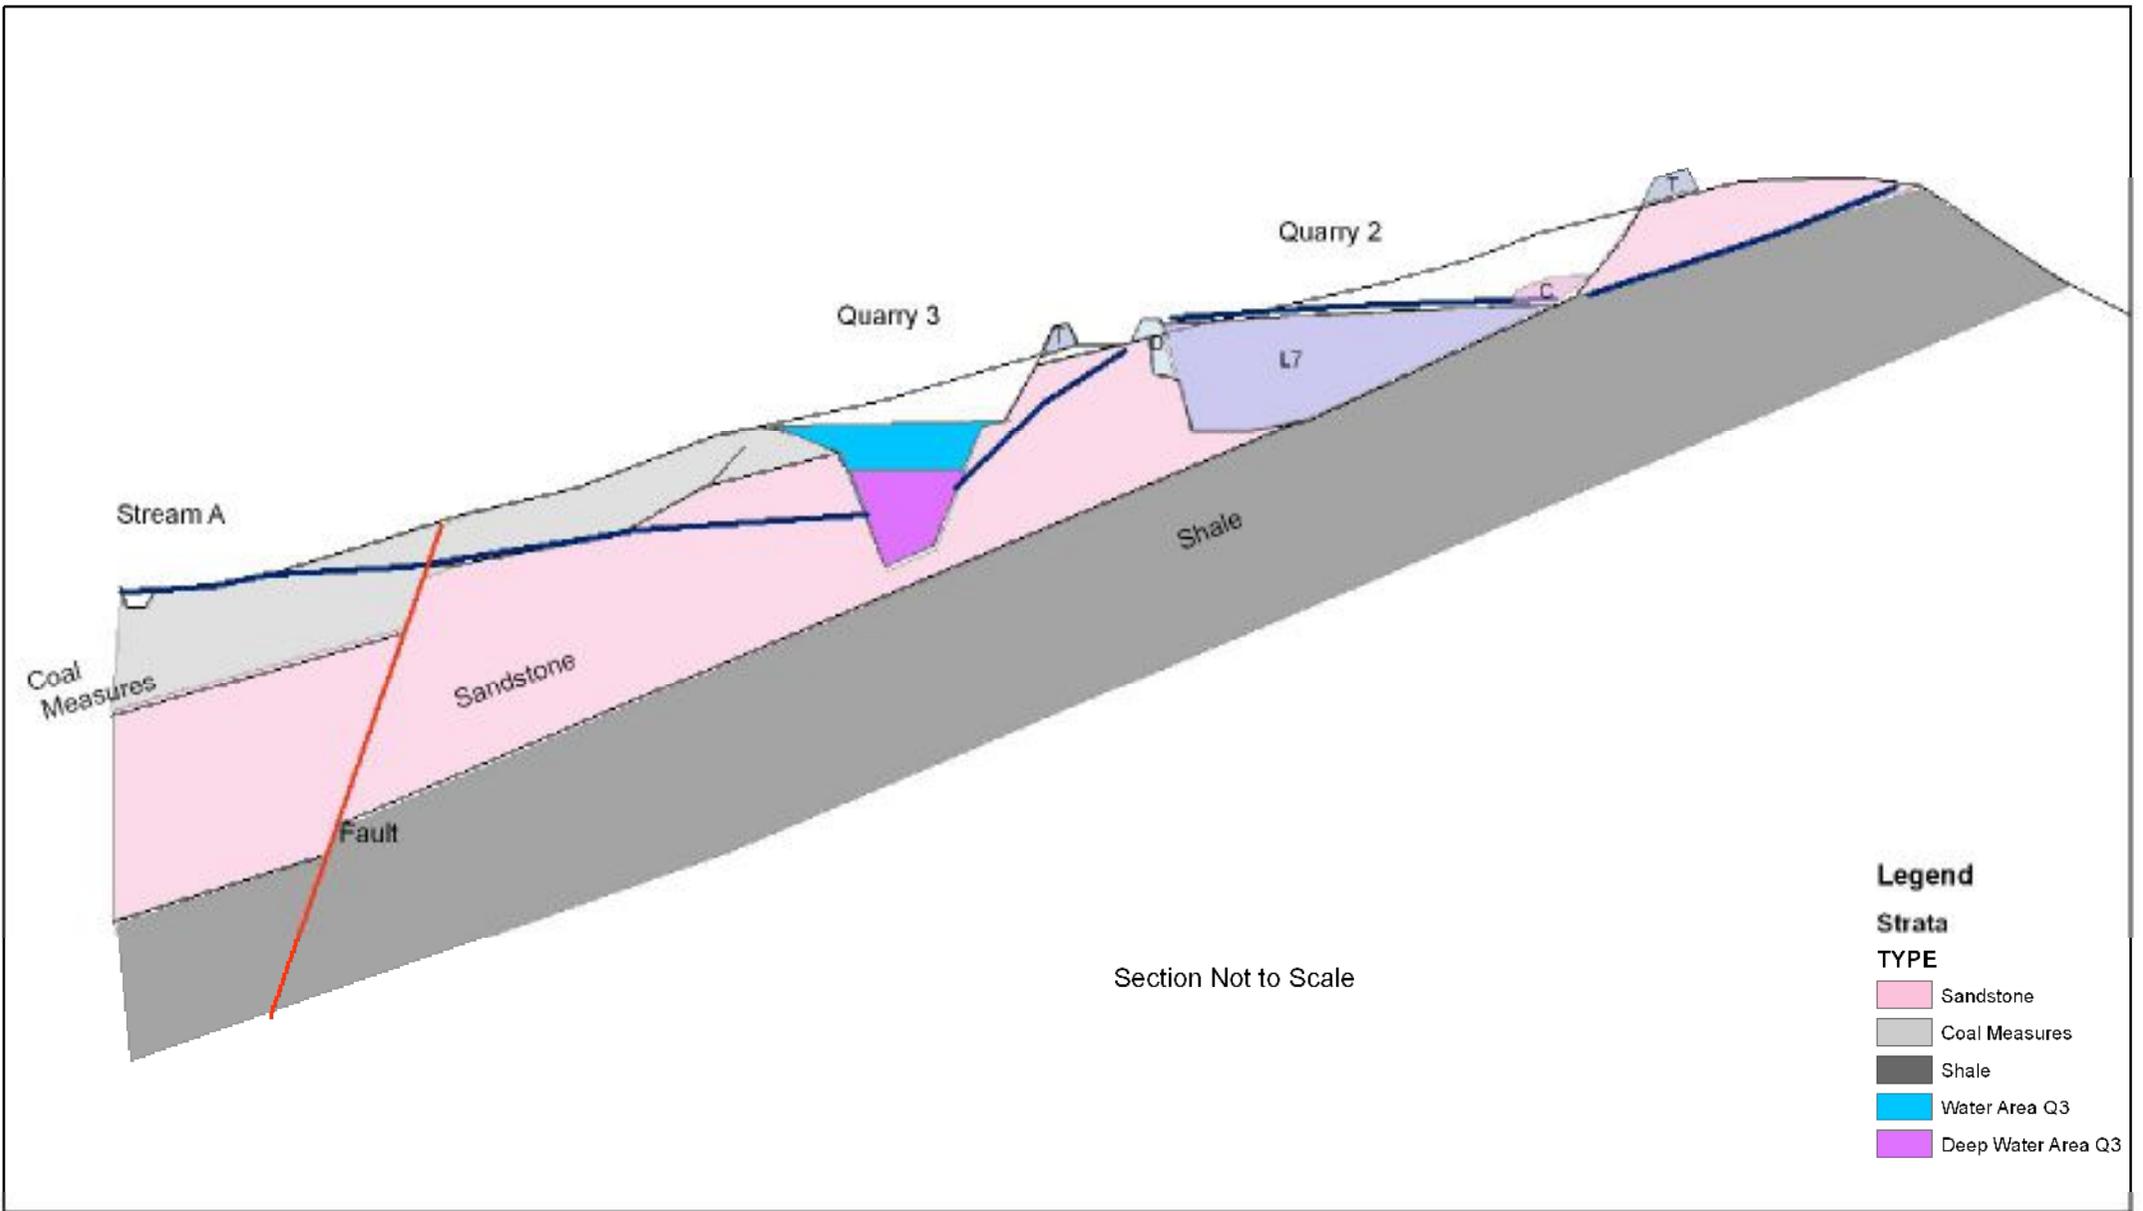
Fig 3

## Typical Section

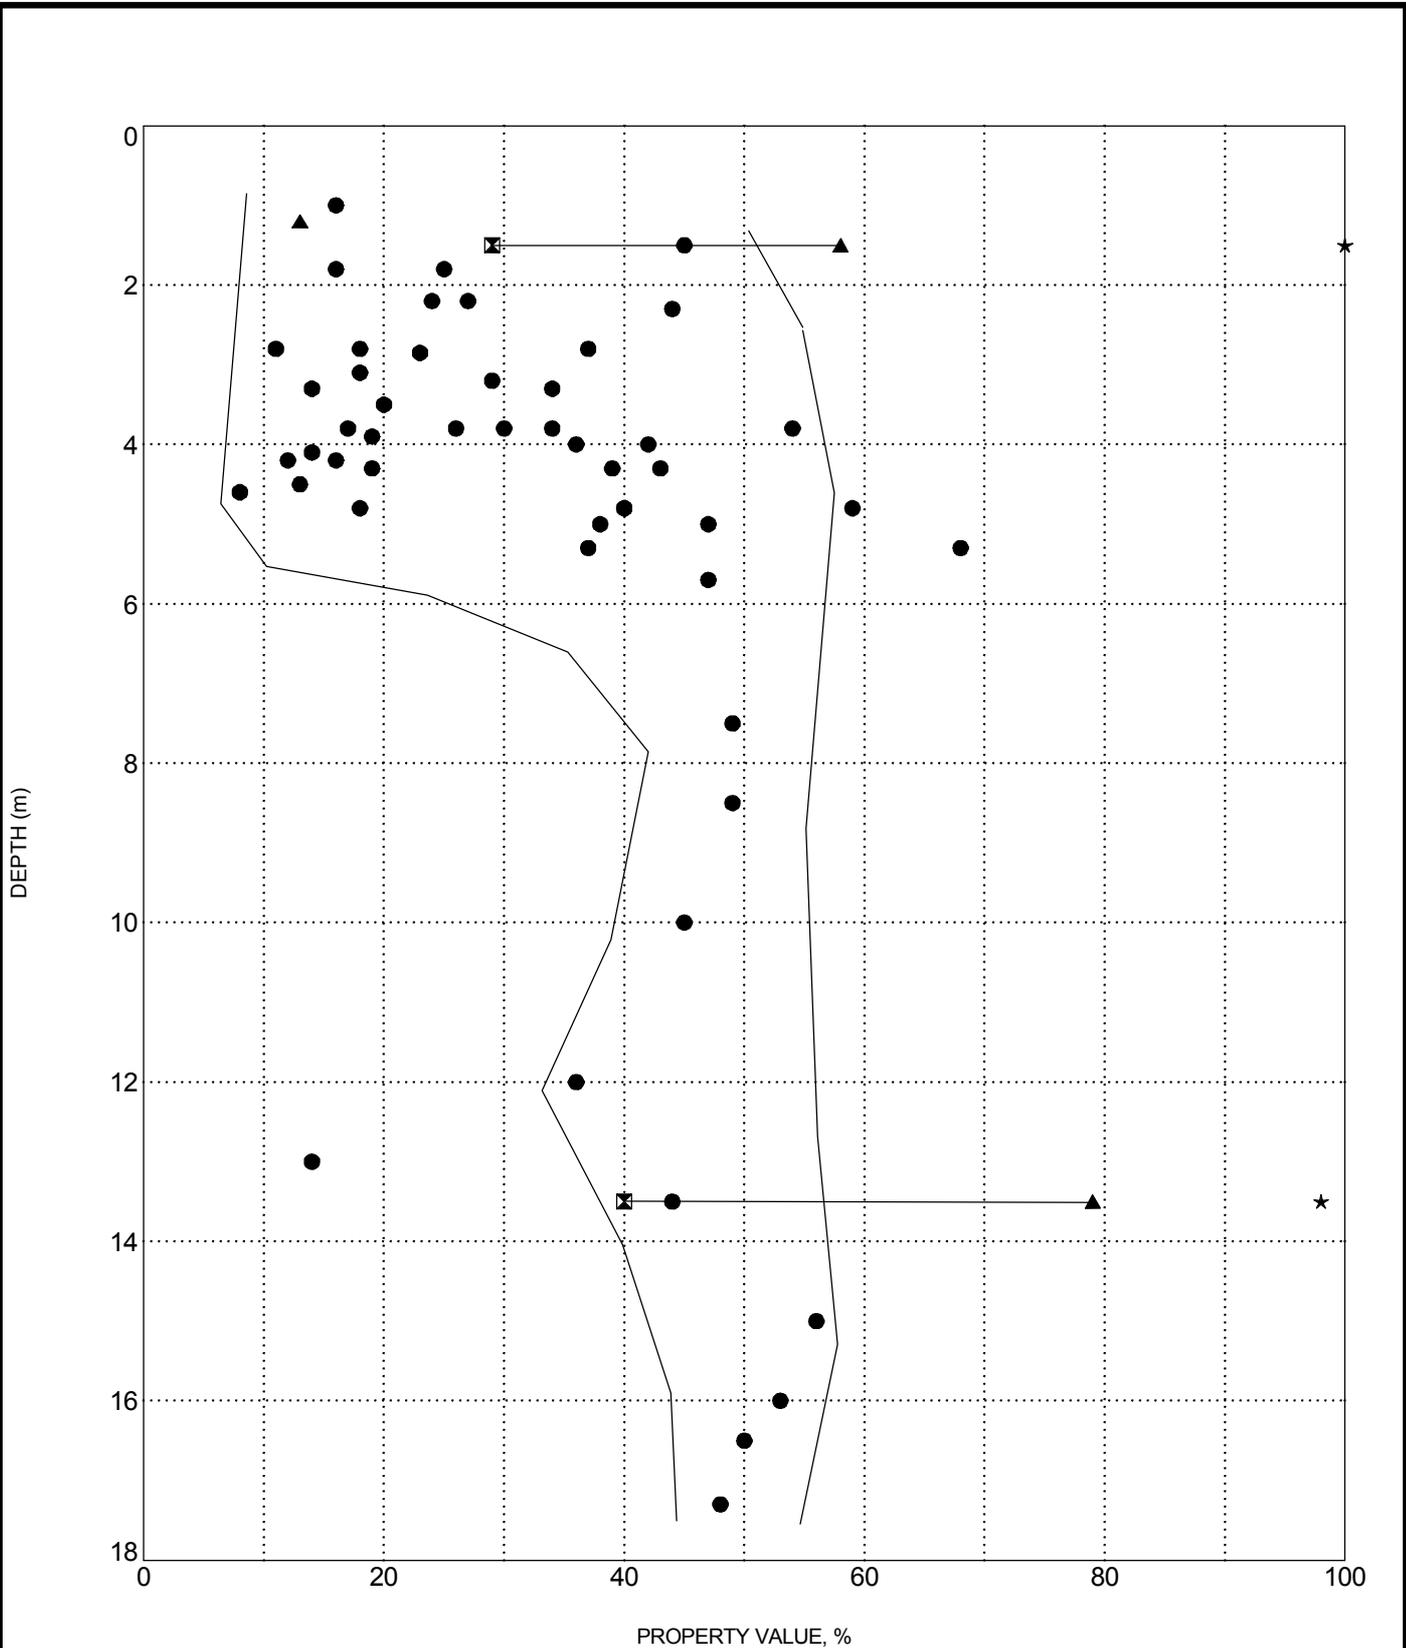
**FIG 4B**

LEGEND	
●	Water Content
⊠	Plastic Limit
▲	Liquid Limit
★	Fines

### T5 INDEX PROPERTIES VERSUS DEPTH

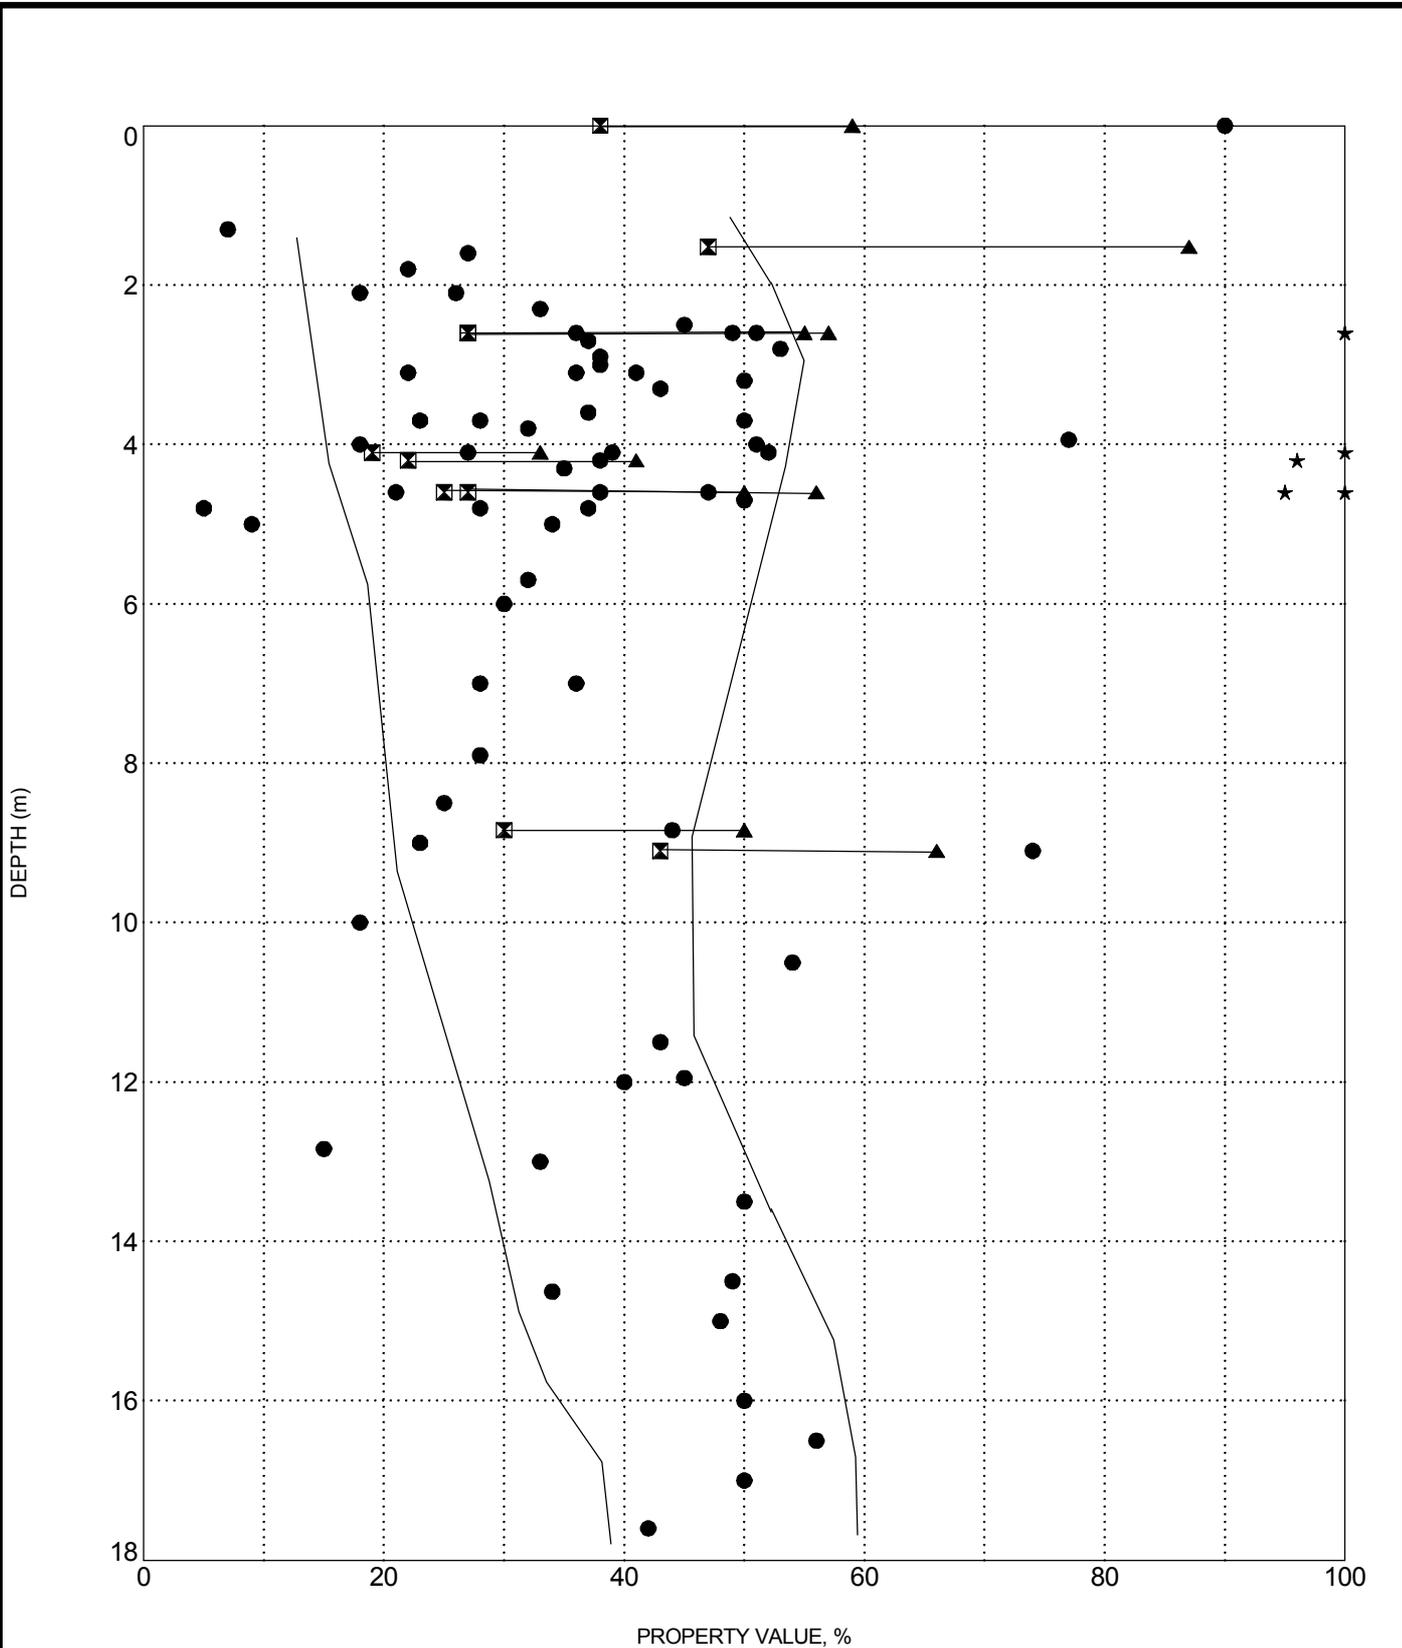
**FIG 4E**

LEGEND	
●	Water Content
⊠	Plastic Limit
▲	Liquid Limit
★	Fines

### T4 INDEX PROPERTIES VERSUS DEPTH

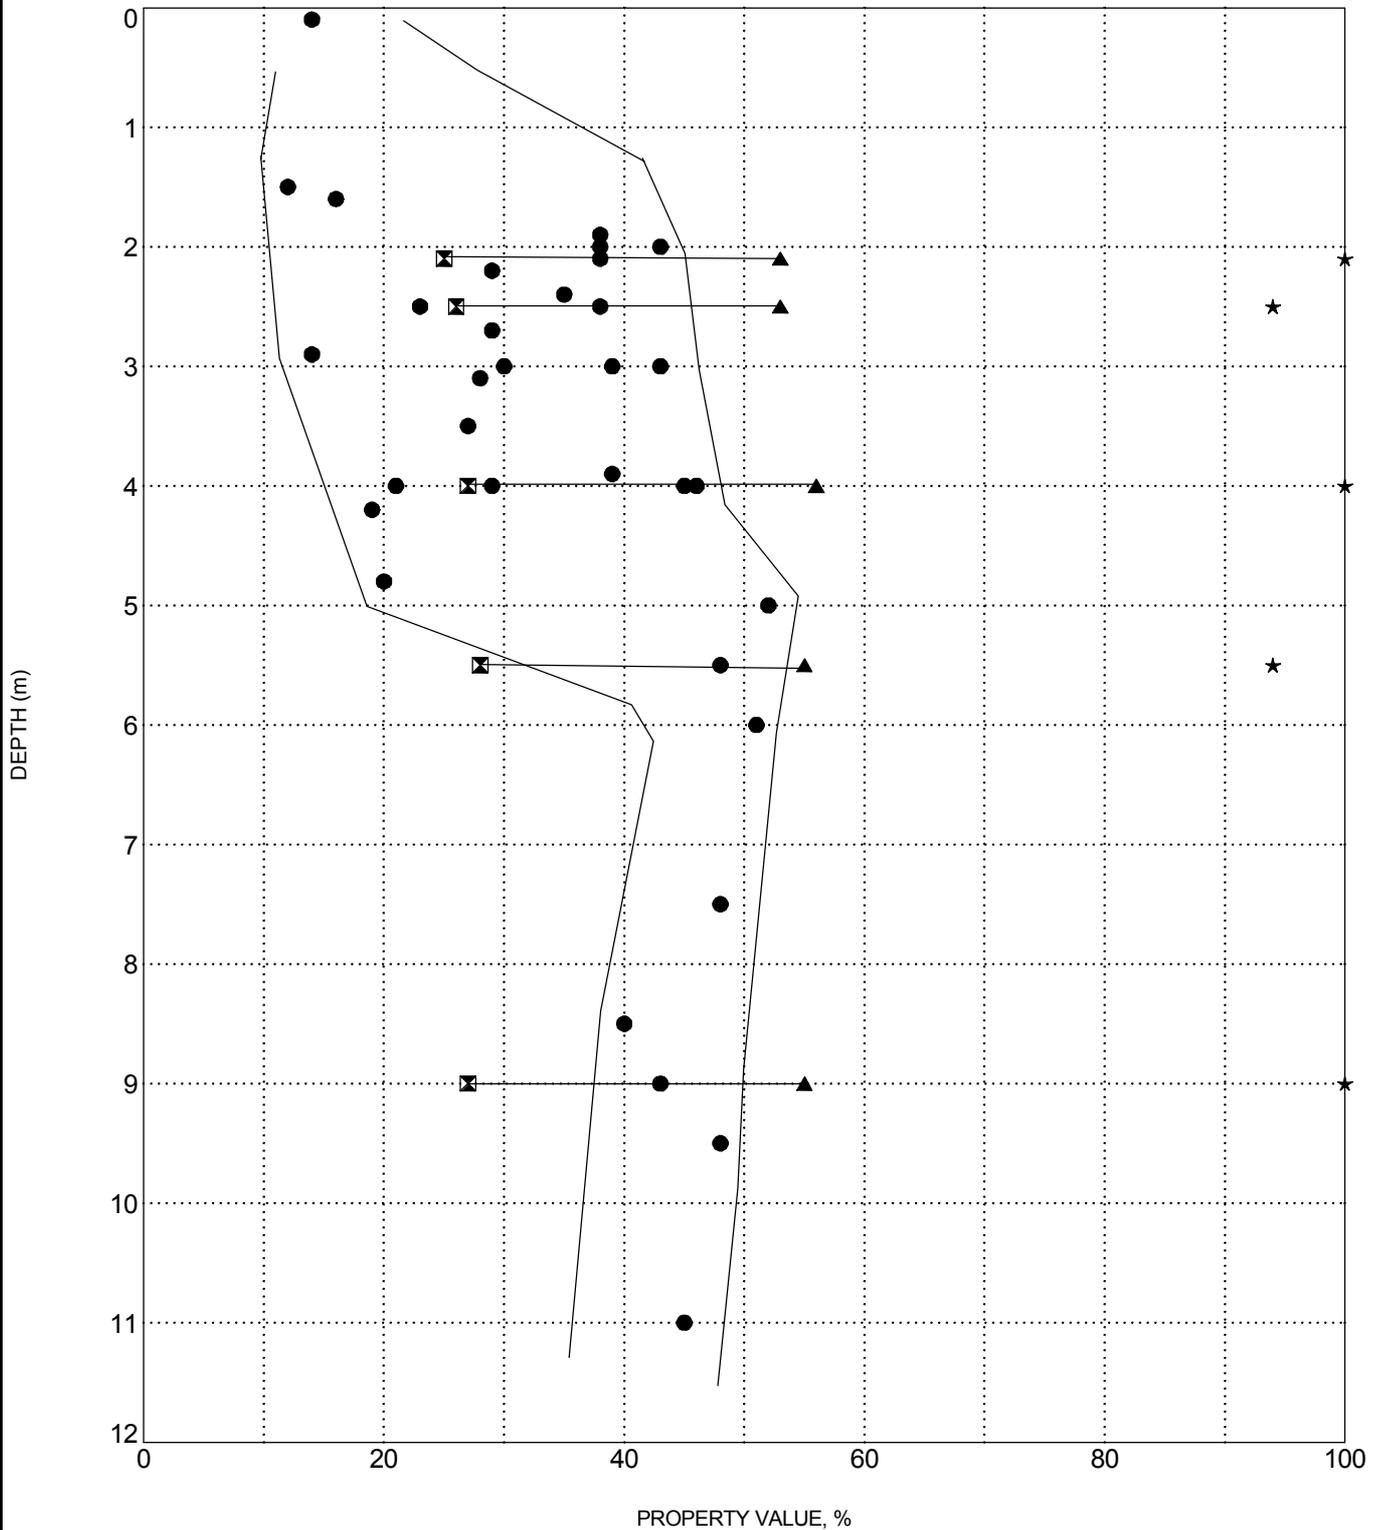
**FIG 4L**

LEGEND	
●	Water Content
⊠	Plastic Limit
▲	Liquid Limit
★	Fines

**T3 INDEX PROPERTIES VERSUS DEPTH**
