Project: Moneystone Park  
 Job No: 418055  
 Client: Laver Leisure

Project: Moneystone Activity Park SI

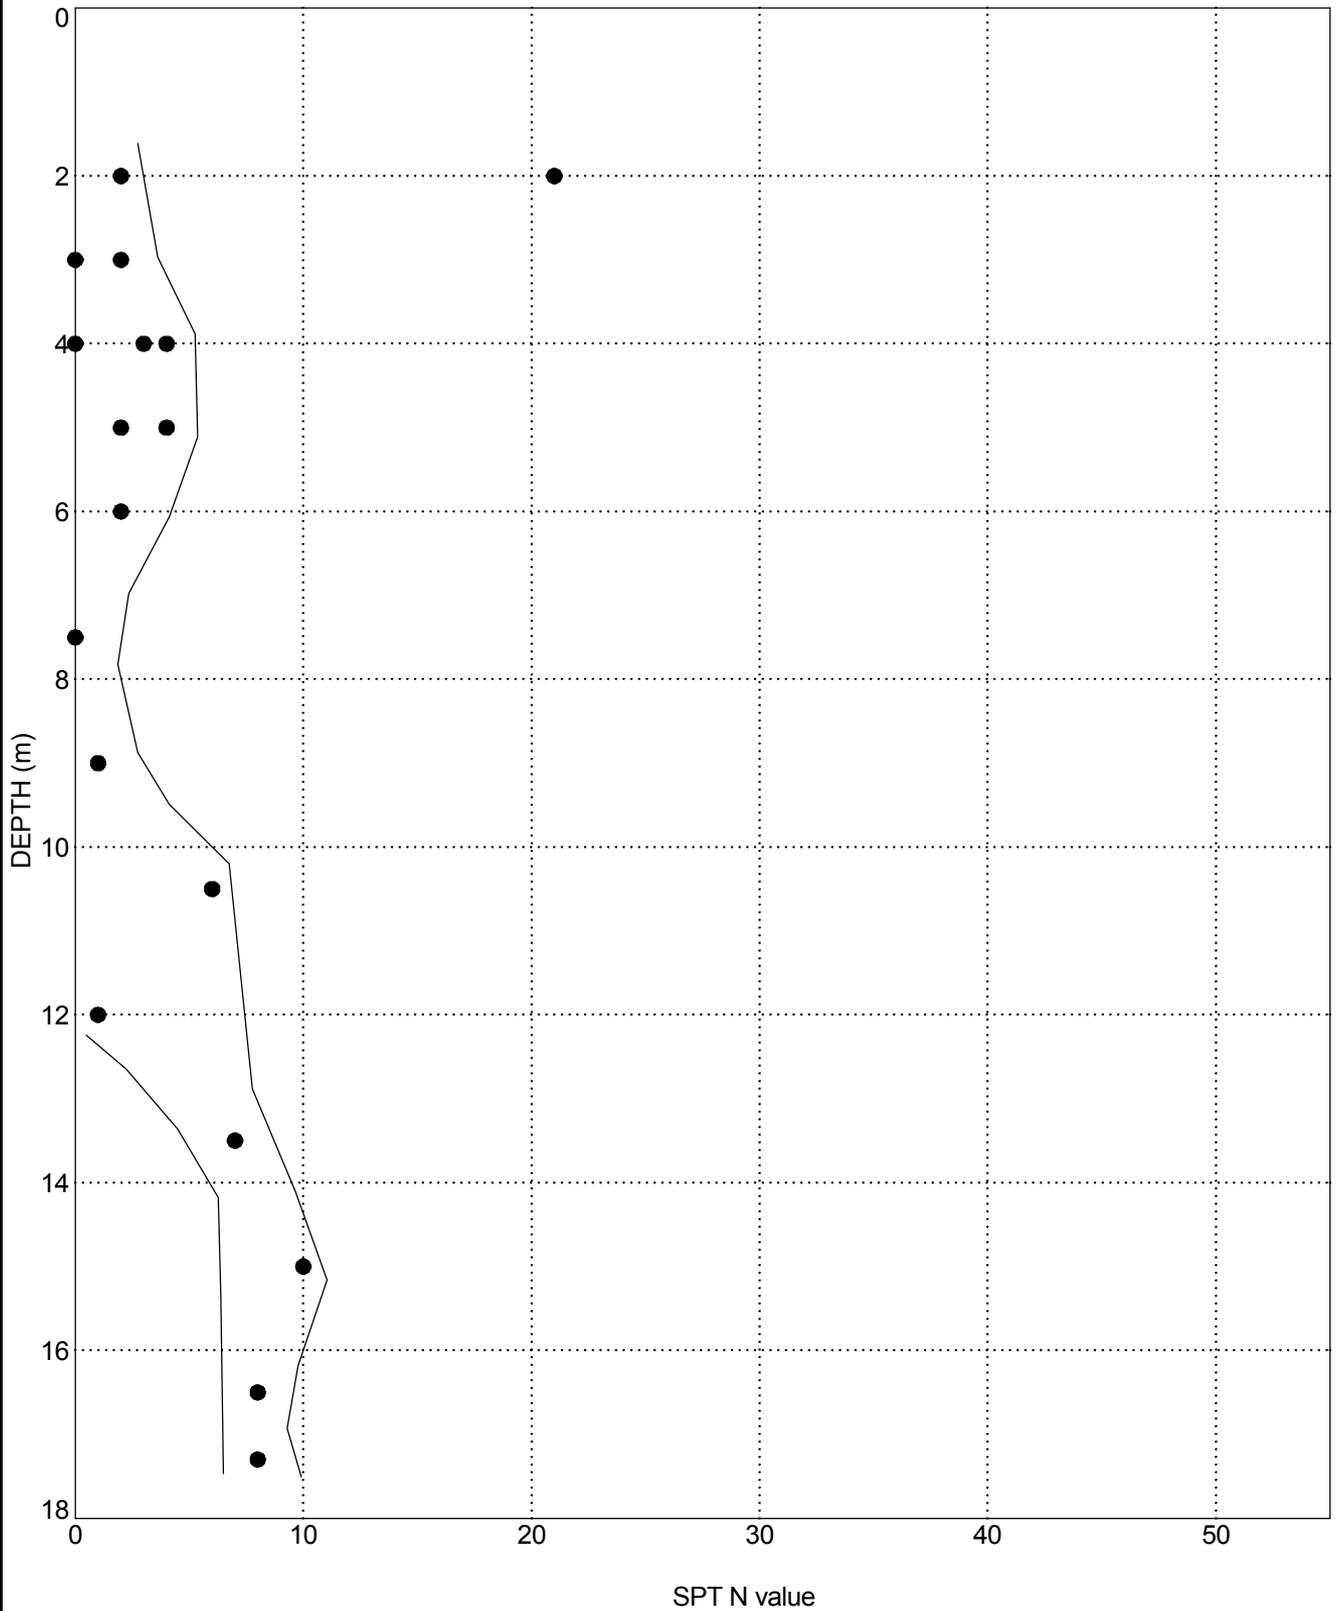
**FIG 5B b**

**AREA B T5 SPT RESULTS**

**SPT VERSUS DEPTH**

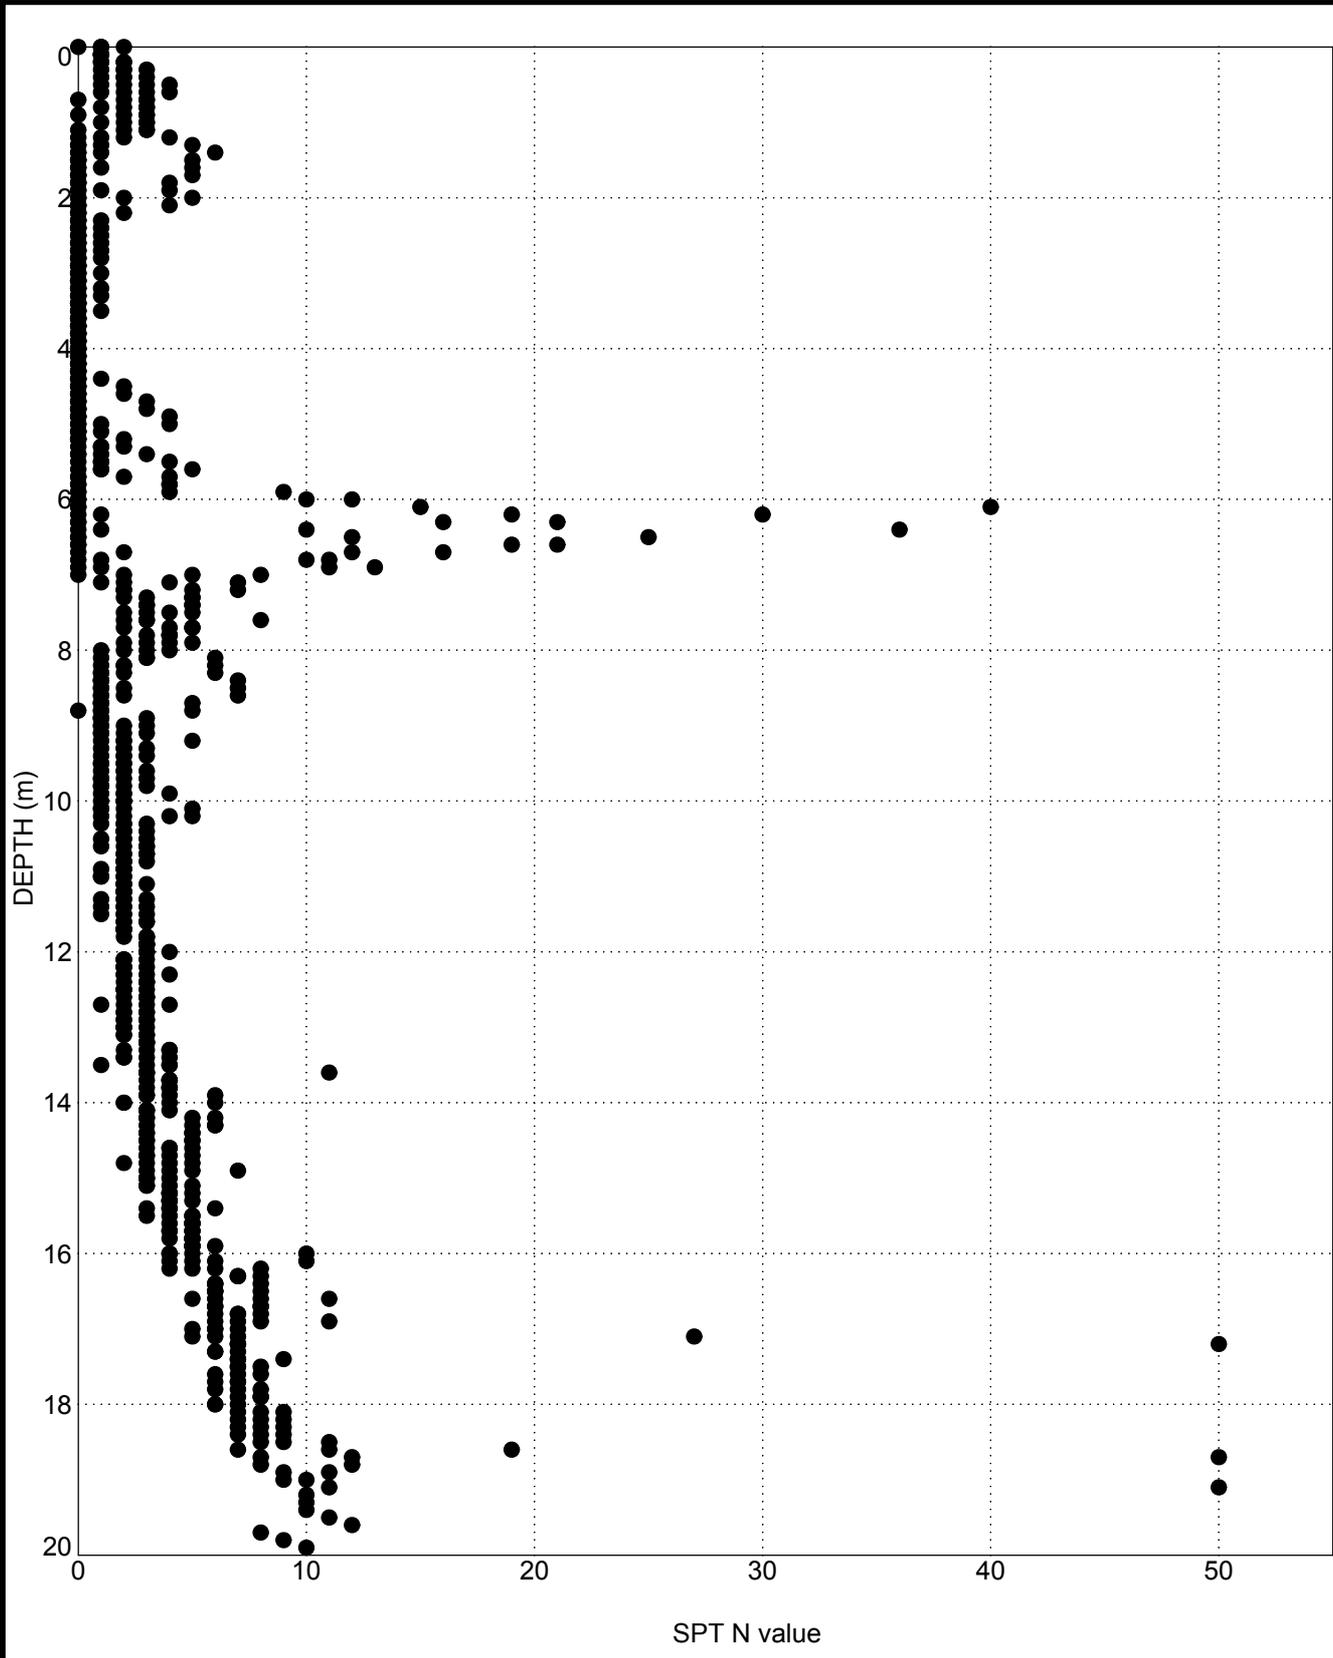
Fig 6E

### AREA E T4 RESULTS

#### N100 Dynamic Probe VS DEPTH

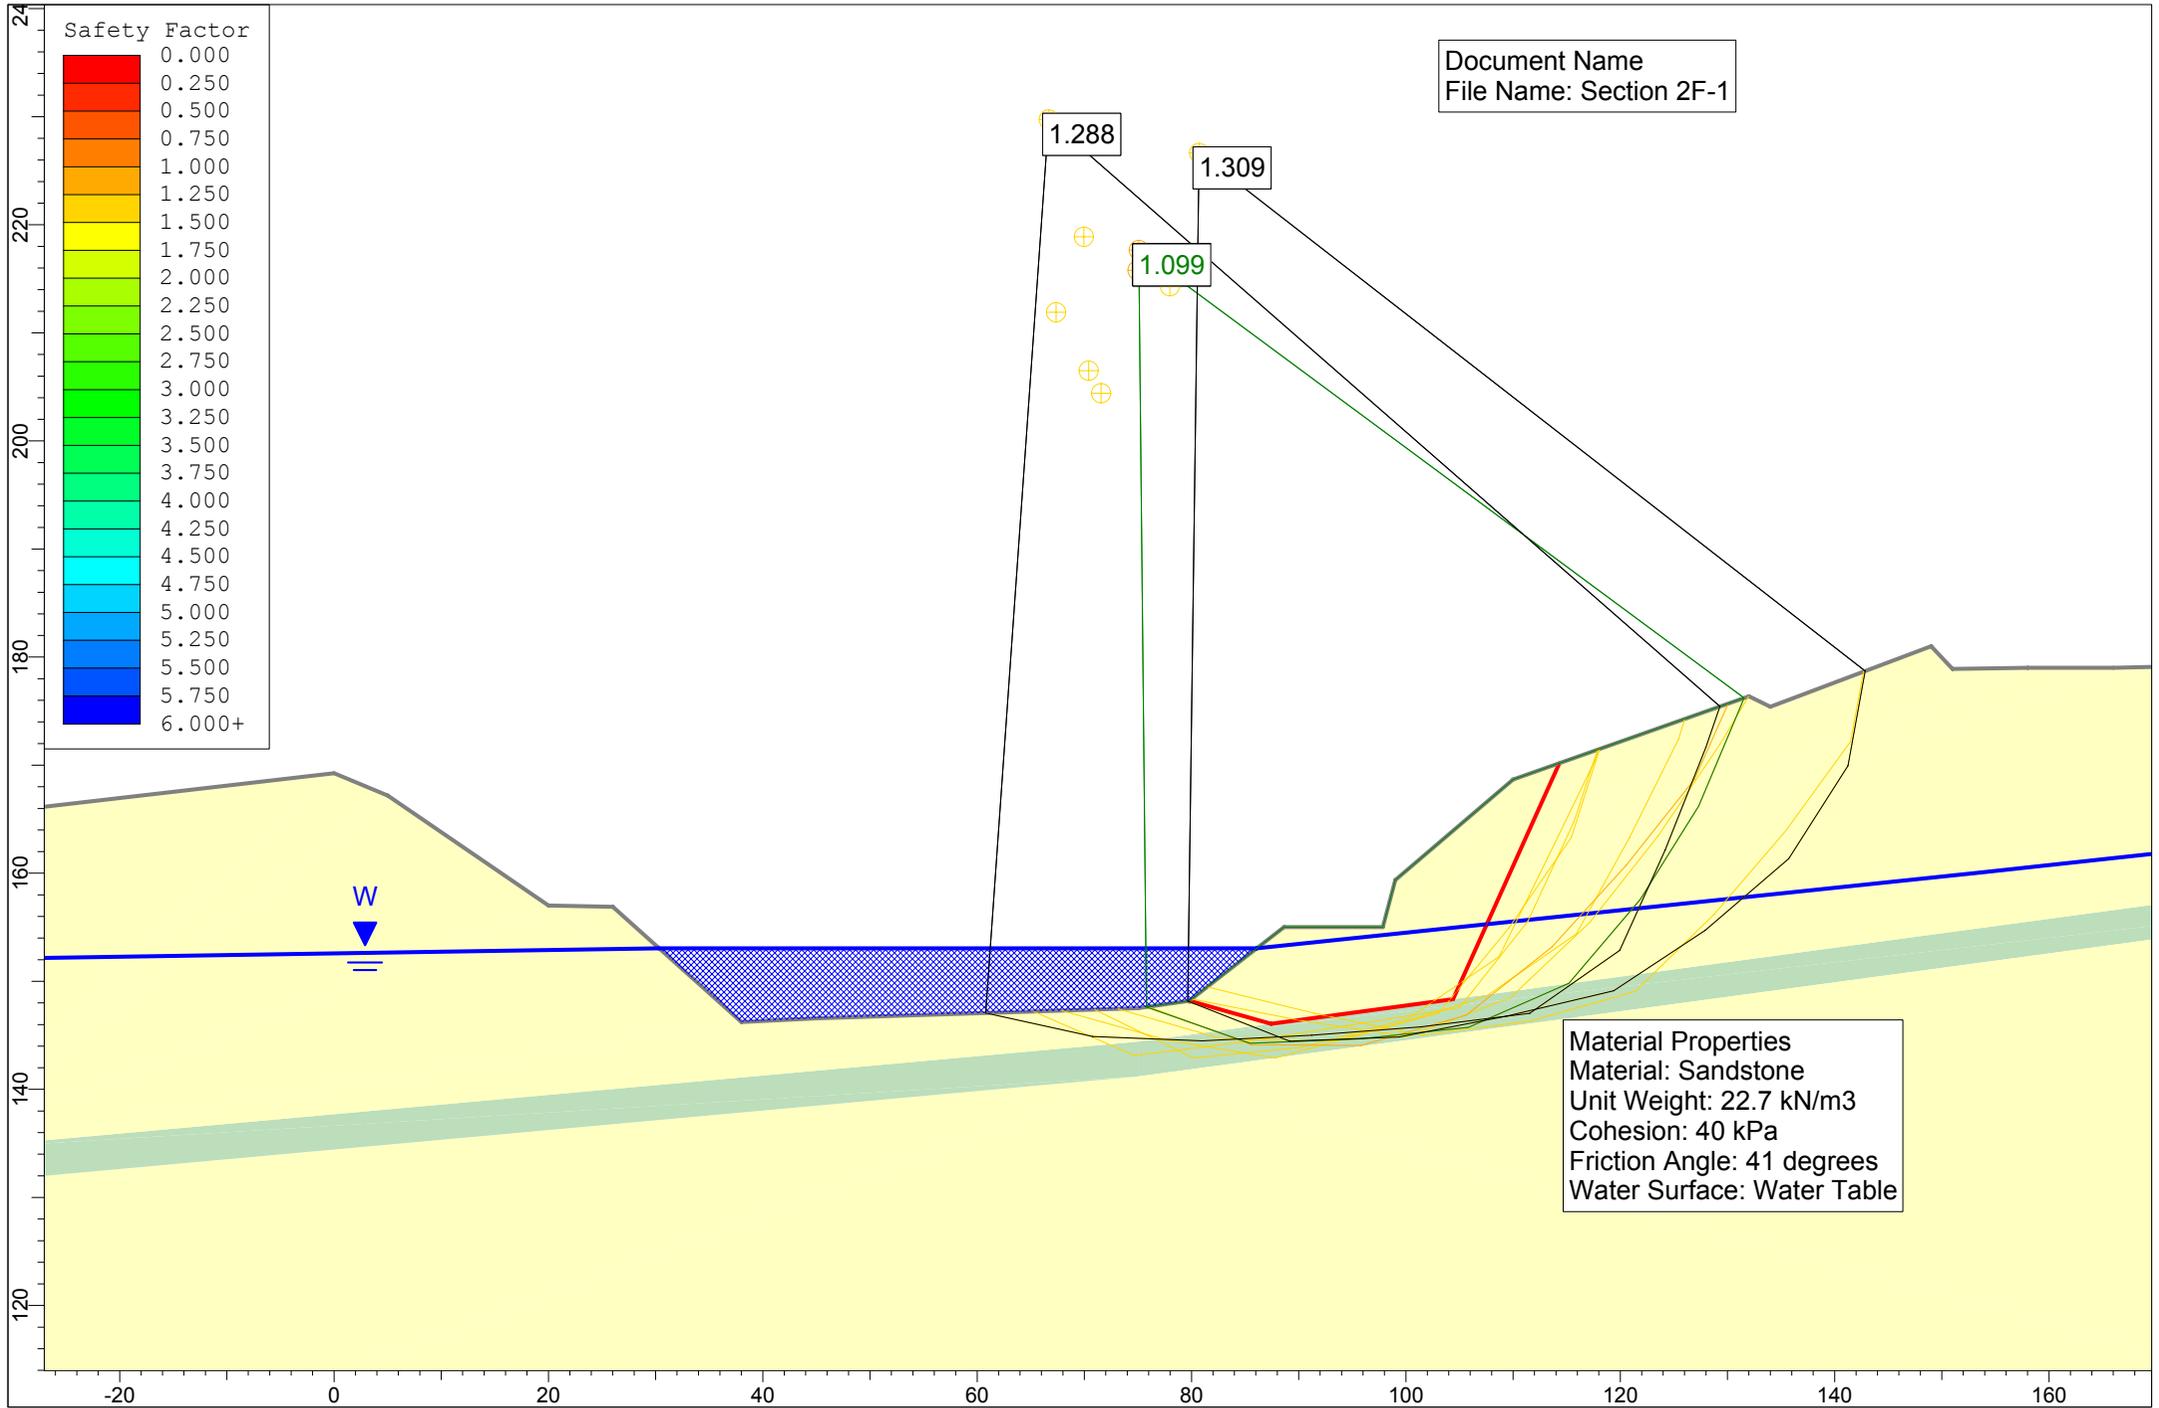
Document Name  
File Name: Section 2F-1

Material Properties  
Material: Sandstone  
Unit Weight: 22.7 kN/m<sup>3</sup>  
Cohesion: 40 kPa  
Friction Angle: 41 degrees  
Water Surface: Water Table

Analysis 2D was undertaken to evaluate the sensitivity to sandstone weakening. The analysis found that provided fracture planes had a cohesive shear strength in excess of 10kPa the overall slope remains stable. In the remaining analysis a cohesion of 40kPa was used.

Analysis was also undertaken to evaluate the influence of the various changes in lake level being proposed. The analysis shows how by lowering lake level the stability of the slope reduces, however the 2F-1 analysis confirmed that even without the north face being covered stability is retained. However, as proposed by installing the gravel slope below 155m AOD stability can be increased above 1.3.

Soil Units	Colour	Unit weight kN/m <sup>3</sup>	Cohesion kN/m <sup>2</sup>	Phi degrees
Sandy Gravel	orange	18	1	40
Tailings	brown	14	1	28
Sandstone	yellow	22.7	40 <sup>(1)</sup>	41
Shale	green	22	1	12.5
Note: (1) Cohesion reduced to 10kPa in analysis 2D

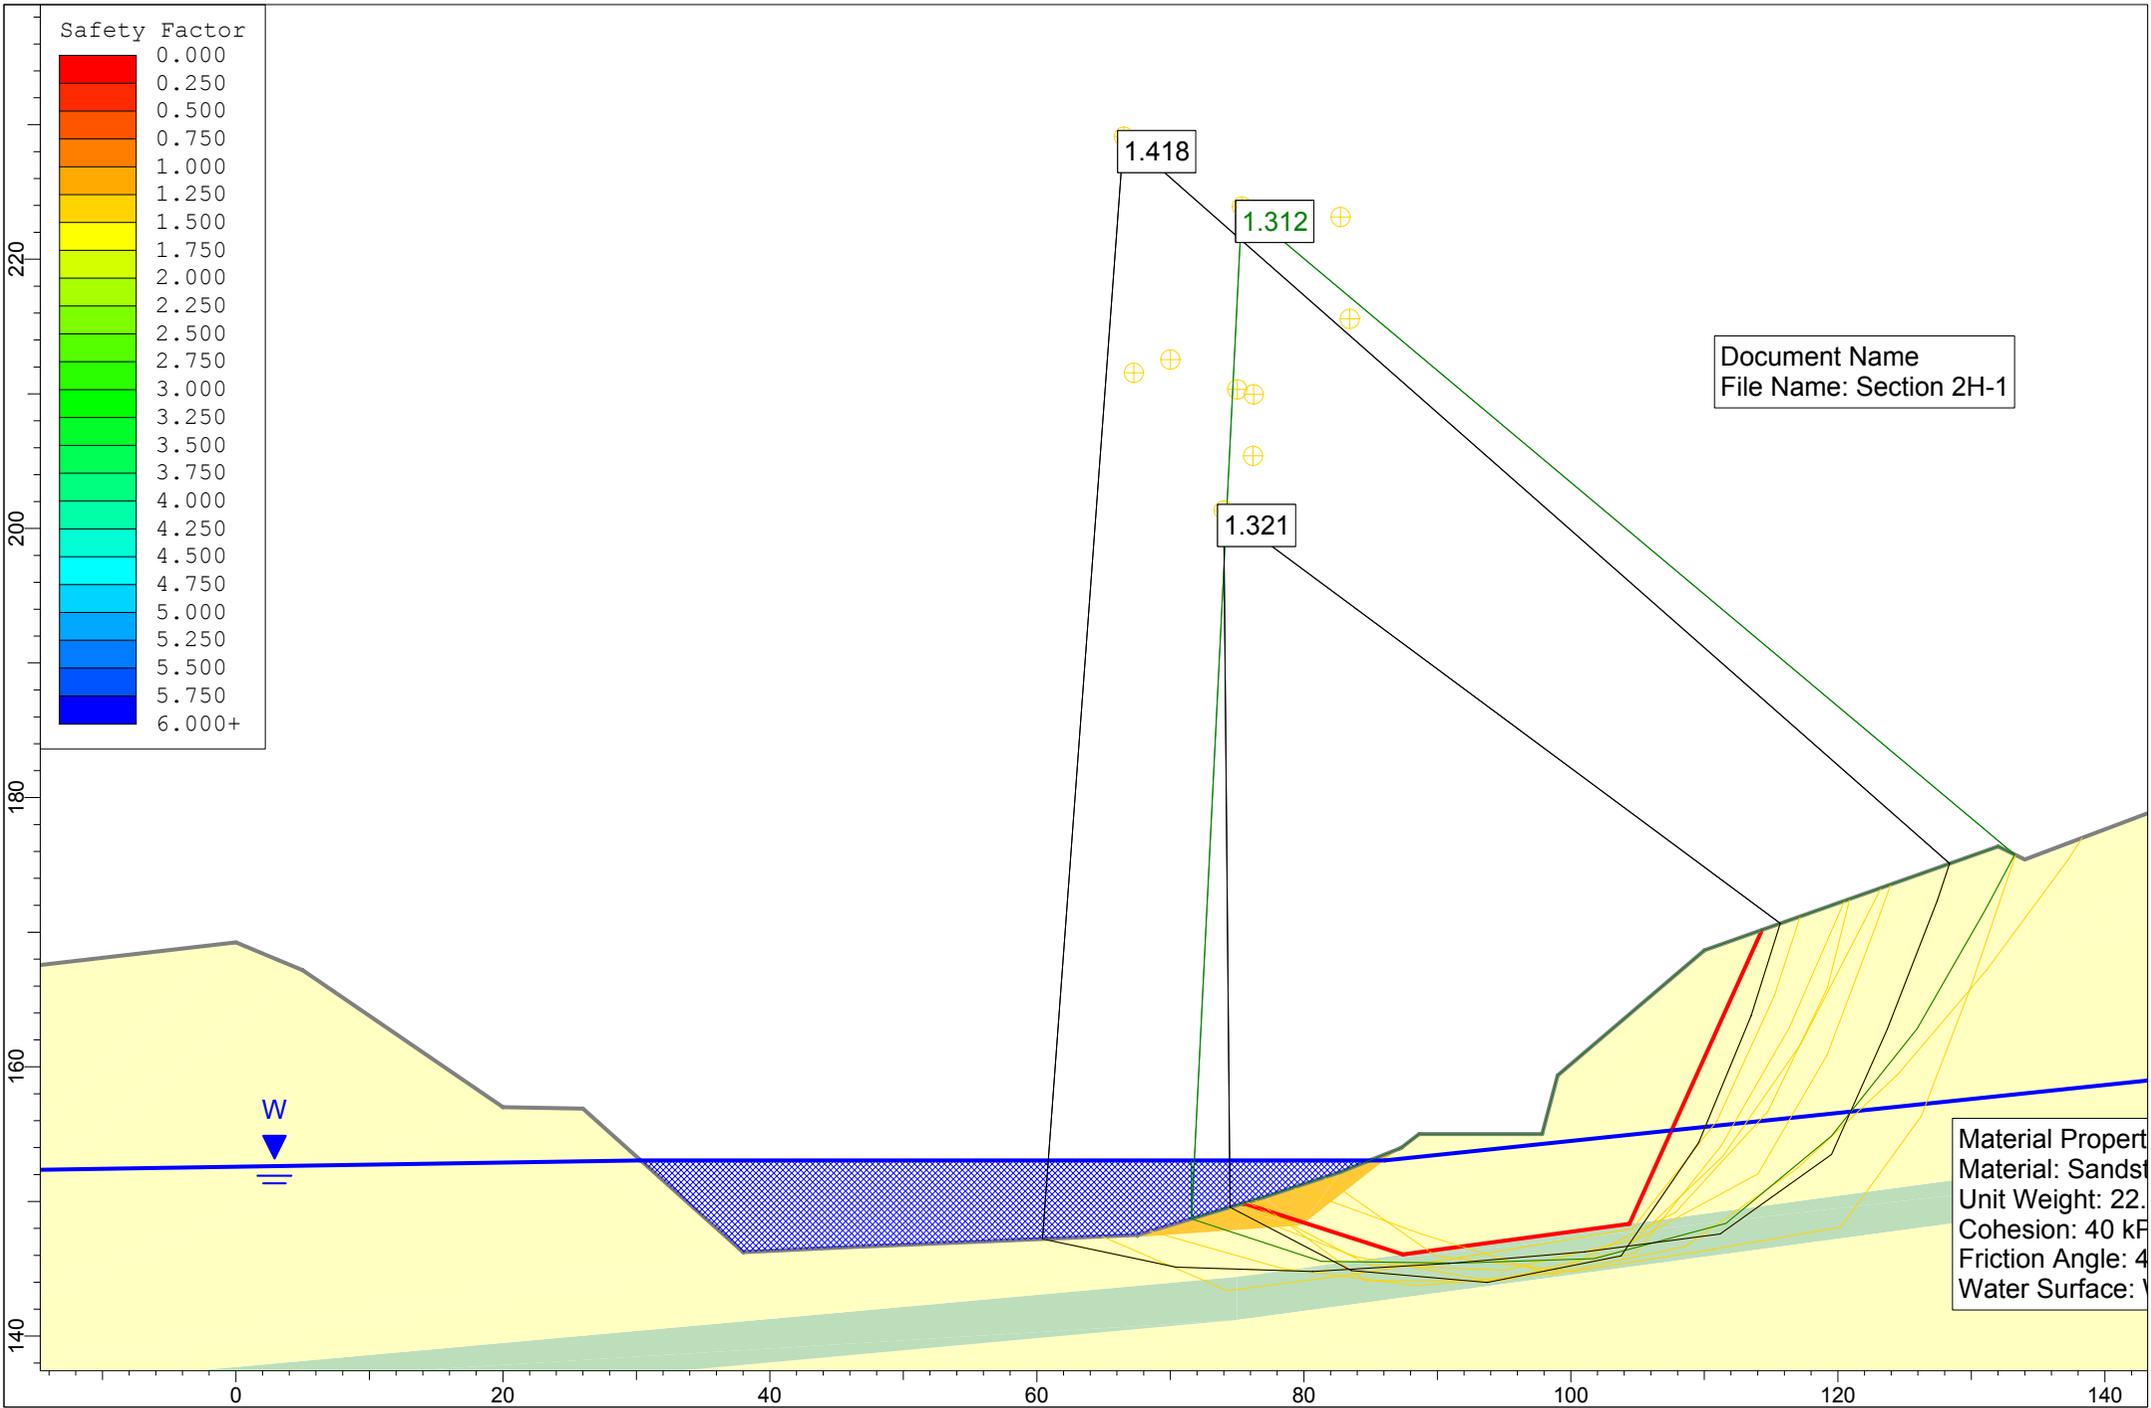
Document Name  
File Name: Section 2H-1

Material Property  
Material: Sandst  
Unit Weight: 22.  
Cohesion: 40 kF  
Friction Angle: 4  
Water Surface: Y

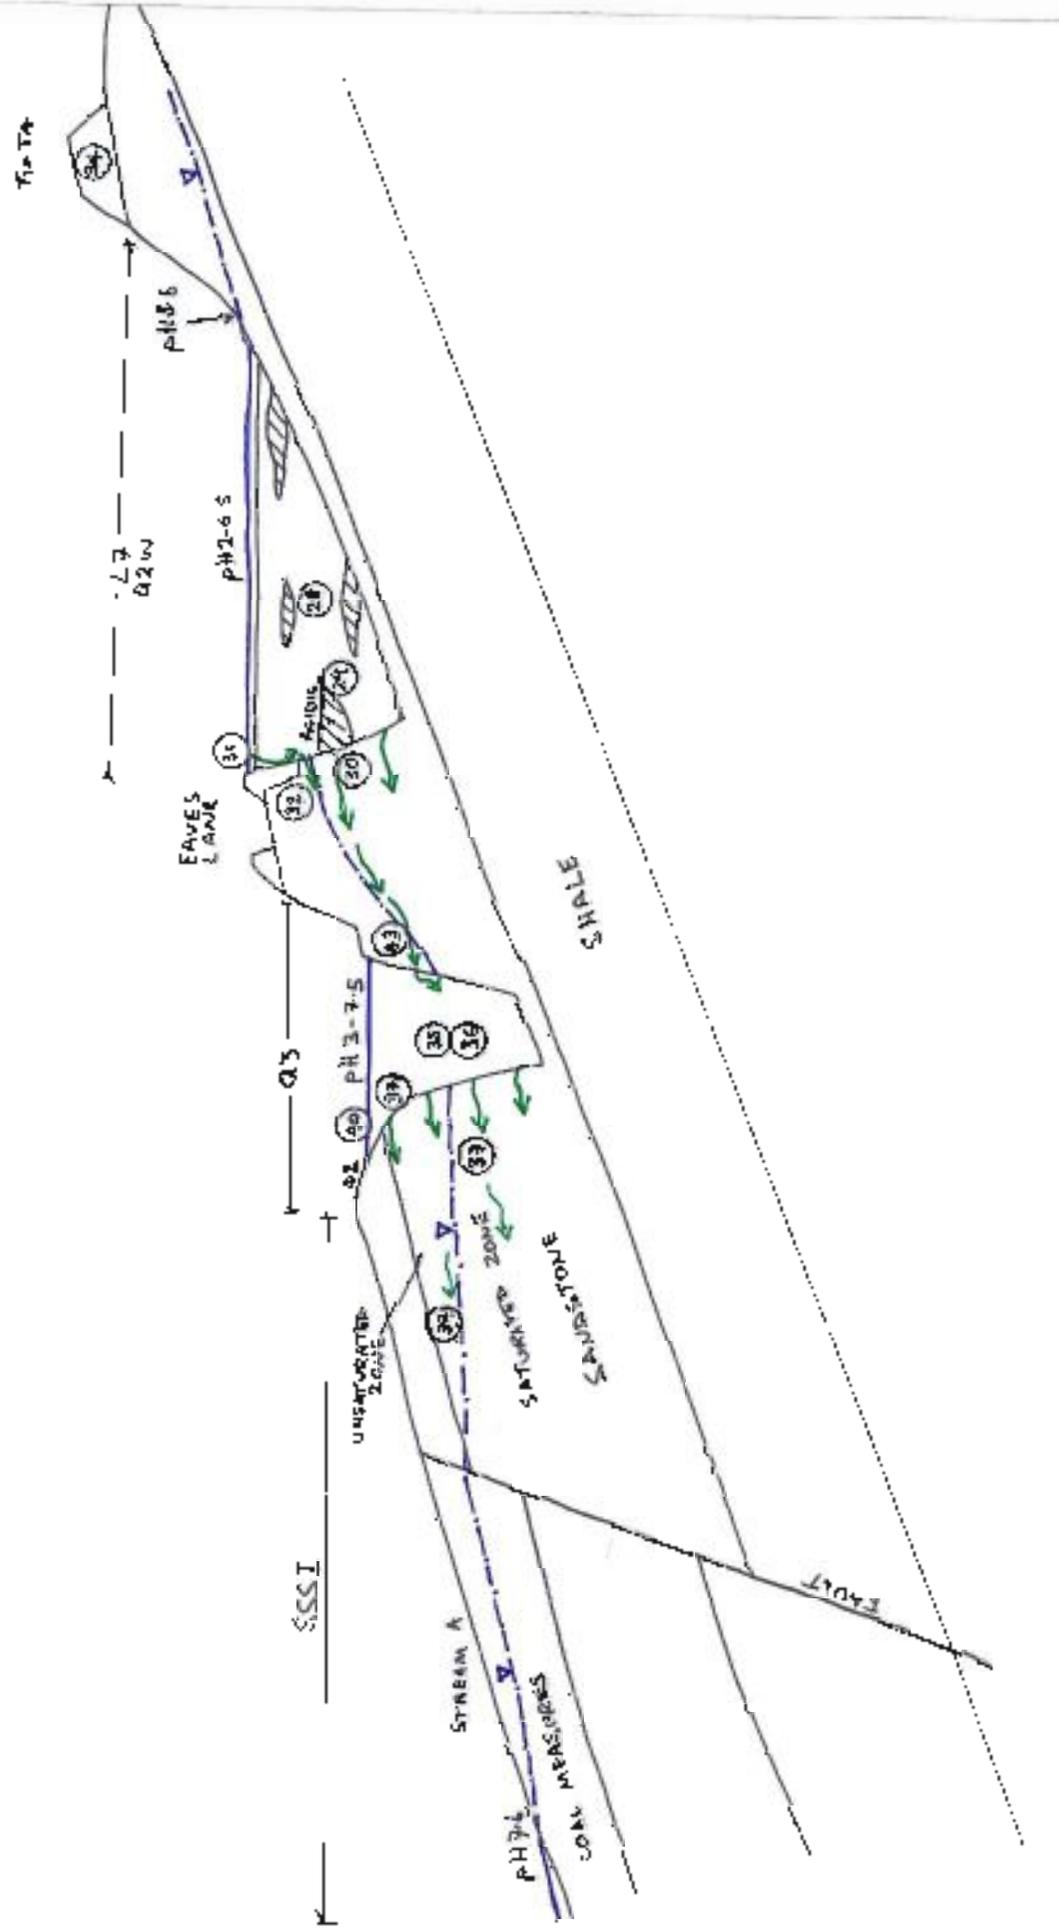
Notes: - NOT TO SCALE. This model is schematic only and does not reflect the specific ground conditions identified on or off the site.  
 - See Table 2.8 - Conceptual Model Table
