# Heritage Statement & Impact Assessment Ivy House Farm, Rownall

**27th September 2017**

prepared on behalf of JCM Group Holdings Ltd

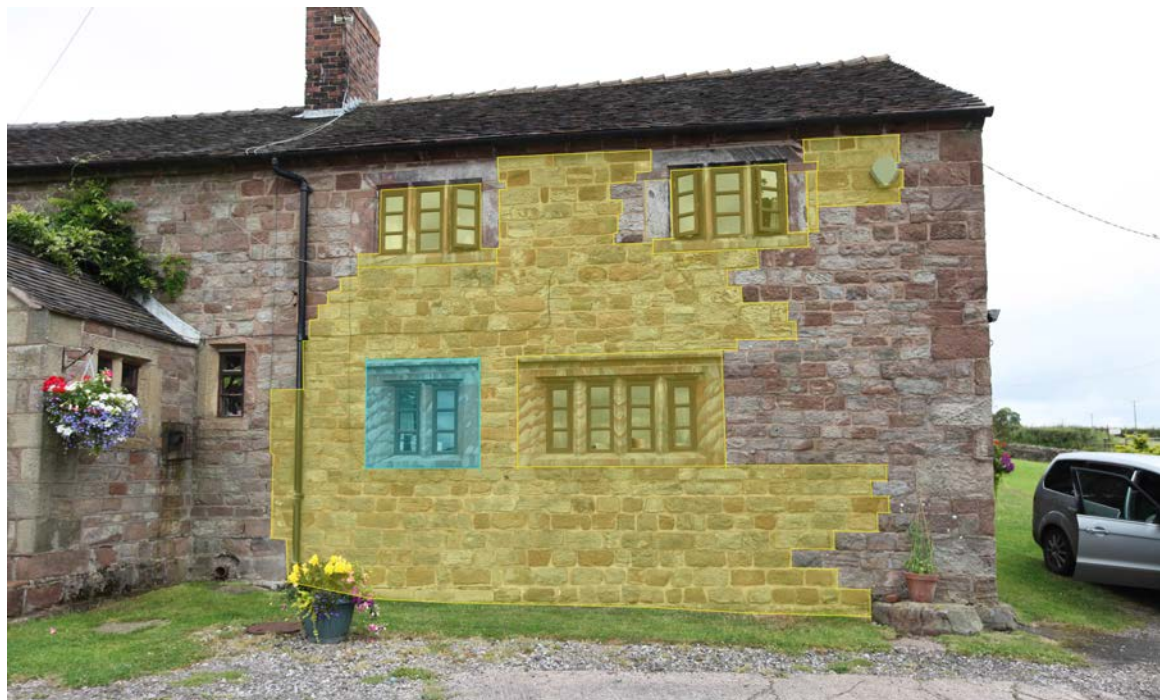
Area of reconstructed stonework, approved in 1992 – eastern bay. The 'blue' window is a new mullioned window approved in 1992

4.2 Alterations approved with listed building consent in 1992 under application number: SMD/1992/0776 include extensive reconstruction works to the eastern end bay, which still contains the remains of a smokehood. The end bay originally contained one large four-light chamfered mullioned window and a small (later) inserted fixed-light, a four-paned timber window (19<sup>th</sup> century); listed building consent was given for replacing the small window with an entirely new two-light chamfered mullioned window, an alteration which does not follow best practice (in accordance with SPAB principles). The other mullioned windows were also quite comprehensively replaced, with very little original masonry re-used. Furthermore, the reconstruction work to stabilise the front elevation included the total reconstruction of both internal and external skins of the masonry for a large part of this bay and new concrete strip footings combined with underpinning. Breezeblock footings are still visible. The drawings note on plan – ‘beams replaced as required’. However, the evidence on site suggests that the beams in the eastern bay were retained and propped in-situ whilst the front wall was rebuilt. Most of the hand written annotations on the 1992 plans which have been microfilmed are illegible.

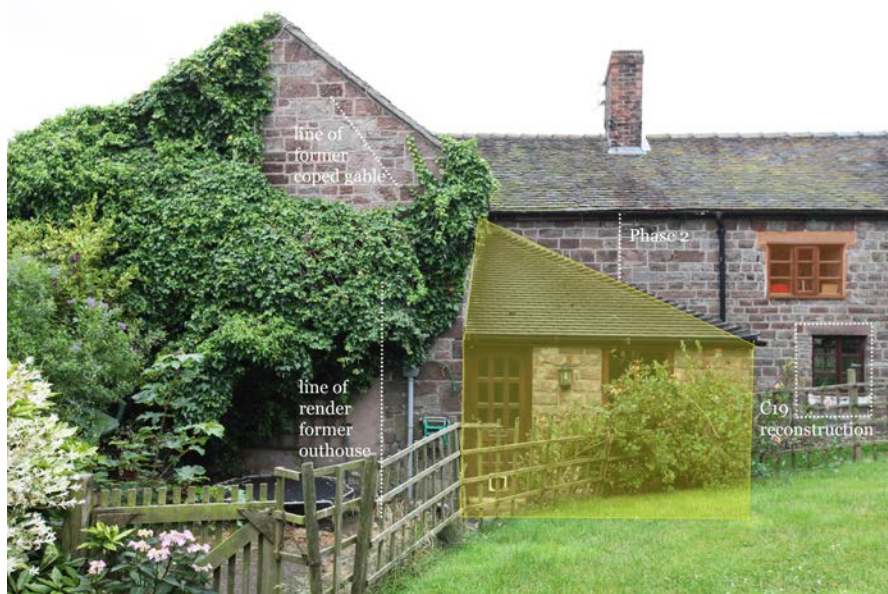
*Utility extension probably dating from the 1980s and illustrated on the 1992 survey plan. The 'orange' window is a late insertion, probably dating from the 1950s or 60s. Note the gable end, with its evidence of a narrower gable with a steeper roof pitch.*

4.5 A datestone on the front porch "J.J. 1984" also reveals a phase of building work undertaken by the previous owner, Mr J. A. Jackson and this may also be the date of the reconstructed porch / utility extension.

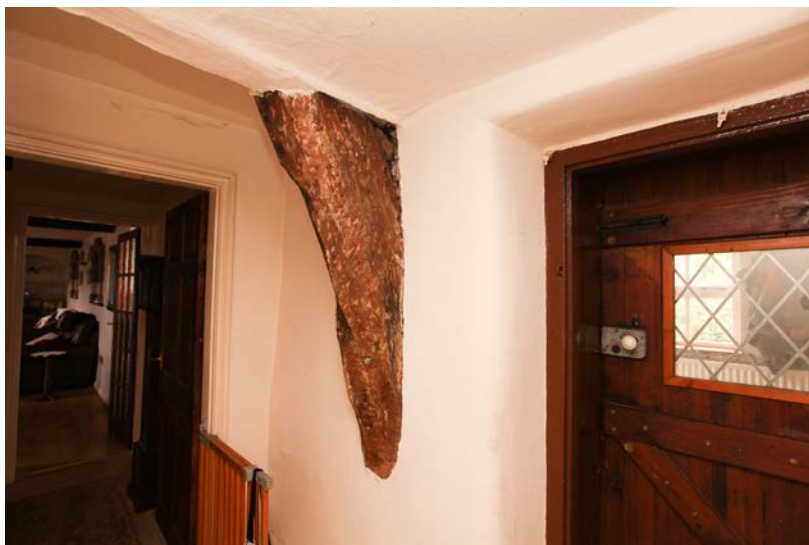
*Cruck truss embedded in the north wall of the eastern bay*

4.6 The earliest phase of the building is represented by the remains of a single, double-bladed cruck truss. The location of this truss and its details, embedded in the wall in the eastern bay, suggests that it falls along the centreline of a two-bay structure, with stone masonry outer walls. F. Cleverdon suggests that a second truss was removed in the 20<sup>th</sup> century, but this is not evident and unrecorded. Some of the masonry within the eastern gable end may date from this phase, although that is also inconclusive. The original end masonry wall (or cruck) to the west has been removed. Cruck blades and truss, with tie beam, similar to that found at The Grange, Cheddleton, are found within the building<sup>1</sup>. They are found invariably in the Moorlands within stone masonry structures. Given that there is a clear 17<sup>th</sup> century phase of masonry within the building, the cruck blades / truss are likely to date from the late 16<sup>th</sup> or early 17<sup>th</sup> century.

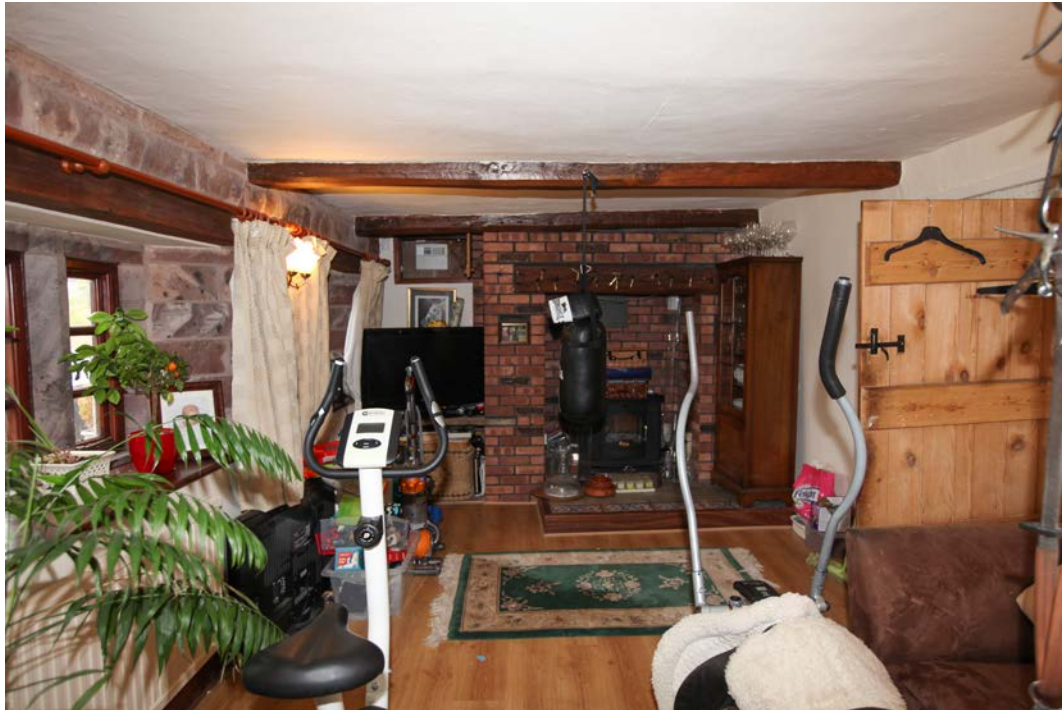
*Former smokehood with its bressumer is visible with a modern brick chimney breast inserted. The window wall to the front of the house has been rebuilt although transverse beams appear to be in-situ.*

4.7 The presence of a smokehood in the eastern bay against the cruck frame probably represents a second or even a third phase of construction. The disposition of the windows to this bay suggests a modification after the construction of the two western bays. Another possibility is that the eastern 'wing' was originally a single-storey kitchen and was later raised to create additional bedrooms, serviced by their own winder staircase.

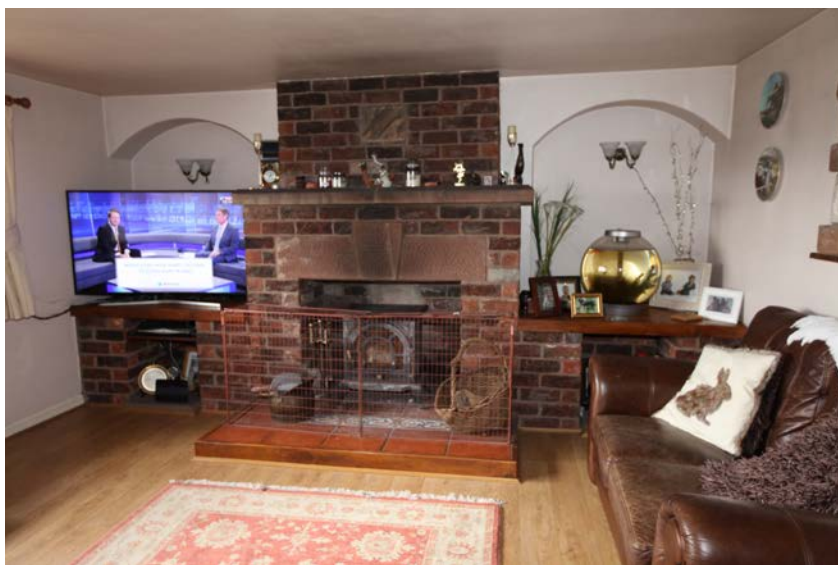
*Modern fireplace surround, brickwork, datestone and plastered niches inserted into the original end wall of the Parlour.*

chimney breast and a fire window indicates that this room was a large Hall (Houseplace) with a separate Parlour to the west, approached via the Hall. The location of the internal partition separating the present staircase hall from the present lounge is entirely new and there are no historic partitions. The original floor plan arrangement would have contained a partition separating the two five-light ground floor windows into two similarly-sized rooms. The western parlour would have contained a smaller fireplace and hearth; whilst the chimney breast survives, all evidence for the original hearth and fireplace has been disfigured by comprehensive remodelling with a modern fireplace and arched plastered niches.

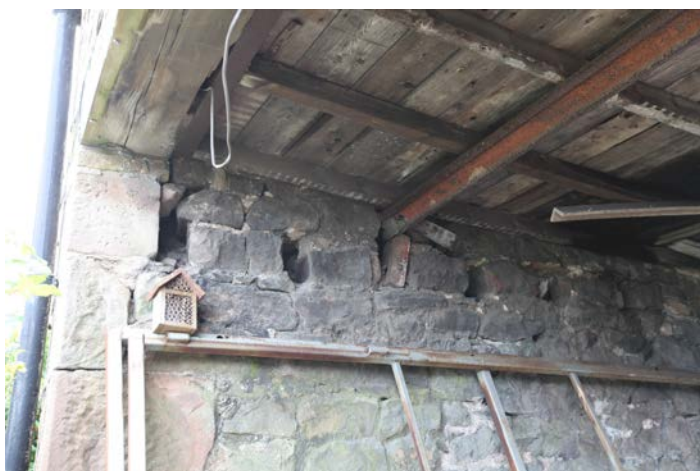
*Inserted and raised floor into cart bay with altered joists and lintel. The original sockets for the joists which ran axially are still visible.*

4.11 During the 19<sup>th</sup> century a cart bay was added to the western end of the farmhouse with a hayloft over. This cart bay was also altered earlier in the 20<sup>th</sup> century, by raising the lintel, probably to accommodate a tractor. The original joists were all removed and the hayloft raised. All of the original sockets for the hayloft floor joists are still visible.

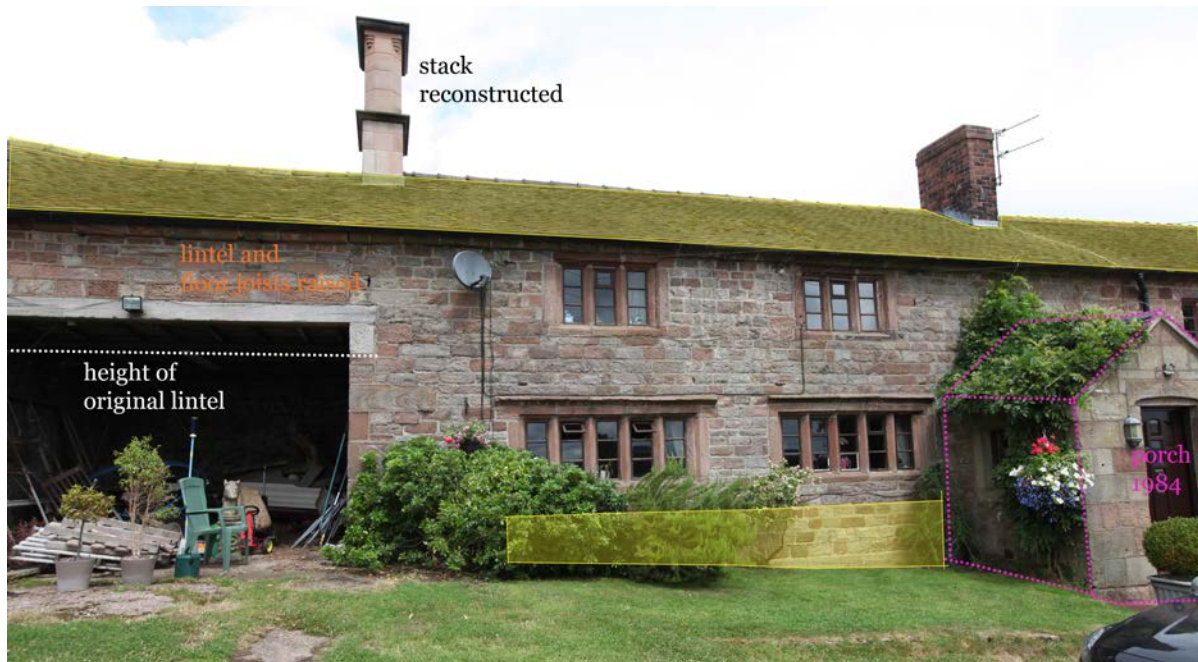
*Western bays with five-light mullioned windows and rebuilt lower courses. Western cart bay added in the 19<sup>th</sup> century but altered later to raise the lintel. The stack was reconstructed in recent years. Its ornate appearance with corbelled decorative capping reflects the higher status of this part of the building and the Parlour end. Roofs were comprehensively re-roofed with new timbers throughout.*

4.12 Photographs have been annotated to show some of the complex phasing. The yellow shading represents the most recent phase of reconstruction, whilst the orange shading represents

alterations to insert new windows, with concrete lintels, carried out in the earlier 20<sup>th</sup> century, prior to listing.

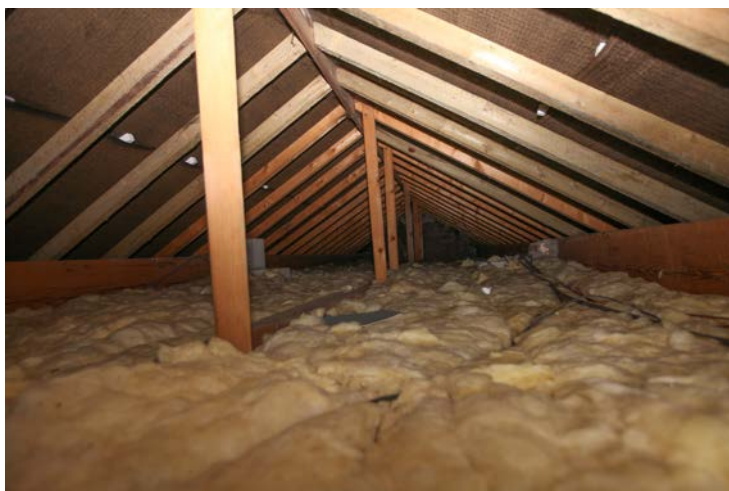
*Roof structure to the two western bays of the farmhouse, to the west of the brick chimney stack, are entirely new and probably date from the 1990s refurbishment.*

4.13 In recent times the entire building has been re-roofed. Photographs of the roof spaces show these to be largely new timbers. Trusses and rafters have been removed along the length of the roof and replaced in modern timber. Only the easternmost bay and the northern 'wing' retain some fragments of the 18<sup>th</sup> and 17<sup>th</sup> century purlins. A single 17<sup>th</sup> century truss survives, part within the first floor eastern bay and part within the roof. When the building was altered to extend the accommodation in the 17<sup>th</sup> century (or to create a separate dwelling), a new staircase was inserted.

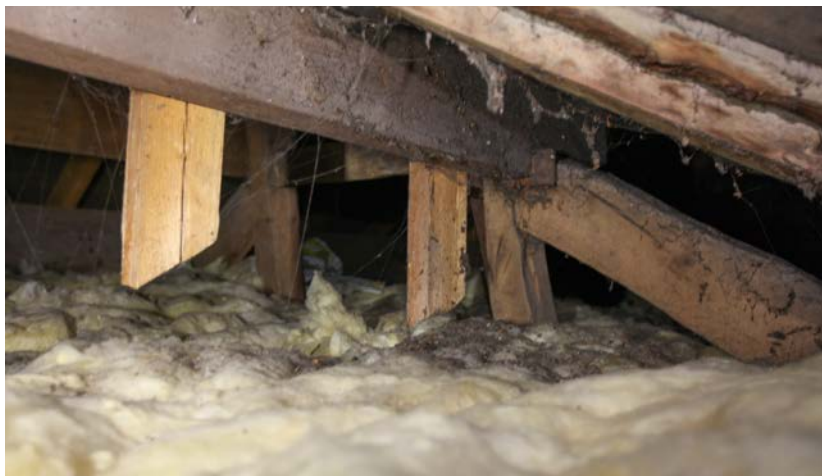
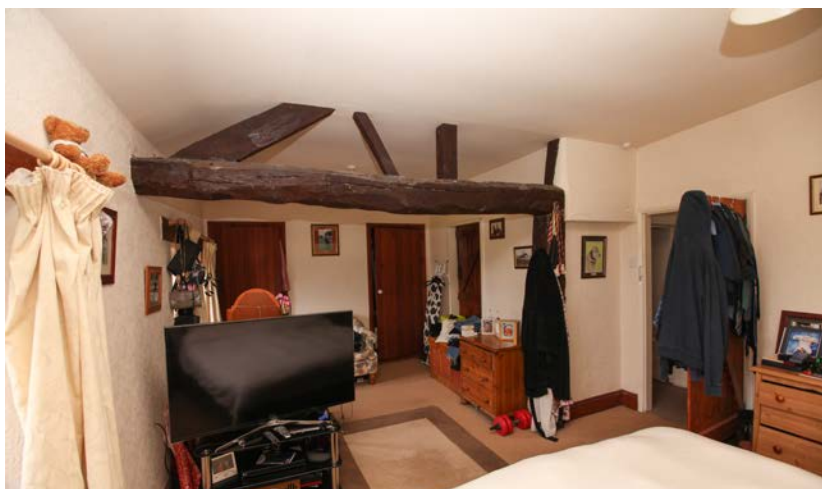
*The remains of a truss within the eastern bay of the farmhouse, with double trenched purlins, within the roof space relates directly to the exposed remains of the same truss at first floor level (below). Until the 1990s an internal partition ran along the line of this truss creating two bedrooms. The raised ceiling height within the first floor bedroom, however, above the line of the tie-beam, is an earlier alteration of the nineteenth century, as this was carried out with lime-plastered laths, which are still evident within the roof space.*

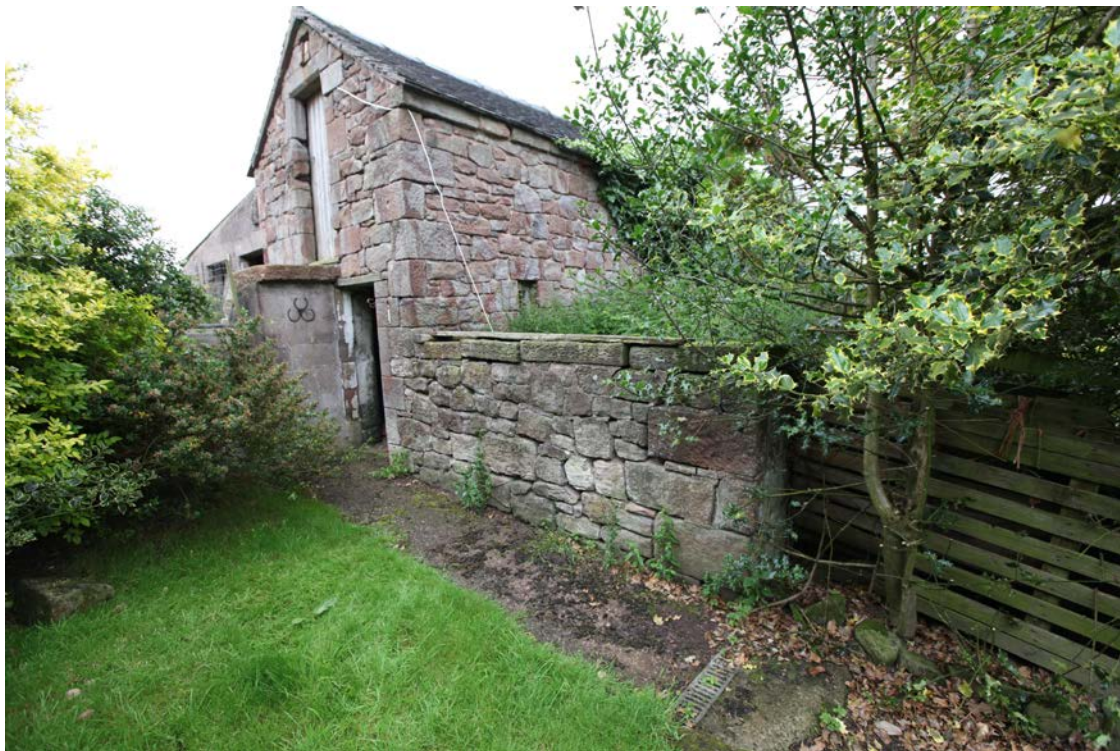
Combination building of pigsties, hayloft and privy – probably mid 19<sup>th</sup> century

5.1 The range of buildings to the north of the farmhouse comprise a combination building housing pigsties, with hayloft over, external pens and a domestic privy. The original form of the building is largely intact and probably dates from the mid 19<sup>th</sup> century. The building is constructed in rubblestone, uncoursed sandstone, with quoins. The use of a slightly decorative stone surround to the hayloft doorway, with chamfered surround and carefully finished details, door surrounds and quoins indicates that the building was purpose-built. The building has been extended to the north since 1925 with a corrugated iron shed, as this appears on the 1938 OS map, although this extended shed has involved no alterations to the original structure.

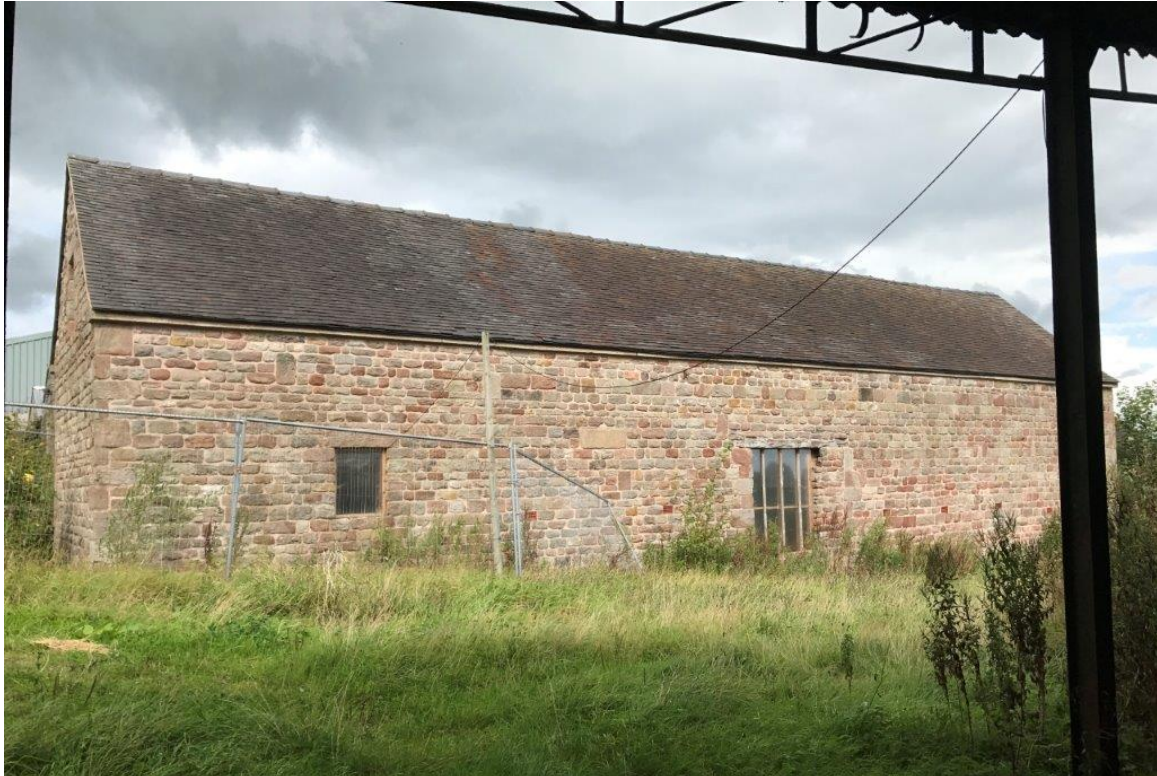
*Grade II listed barn – possibly originally designed as a threshing barn, but adapted to form a cow-house. Above – winnowing door (?) with (below) hayloft and openings for cow byres*

6.1 The barn lying to the south-west of the farmhouse appears to be the only agricultural building originally associated with the farmhouse and it may have housed several functions. Its date of construction is not possible to determine as it has been extensively altered but it is large enough to be a threshing barn, which, with its masonry could place it around the early 19<sup>th</sup> century. It is without any evidence for coped gables, as would be expected in this region for a barn of the 18<sup>th</sup> century. There is a straight joint to the right of the winnowing door, perhaps indicating a former cart entrance. The barn may have been originally accessed from the south

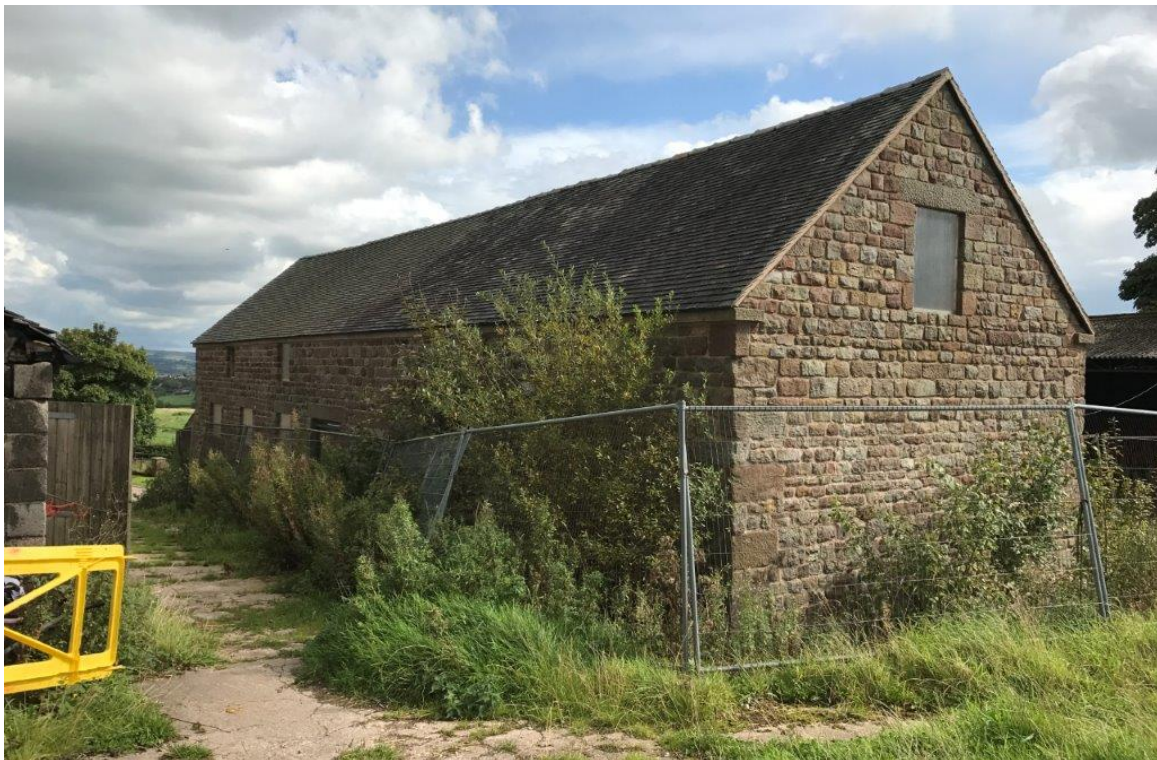
6.2 The range of window and door openings to the south elevation suggests that the building was also at one time in use as a cowhouse.
