# Heritage Statement and Impact Assessment

## Extension and internal alterations at Brook Cottage, Endon

Mel Morris Conservation has been appointed to prepare a Heritage Statement and Impact Assessment for a single storey extension to Brook Cottage, Endon, a grade II listed building.

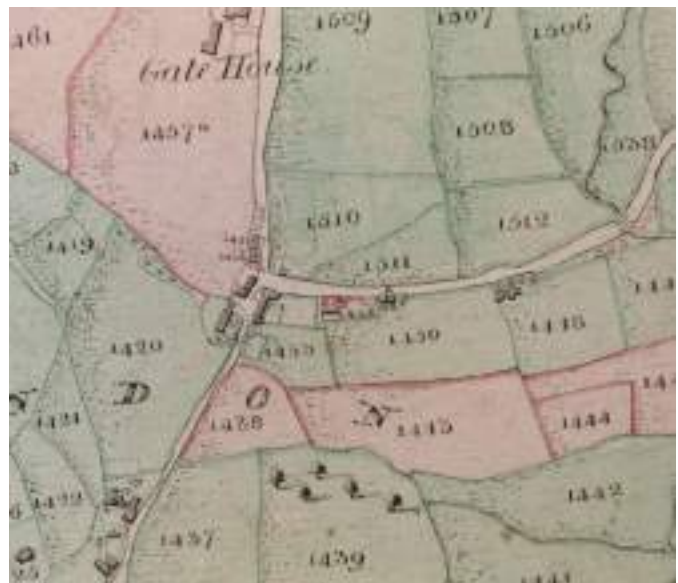
Right – Mill Bridge is visible to the right on the 1816 map – Survey of the Manor of Horton. Brook Cottage is visible on this map, probably depicted before it was extended.

The current route of the main road was a diversion of the turnpike. Between 1816 and 1820 the new line was constructed from the Plough Inn to the present Black Horse Inn. The Enclosure map and the Horton Manor map of 1816 both show the turnpike road before it was diverted avoiding the steep rise up Endon Bank and the ford.

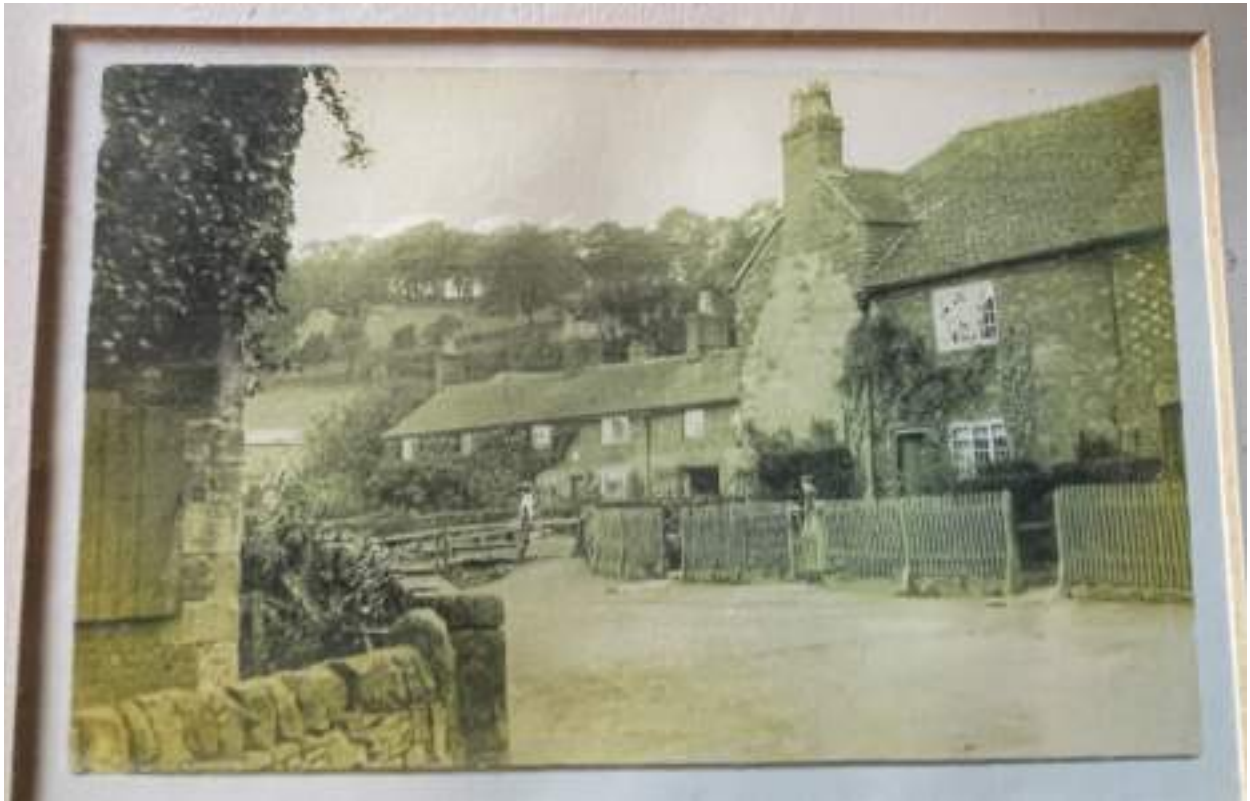
Photo – early 20<sup>th</sup> century of Brook Cottage and Middle Cottage (by permission M Benson)

A photograph taken in ca. 1910 (37/48510 - Source: Staffordshire Museum Service) illustrates a view from the south looking towards the flank wall, across the brook, and the stone gable facing the street can be clearly seen. A photograph owned by the applicant at a similar date shows the view from the street (see below) and reveals a

gable which would have supported a very steep pitched roof, probably thatched. This is similar in height to the cruck and would have connected perpendicular to it.

At a later date, and judging by the brickwork, this may have been any time between the 1930s and 1950s, the raised two-storey gable was remodelled twice, the stone higher part of the gable was removed, and the brickwork was remodelled removing the evidence of the former steep pitched roof and drawing a horizontal break between the stone masonry and the brickwork.

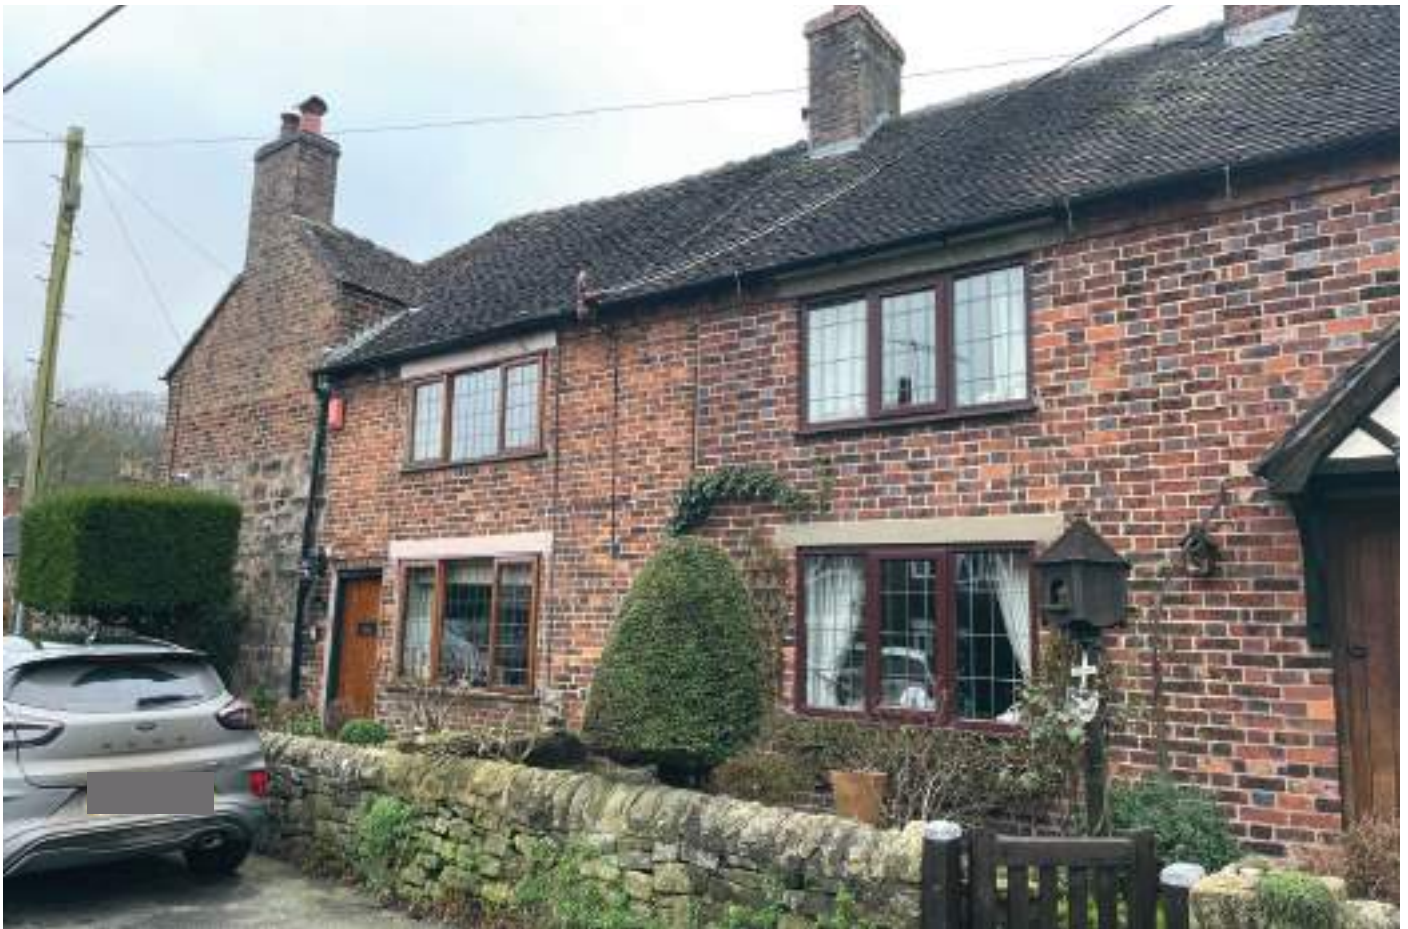
1. Elevation of Middle Cottage and Yew Tree Cottage. These both share a sawtooth eaves which is very typical of the 18th century. Map regression indicates that Middle Cottage was once part of Brook Cottage. Windows and doors to both cottages have been remodelled. There is a straight joint between Middle Cottage and Yew Tree Cottage, which also has flared headers typical of the early 19th century. It is likely that a further cruck truss was originally located on the line of this straight joint.

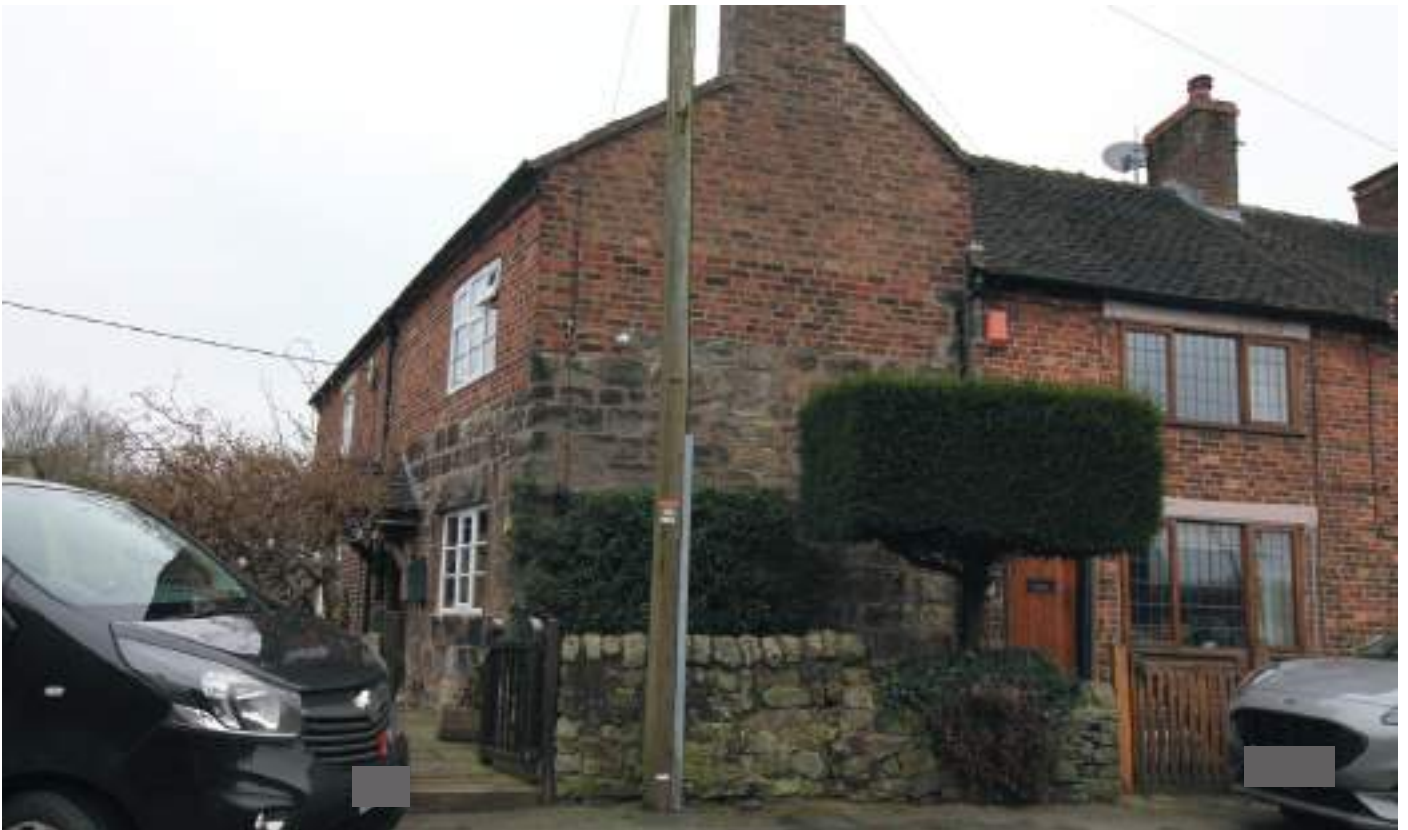
2. Gable end to the street, with 17th century stone masonry, area of remodelled brickwork to the gable incorporating two phases of brickwork, the later phase a significantly paler colour.

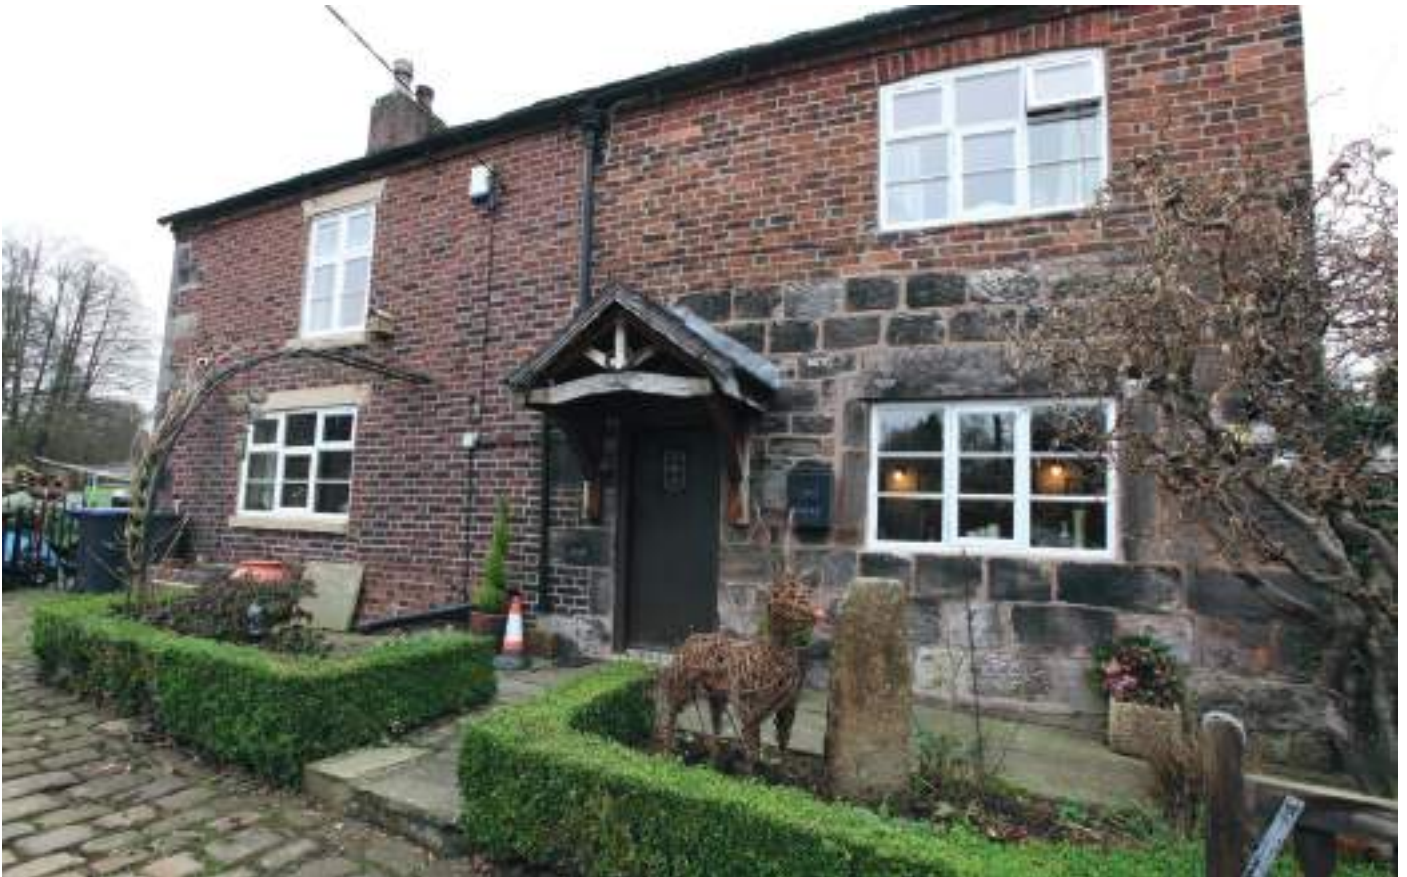
3. Elevation to the south overlooking the brook. Three distinct phases are represented in this elevation although the window pattern is unifying, as is the patina of mellow brick and stone. The first floor window to the right has a shallow segmental arch, also known as a cambered brick arch (comprising a square top and curved bottom), which is found typically during the first half of the 18th century. The eaves to this elevation is plain corbelled and of two clear phases.

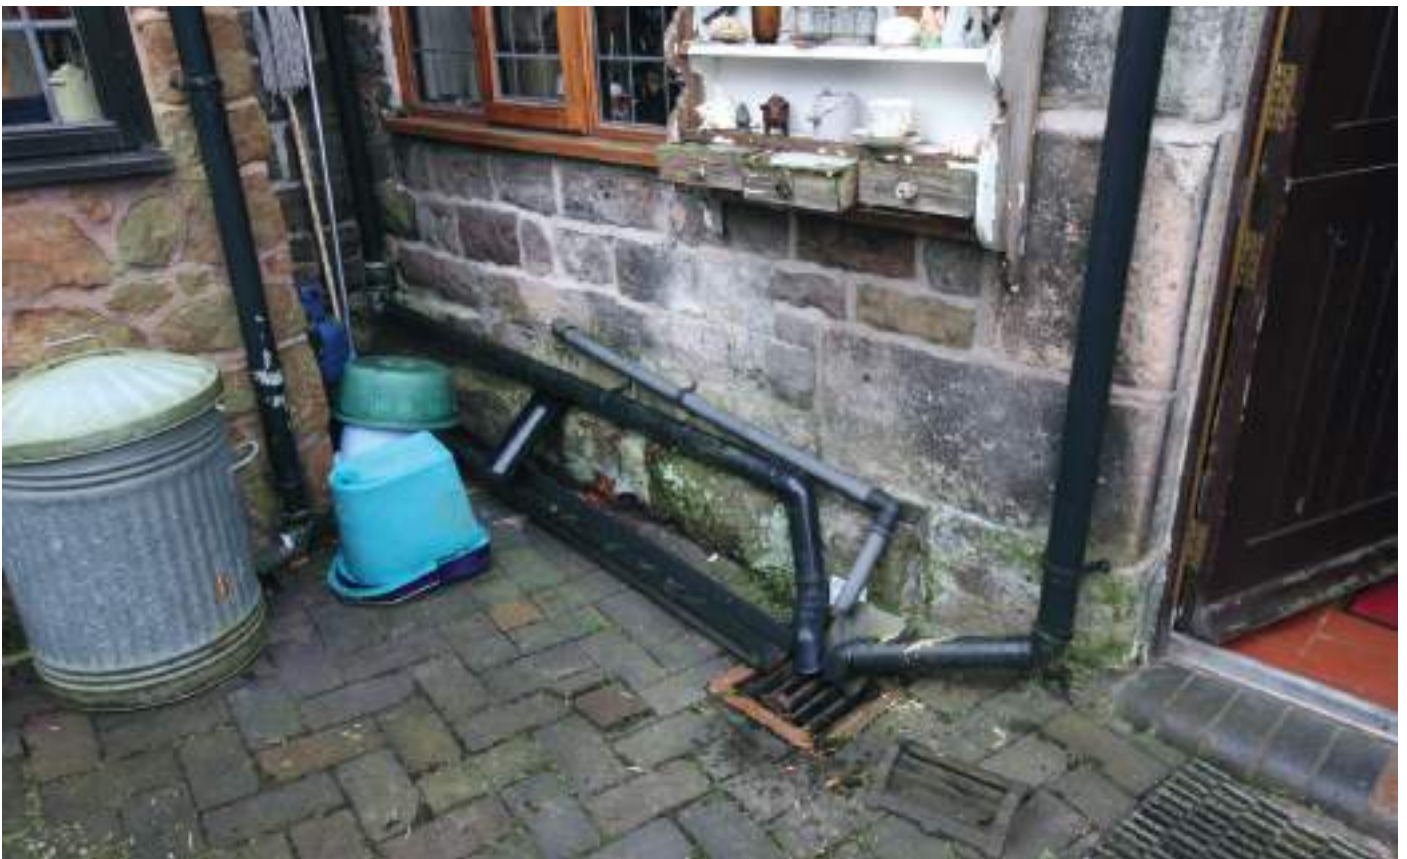
4. Rear elevation with remains of a 17th century stone plinth. This demonstrates that the 17th century building extended as far as the back door before it was extended in the 19th century, so there is a degree of overlap in the front elevation masonry phasing.

The 17<sup>th</sup> century parlour wing contains the remains of a stone plinth, 17<sup>th</sup> century window and a hearth with a depressed arched lintel.

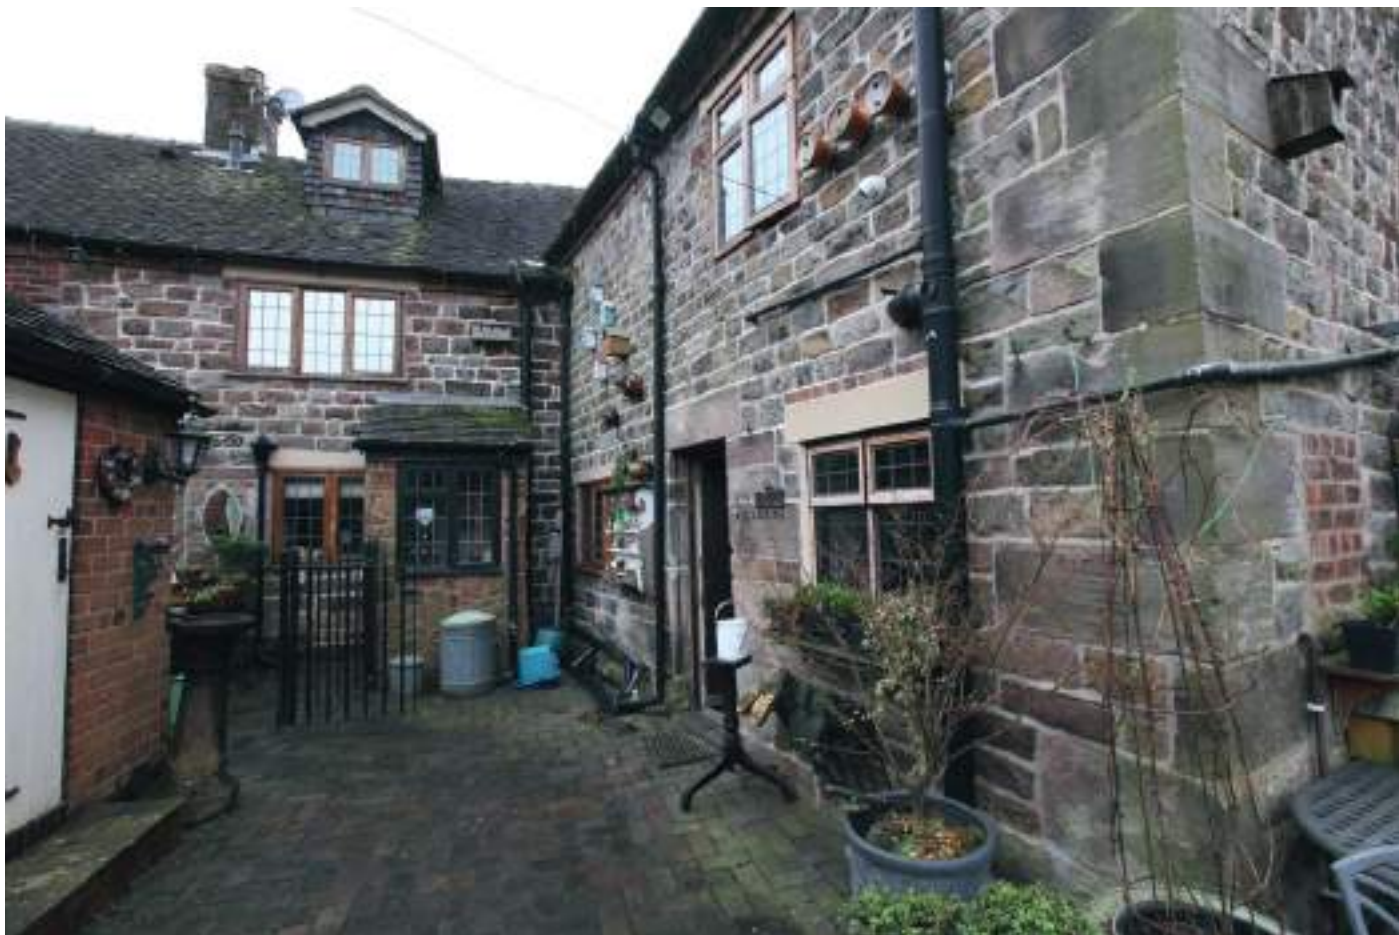
5. Rear elevation of Brook Cottage and Middle Cottage to the left. The stone masonry walls seen here of Middle Cottage were originally part of the same L-plan building, as depicted on the 1882 OS map. The stone masonry is very evenly coursed and this may represent a remodelling, as there is no evidence that the 17th century masonry continued to the corner quoins. Instead, the 17th century masonry terminated at the stone plinth or the doorway. All three windows on this rear elevation are modern (mid-late 20th century) with concrete lintels.

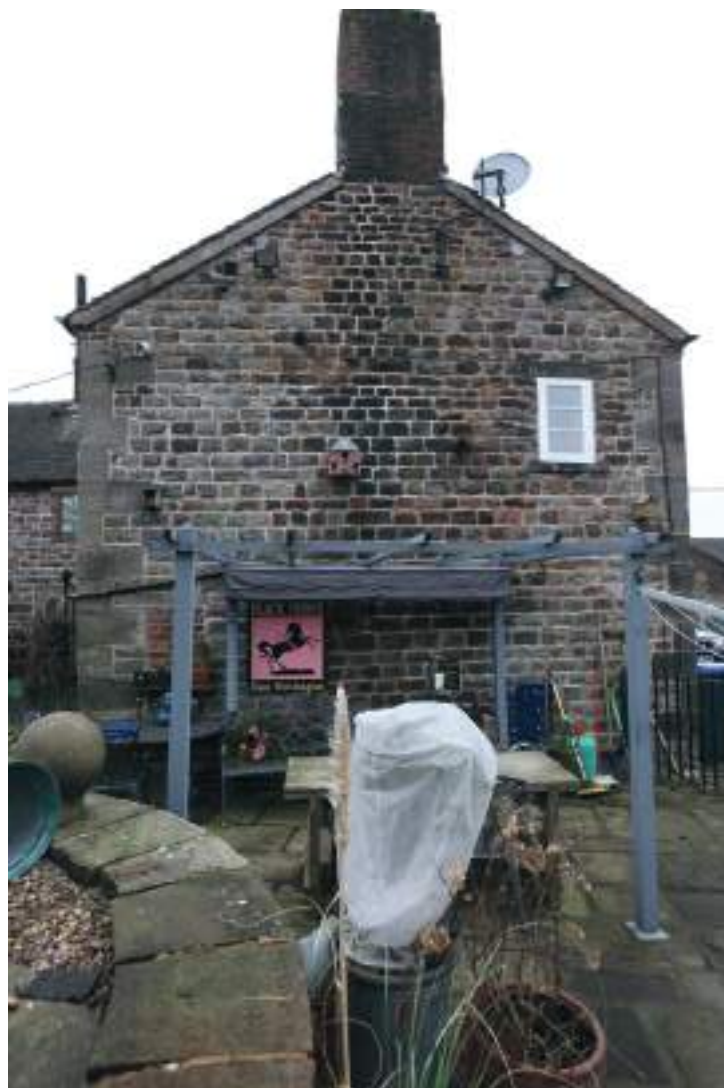
6. Right - gable end with quoins and narrow-coursed masonry. The first floor window is a modern 20th century addition. The chimney stack has been raised, probably in conjunction with early 20th century re-roofing.

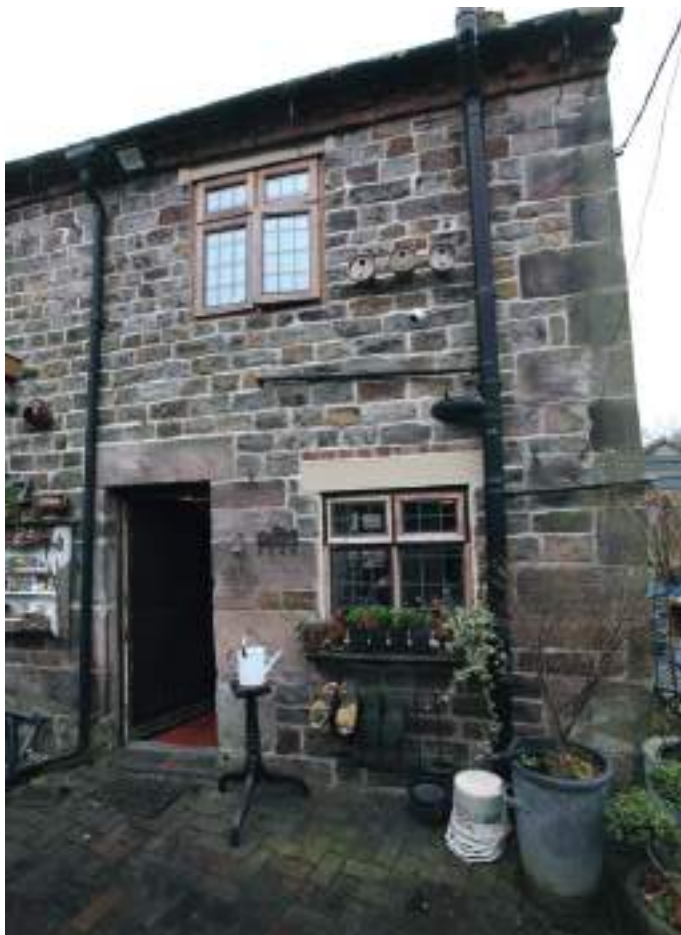
7. Above left - Rear elevation with modern windows and earlier doorway. The plain square door lintel is likely to be 19th century and appears to have been raised, as the quoins are narrow to either side, whilst the lower quoins are much larger. For a 17th century doorway, we would expect to see some sort of moulded surround and / or a much deeper lintel. The eaves are a dentilled corbelled pattern, in smooth red brick to the whole eaves, which indicates remodelling.

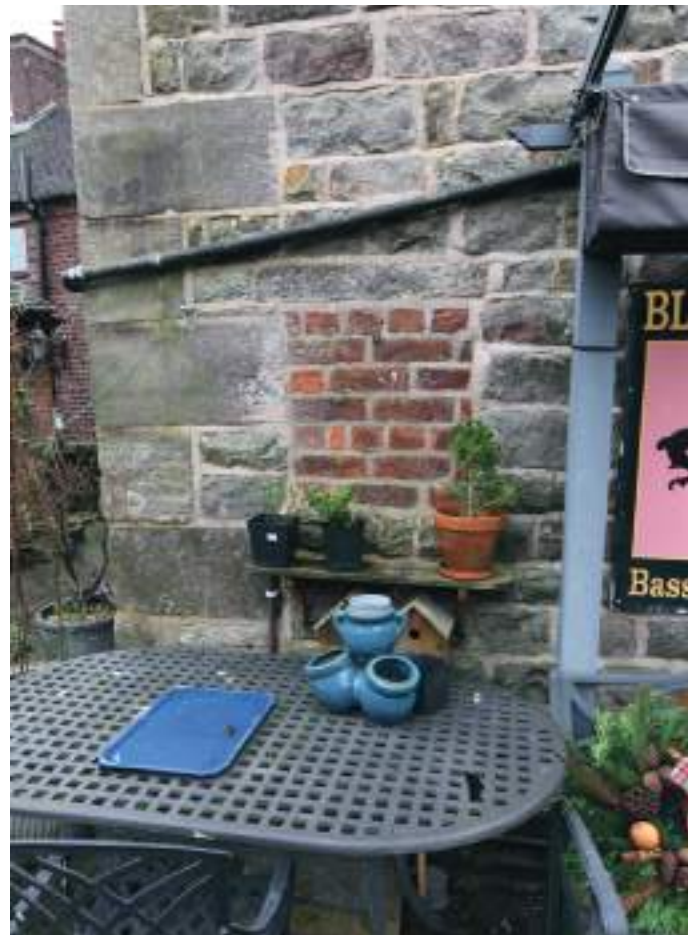
8. Above right - the vertically-tooled (or reeded) quoins with their margins are more typical of 18th and early 19th century tooling. Here there is a blocked former window, which may have been a fire window at one time. It suggests possibly an earlier phase, as there is no evidence of a smoke-bay to this wall.

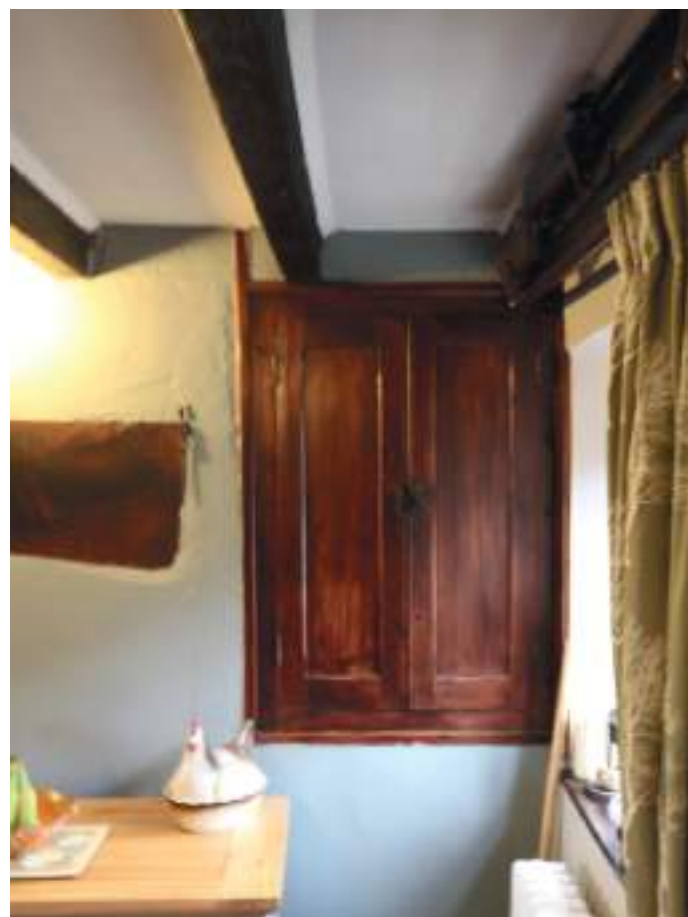
9. Right - the former window has been adapted to contain a small 19th century cupboard.

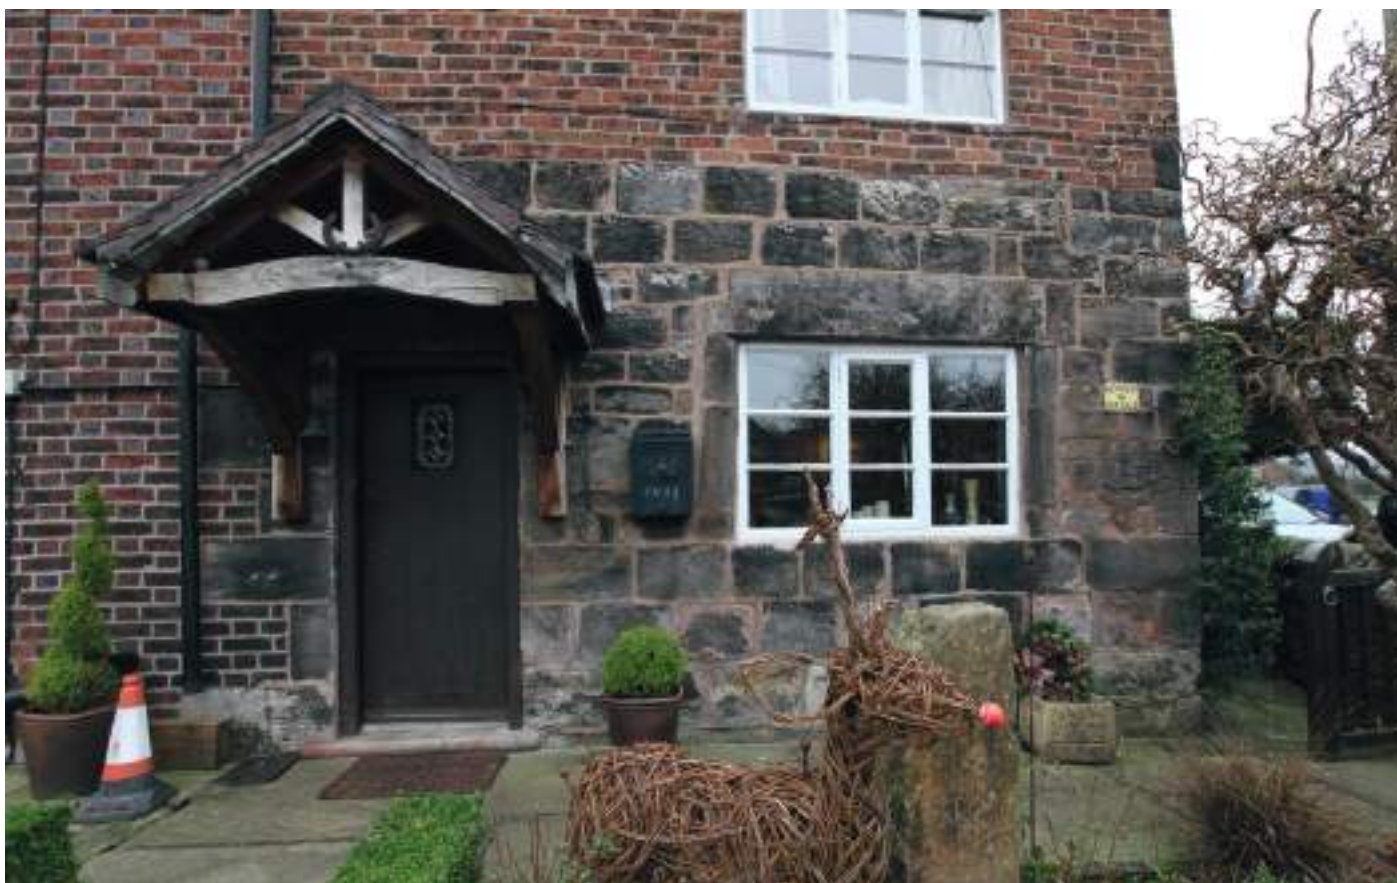
10. 17th century masonry with altered 17th century window. The moulded jambs remain whilst the cill has been lowered and the lintel has been replaced. The door to the left is probably remodelled & extends beyond the line of the straight joint at first floor level.

The proposal for an extension is located on the stone masonry gable of the property. It will form a natural progression of phasing, as exemplified in the discussion of the building evolution in this report. The only physical alteration to the fabric is the insertion of a doorway into the gable end of the property and the local impact of attaching a roof to the gable end, with chased lead flashings and fixings for timbers. The masonry gable does not contain any features of special or architectural interest, with the exception of the small blocked window, which will be preserved intact and is unaffected.

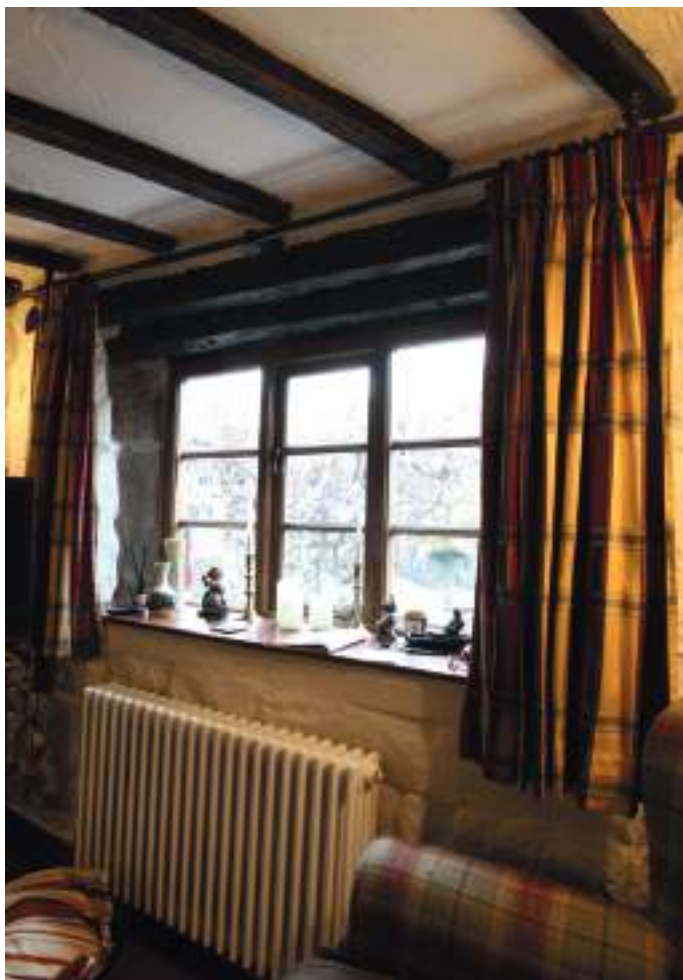
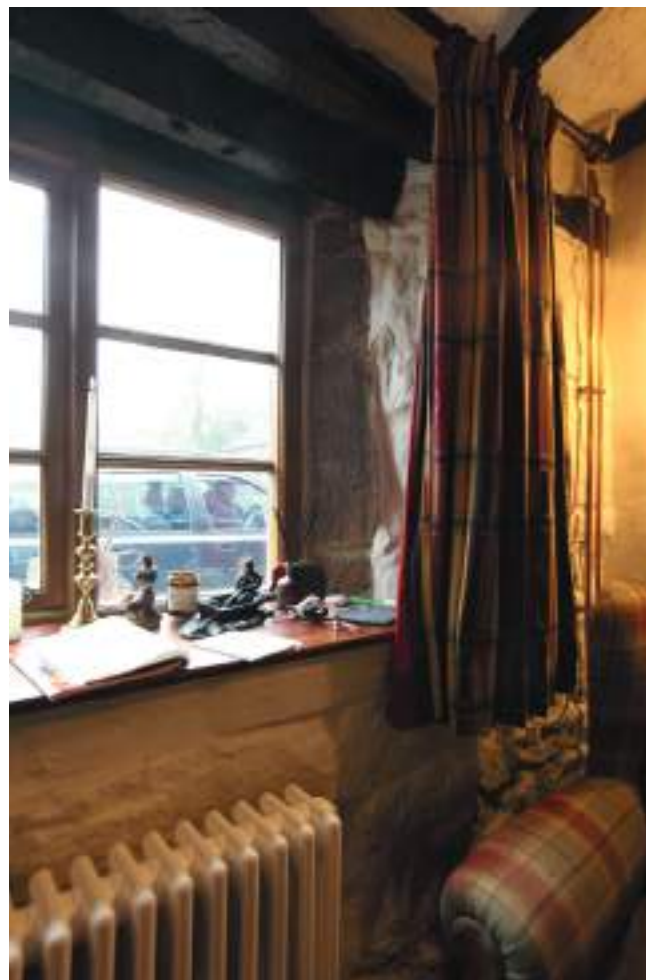
11-12. Two internal views of the altered 17th century window, with oak internal lintels.

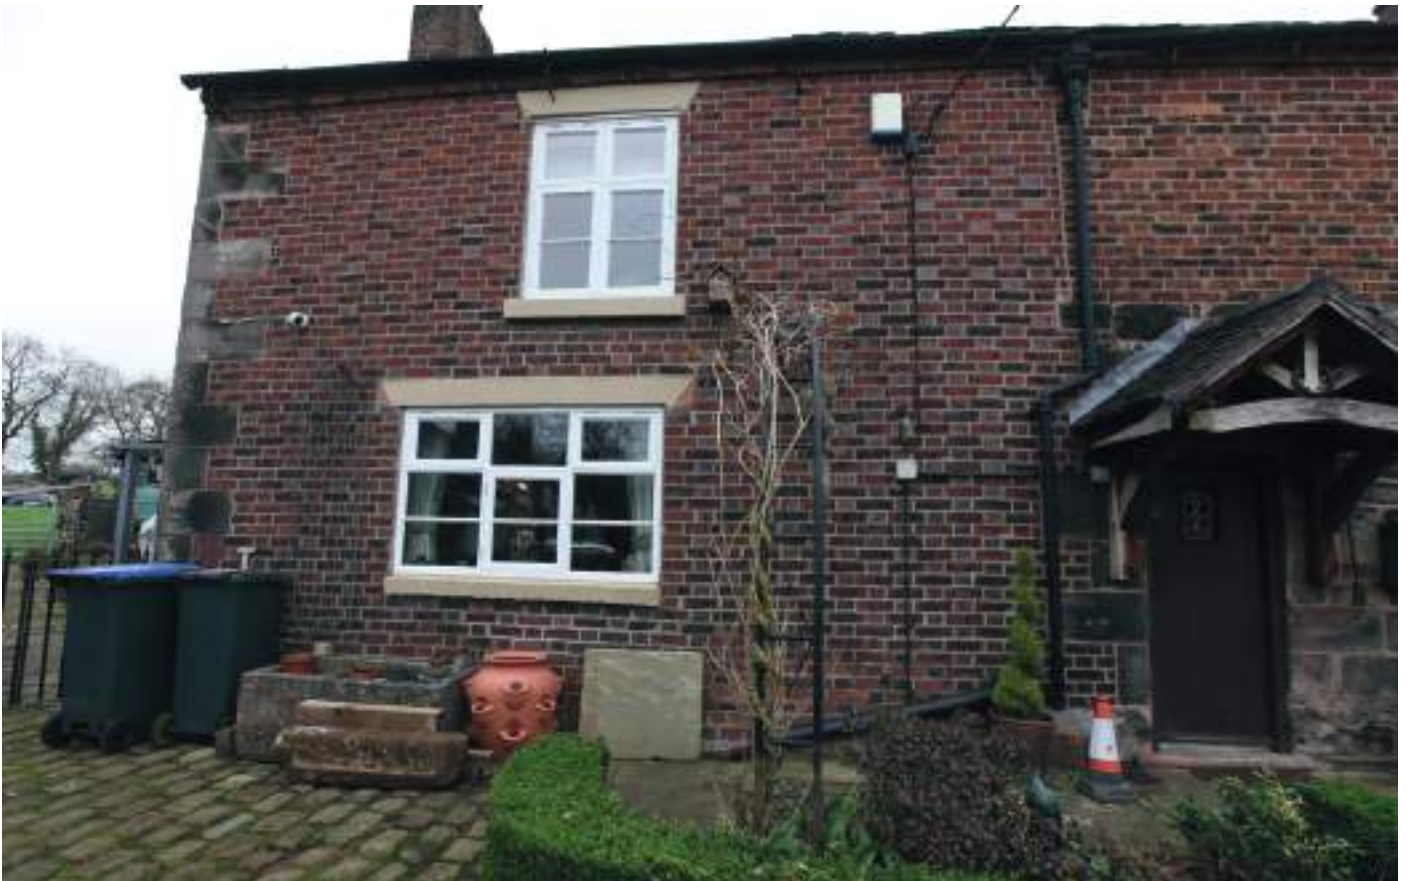
13. Early 19th century Flemish bond brick brickwork and bay extension. The flared headers are a distinct blue colour. The ground floor window has been widened and the lintel appears to be concrete. Original wedge stone lintel to the first floor. A sash window may have been removed and replaced with casements. The distribution of windows is odd because there are no brick closers, which would be expected in conjunction with Flemish bond brickwork, and the right jamb of the first floor and ground floor windows are not directly aligned.

The large second bay to Brook Cottage, which now functions as a Dining Room was largely built in the first half of the 19<sup>th</sup> century. It has details which are fairly typical – the use of stone wedge lintels (one survives), and the use of striking flared blue headers in combination with red brickwork, set in a Flemish bond pattern for the front elevation are typical, in combination with stone quoins and masonry to the gable and rear elevation.

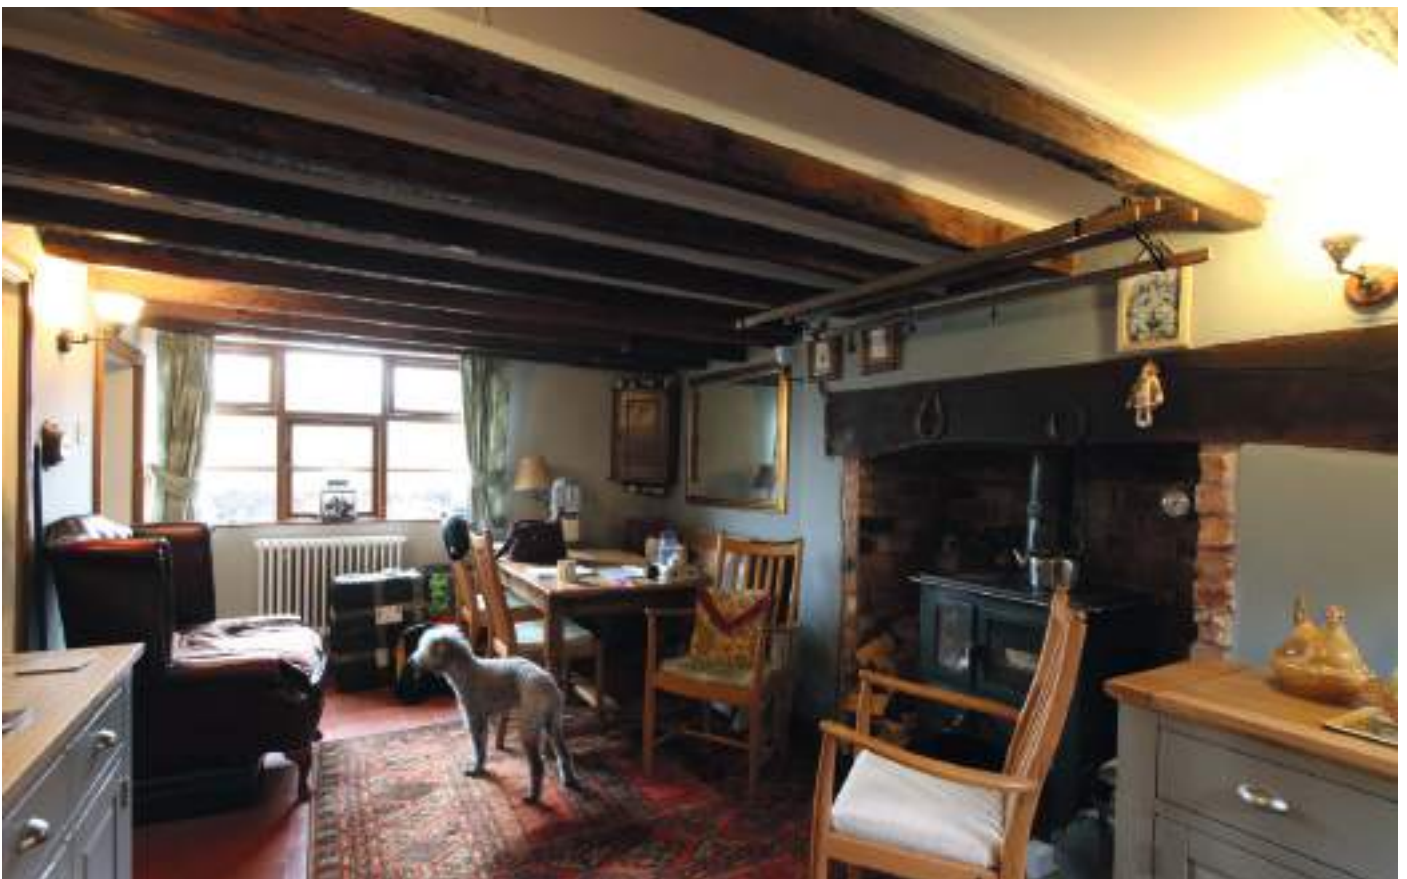
14. Dining Room to the 19th century bay. The hearth and timber lintel are modern and are a remodelling of a smaller hearth. The ceiling joists are pitch pine and 19th century.

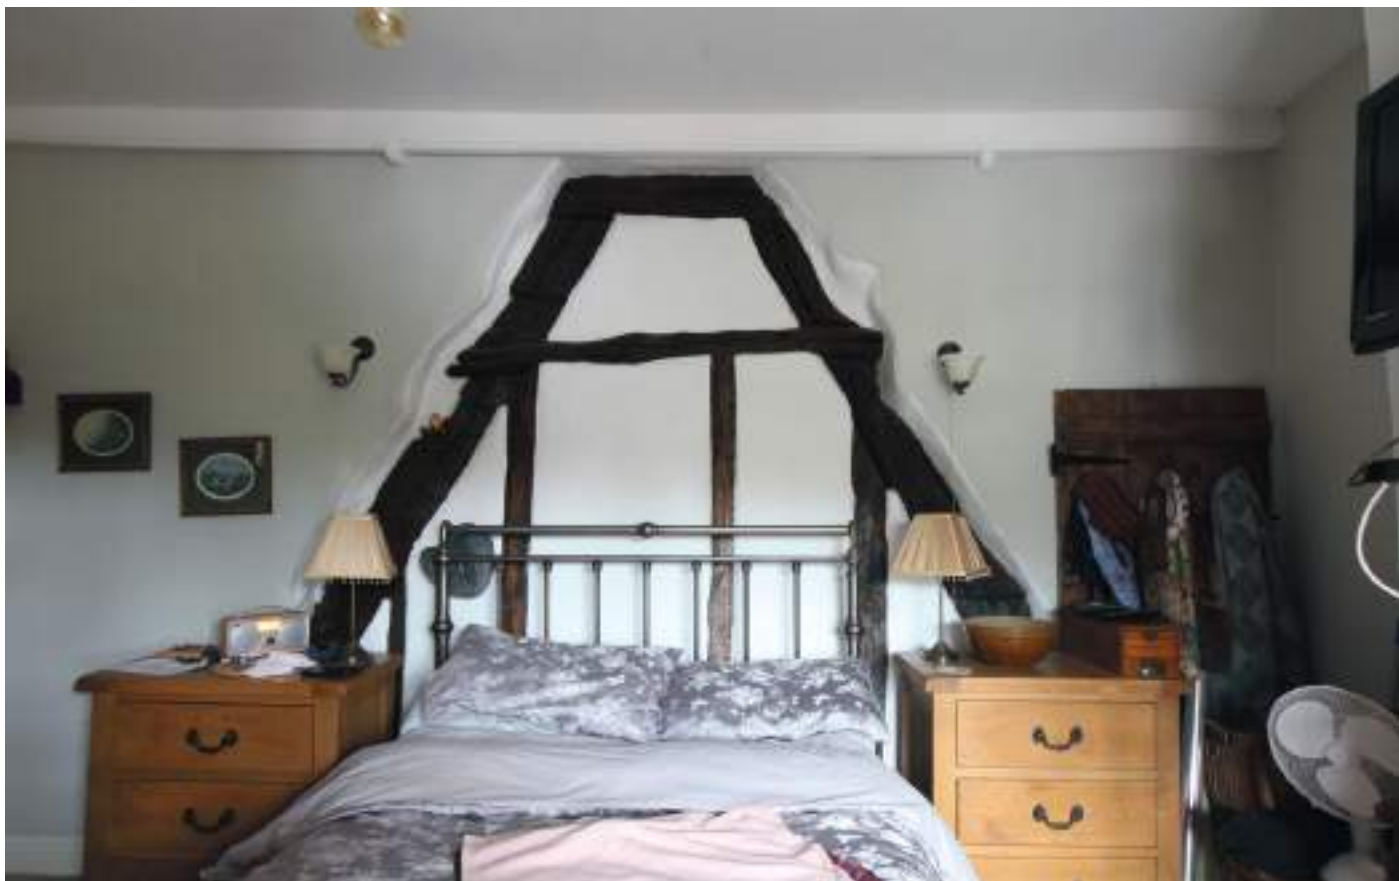
15, First floor - upper part of the cruck frame on the internal wall. This reveals that the dwelling was remodelled with a higher eaves to create a taller two-storey dwelling. The setting out of the timber studwork may represent the location of a first floor doorway. Spurs are visible at roughly the mid-point of each brace, which would reflect the original eaves level.

The party wall between Brook Cottage and Middle Cottage contains a cruck truss. This is the only one known to survive in the building. It seems likely that at least one other truss was located within the next bay, possibly the wall separating Middle Cottage from Yew Tree Cottage. This would have formed a two-bay building with the two bays now occupied by Middle Cottage and Yew Tree Cottage. The cruck is a Type C<sup>5</sup>, which is where the blades are held by a saddle or yoke carrying only a ridge-piece; there is no longer any sign of a ridge piece and it was probably removed during re-roofing; the upper blades of the cruck also contain the remnants of spurs, which may be part hidden in the remaining plasterwork and masonry. The cruck buildings of North Staffordshire lack adequate headroom for an upper floor, the main reason why most survive as a single cruck on a much raised inside wall<sup>6</sup>. The roof space was narrow and would have been large enough for attic storage only. Nevertheless, the cruck also contains clear evidence of a floor, with a middle rail or girding beam which can still be seen in the lounge wall, with three sockets for large beams which would have supported transverse joists. Whether these beams are situated on an internal cruck dividing two rooms or a closed cruck truss (the end wall of a building) is less clear. If they are located on an internal cruck, a whole bay of the 16<sup>th</sup> century building was demolished in order to make way for the masonry parlour wing. There is an incomplete sole plate to the base of the cruck, which may represent the end wall of a separate closed truss. The internal timber studwork within the wall is relatively lightweight and may represent an alteration.

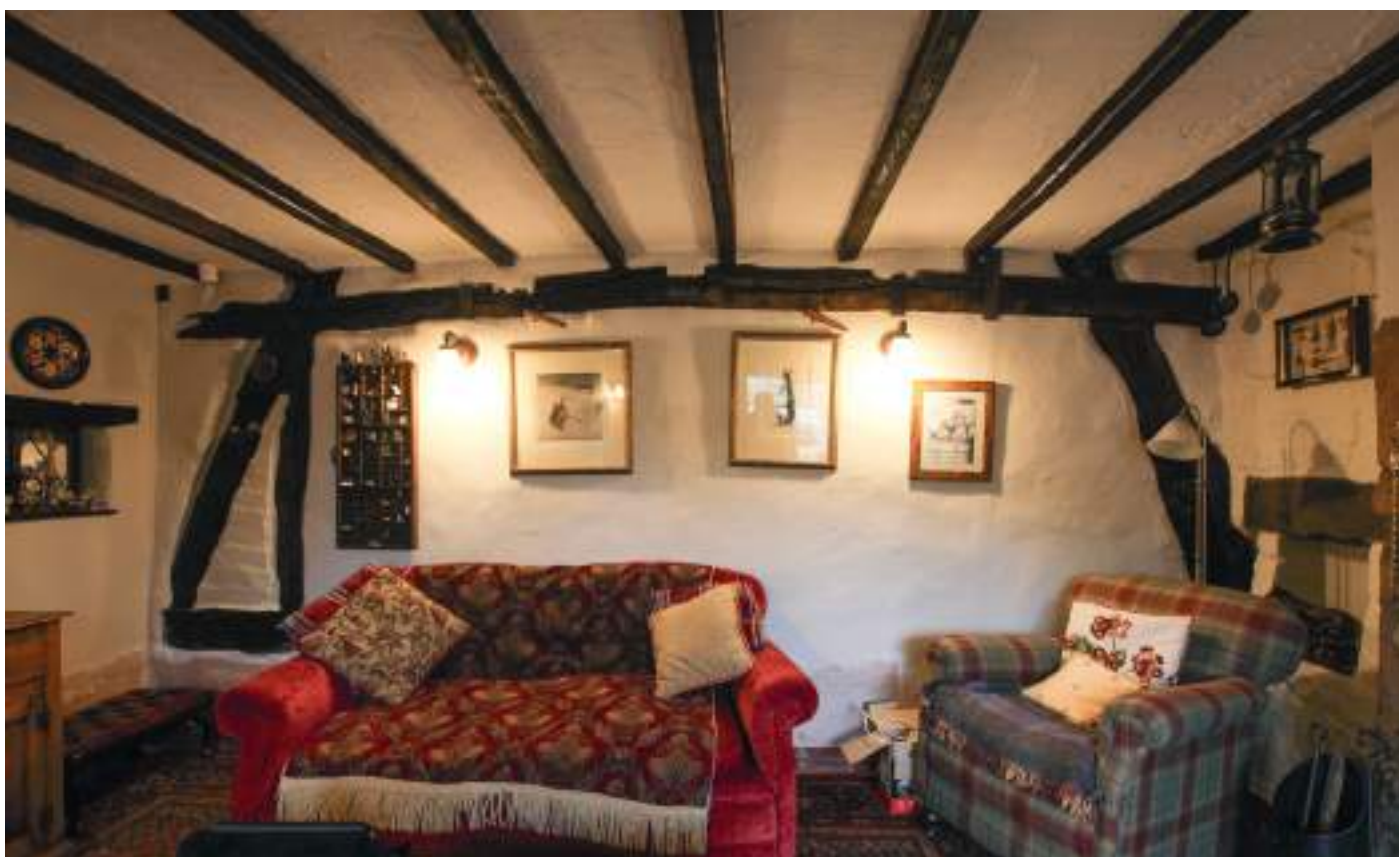
16. Lounge with lower part of cruck. The girding beam reveals the original ceiling height of the 16th century dwelling, which is not dissimilar to the current ceiling height, although these joists are probably 19th century. The alignment of the original three beams which ran across the girding beam is represented by the three sockets in the upper face of the girding beam. Whether this is the closed truss or an internal truss is unclear. If it was an internal truss the remaining 16th century bay was demolished in the 17th century and the 'wing' was aligned perpendicular to the 16th century range.
