# Heritage Statement and Impact Assessment

## Extension and internal alterations at Brook Cottage, Endon

Mel Morris Conservation has been appointed to prepare a Heritage Statement and Impact Assessment for a single storey extension to Brook Cottage, Endon, a grade II listed building.

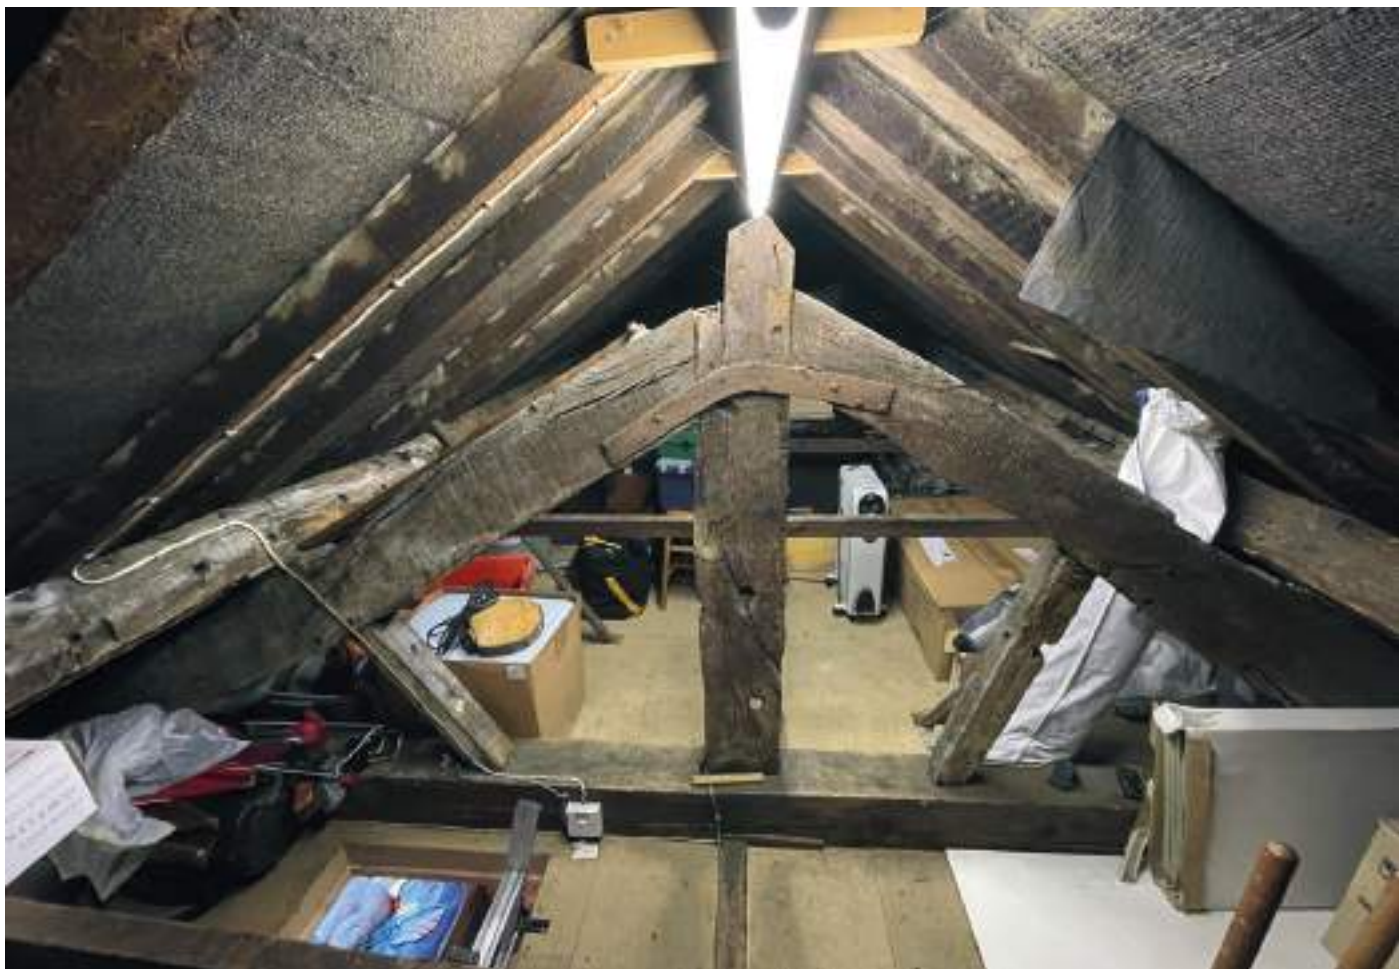
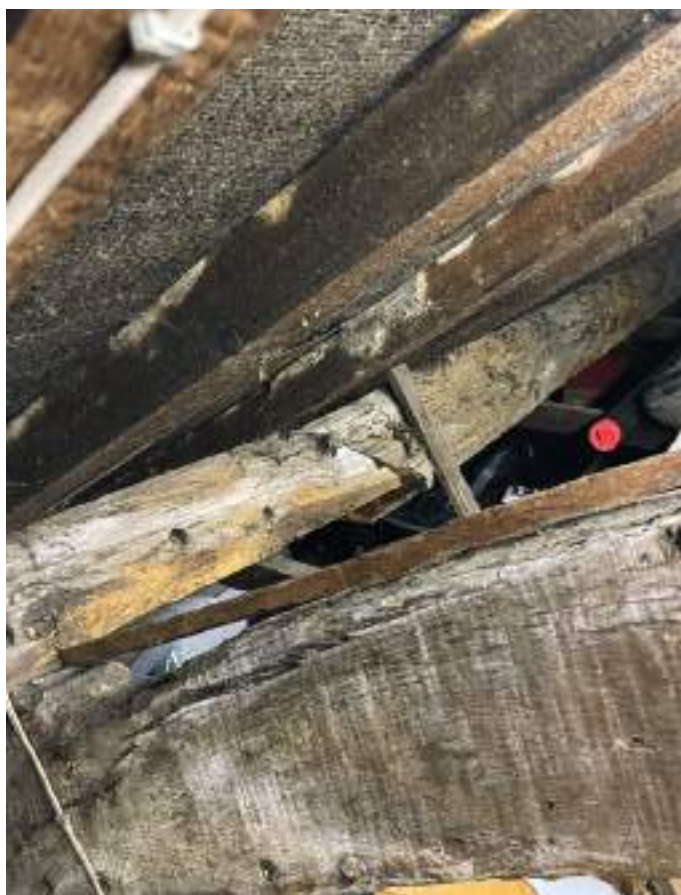
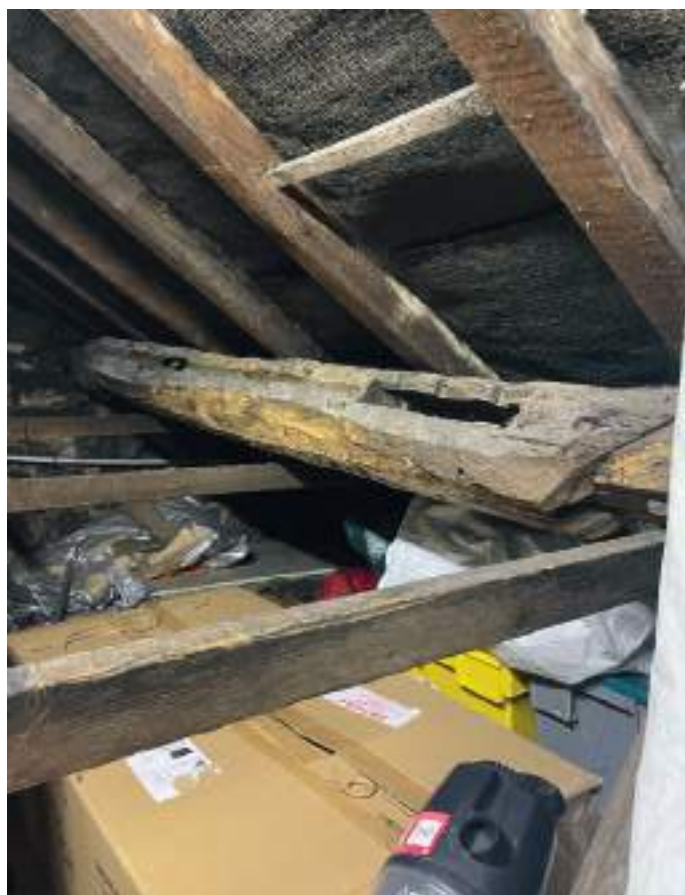
17-19. Roof truss of 17th century origin but re-used on this new alignment in the 19th century, with King post, adapted with the King post cropped at the base and a new tie beam added, along with a pair of raked struts. It is likely that the metal strap was added at the same time to prevent roof spread. Purlins (below) with off-set scarfed and tenoned joints. The purlin to the right is re-used with sockets for additional braces, possibly the remains of a former cruck blade or wall framing. The rafters are all modern (20th century) and the pitch of the roof appears to have been altered during re-roofing, possibly in conjunction with raising the end chimney stack.

The eaves and roof were altered at least twice; inside the roof space there is evidence that a 17<sup>th</sup> century truss has been re-purposed, cut down and remodelled to incorporate

a new tie beam, and that the original curved braces were removed and replaced with small straight struts; at the same time purlins were re-used with one purlin taken possibly from another cruck blade or part of a wall frame. It is not possible to provide a date for the remodelling but it is likely to be contemporary with this early to mid 19<sup>th</sup> century extension; at a later date the roof was altered again and new rafters were added and the ridge was taken slightly higher; this was carried out in conjunction with the remodelling of the eaves at the rear, with new, smooth red corbelled and dentilled brickwork; this was probably carried out at the same time that the gable fronting the street was rebuilt during the early 20<sup>th</sup> century.

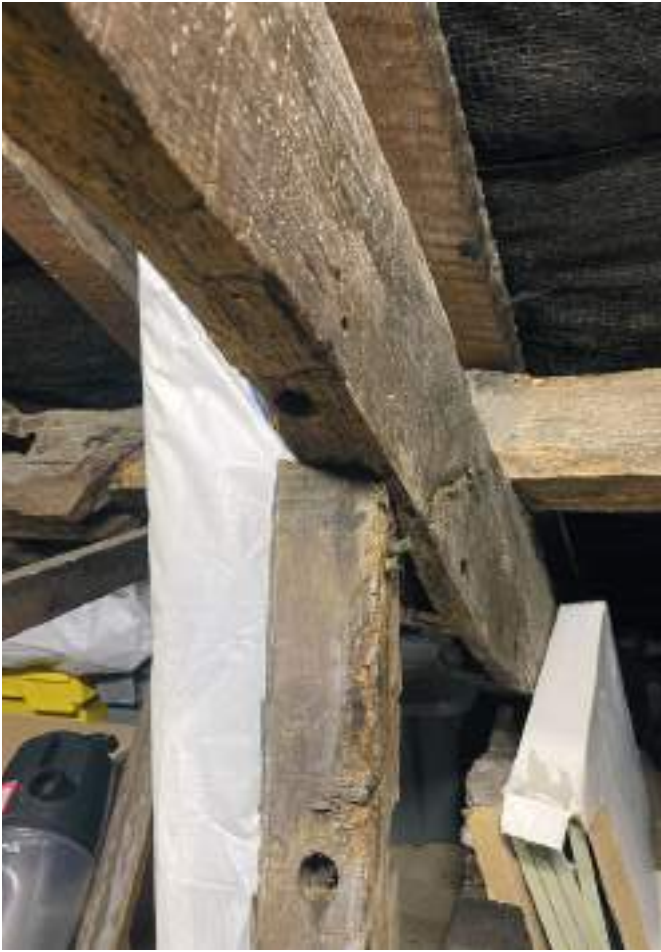
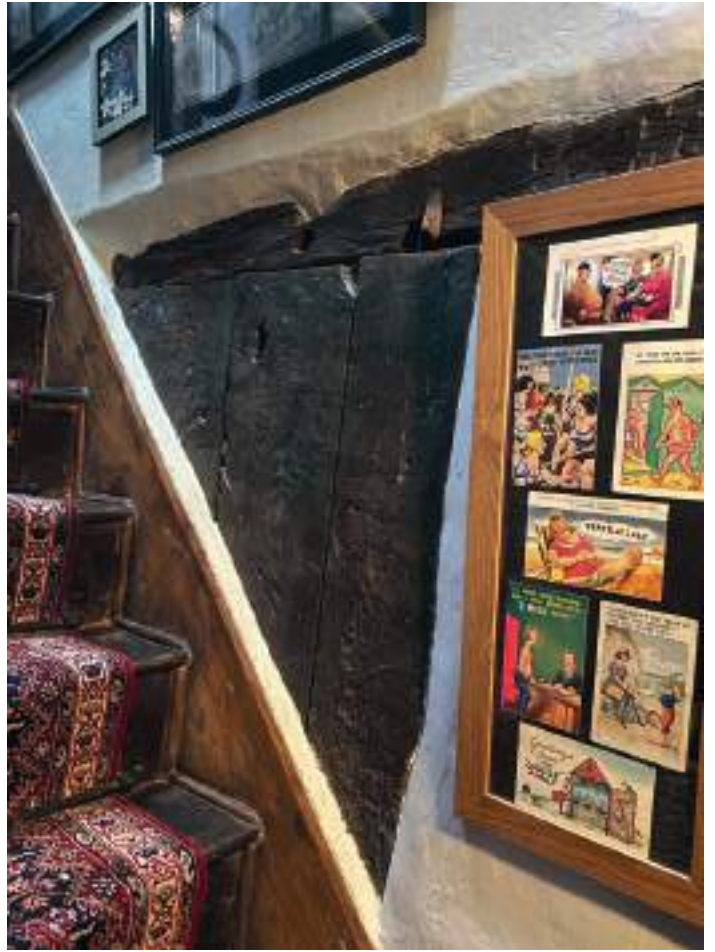
20 - above left. The soffit of the principal rafters to the truss have a 19th century oak strut. The two sockets on the underside are the remains of the mortices for two arched braces. Each of these was secured with oak pegs - peg holes can still be seen.  
 21 - above right - remains of oak boarding to the staircase wall and oak lintel with pegholes. The function of this boarding is obscure.

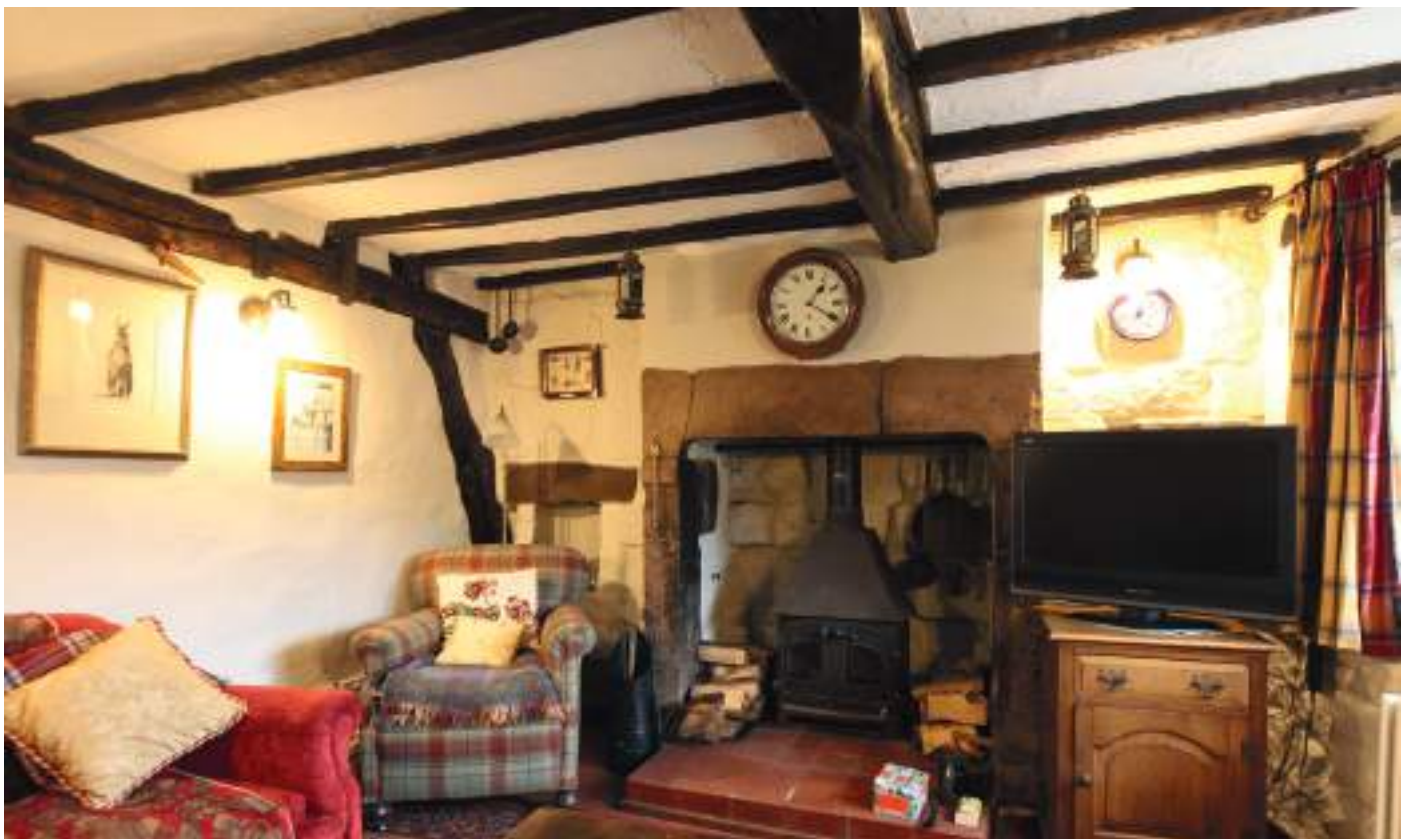
22. Lounge - view looking towards the hearth and the road. The massive spine beam appears to be 17th century but has been de-frased and any signs of adzed chamfers have been removed. The joists are later. The fireplace surround is simple with subtle blocking. The style of lintel with a depressed arch is found in the 17th century but the lack of any mouldings and the smooth face of the lintel and blocking to the jambs suggests it has been re-dressed.

The 17<sup>th</sup> century parlour wing contains the remains of a stone plinth, 17<sup>th</sup> century window and a hearth with a depressed arched lintel.

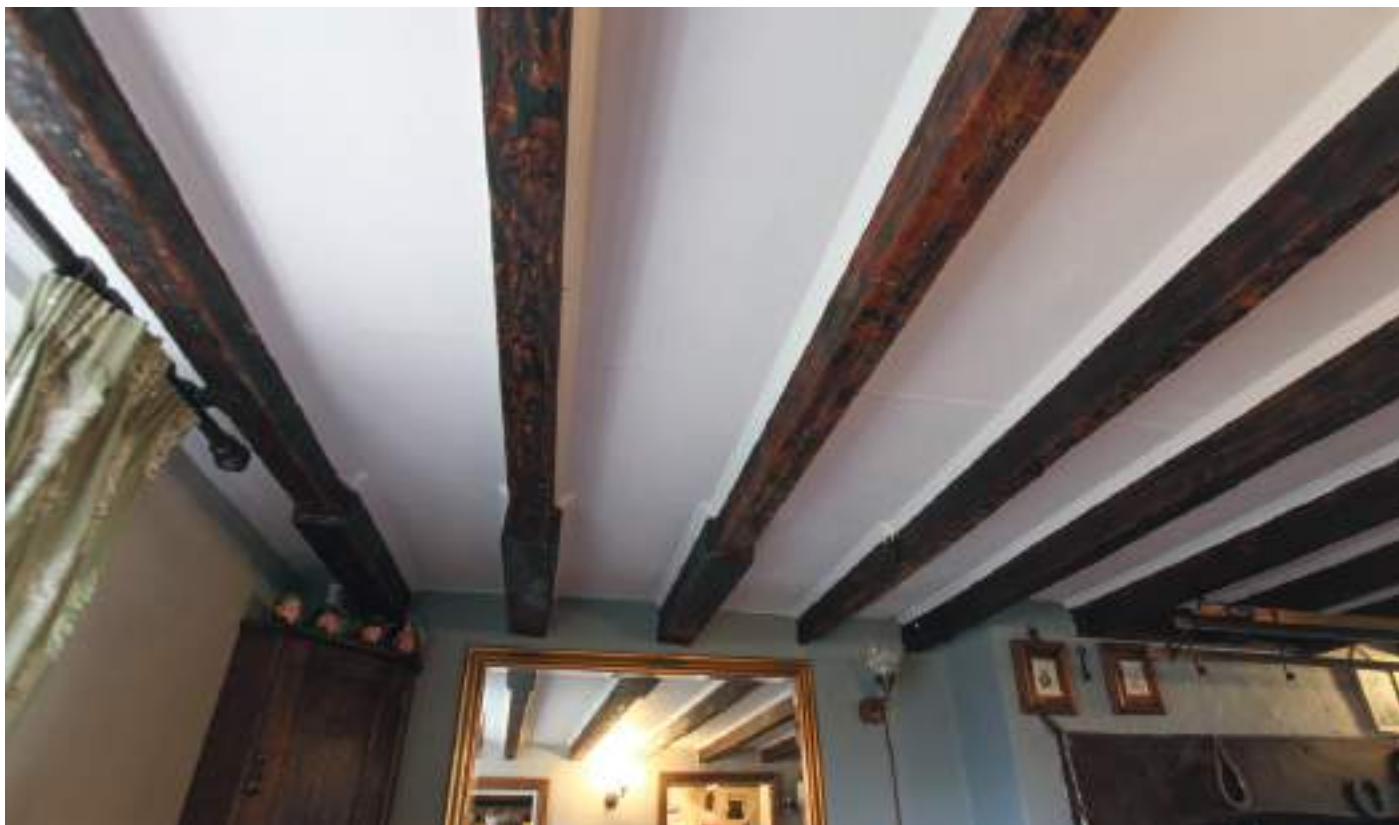
23. Ceiling joists to corner of Dining Room. These have been extended and / or repaired. The home owner says that a blocked doorway was found in this wall when the gable wall was re-plastered and these cropped joists may either reflect the location of a former internal lobby or the location of a former staircase.
