# IGN Structures

## Barn Survey & Structural Assessment

Knypersley Hill Farm, Lodge Barn Road, Knypersley

**Reference:** 25-025R\_001

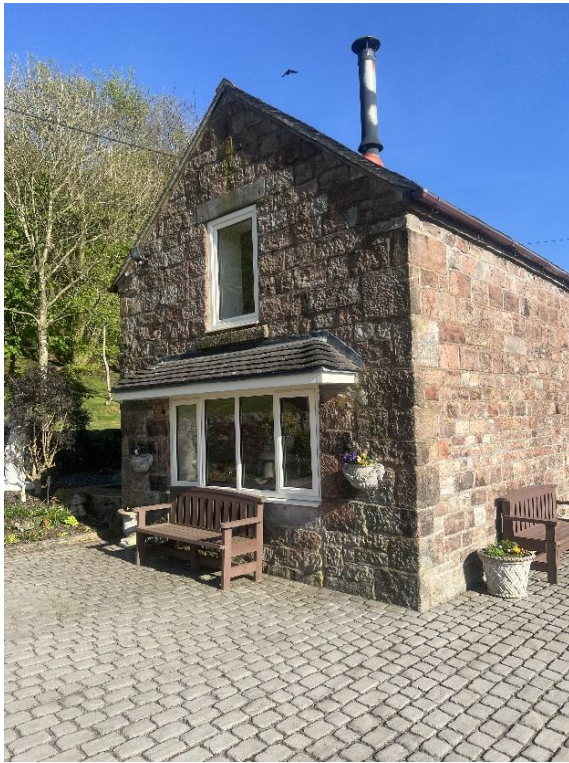
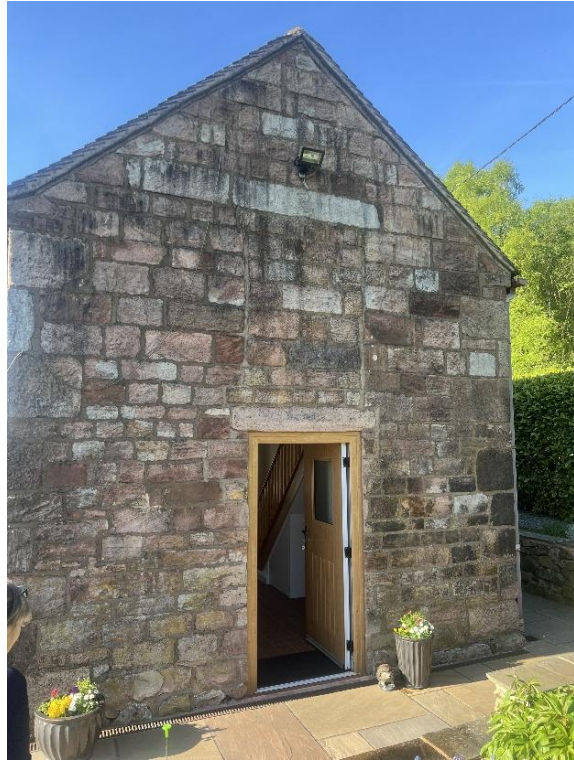
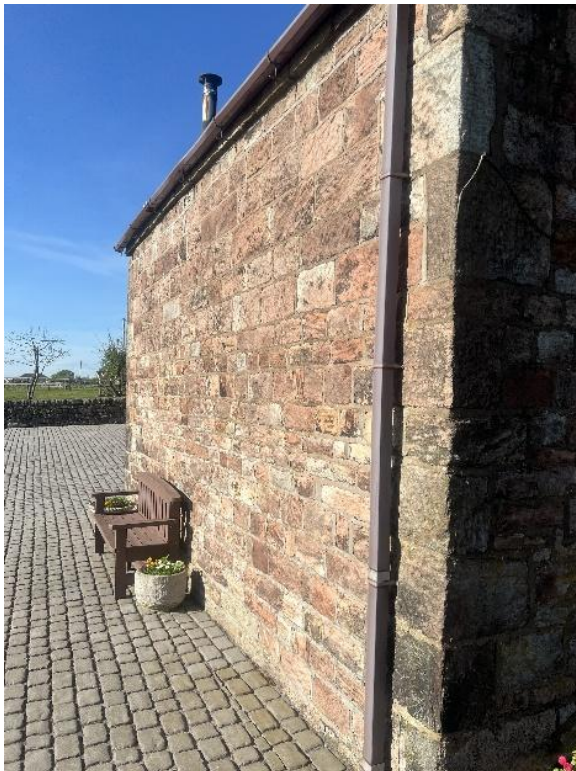
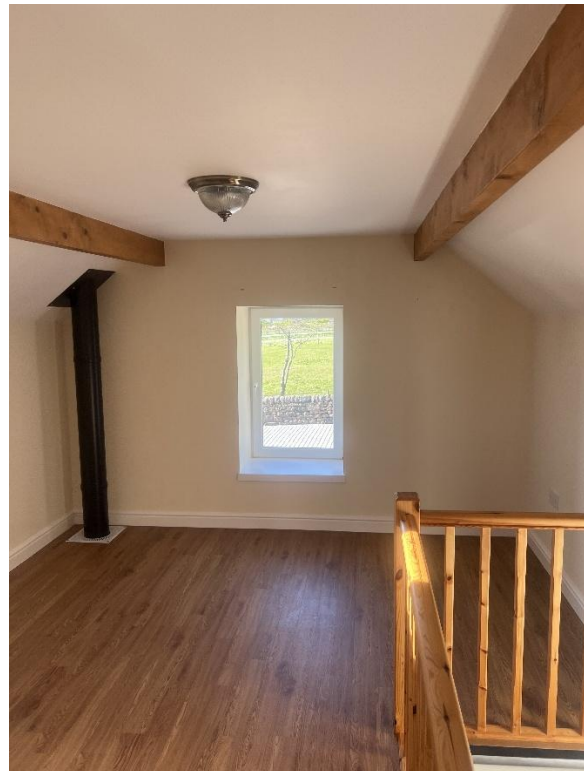
Appendix A

- 3.9 Photographs of the barn and its surroundings are included as Appendix A.
