## Coal Mining Risk Assessment

Victoria Business Park

Knypersley

**Report No. A7643/26/CMRA**

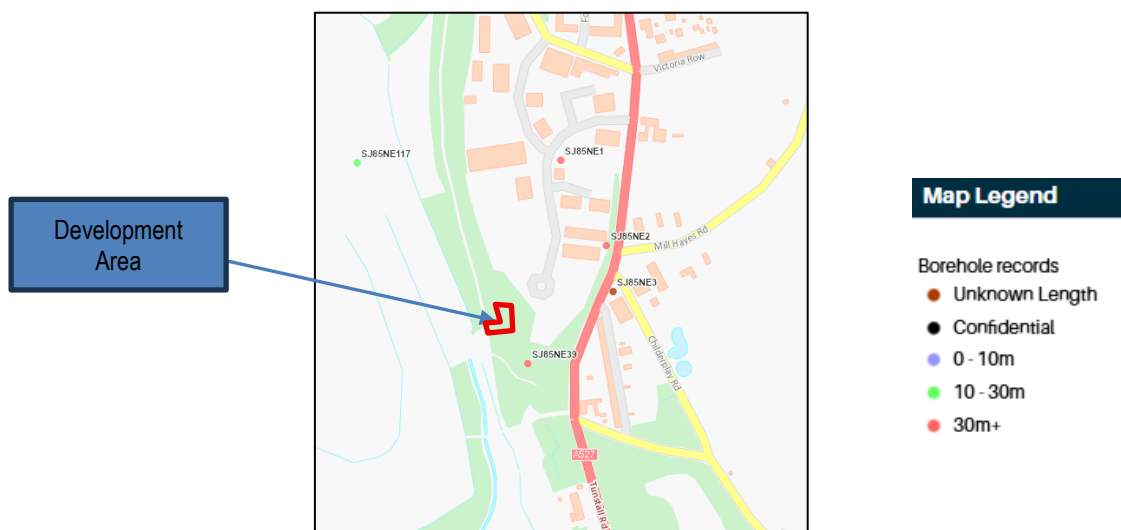
**Figure 4: BGS Borehole Location Plan**

- 3.12 There are several borehole records in the local area to provide information on the geology, as shown in Figure 4, and are summarised in Table 1.
- 3.13 The boreholes indicate a shallow rock layer to the north and east of the site, between 0.68 m and 1.82m and a deep rockhead of between 11.35m and 16.15m.

| Location | Total Depth (m) | Rockhead Depth (m) | Coal Seam Depth/Thickness (m) | Comments |
|---|---|---|---|---|
| | | | 60.88 (1.20) | Bowling Alley |
