PROJECT  
Moor Court Hall  
Farley Road  
Oakamoor ST10 3BD

MAIN HOUSE  
Detailed Ground Floor Plan

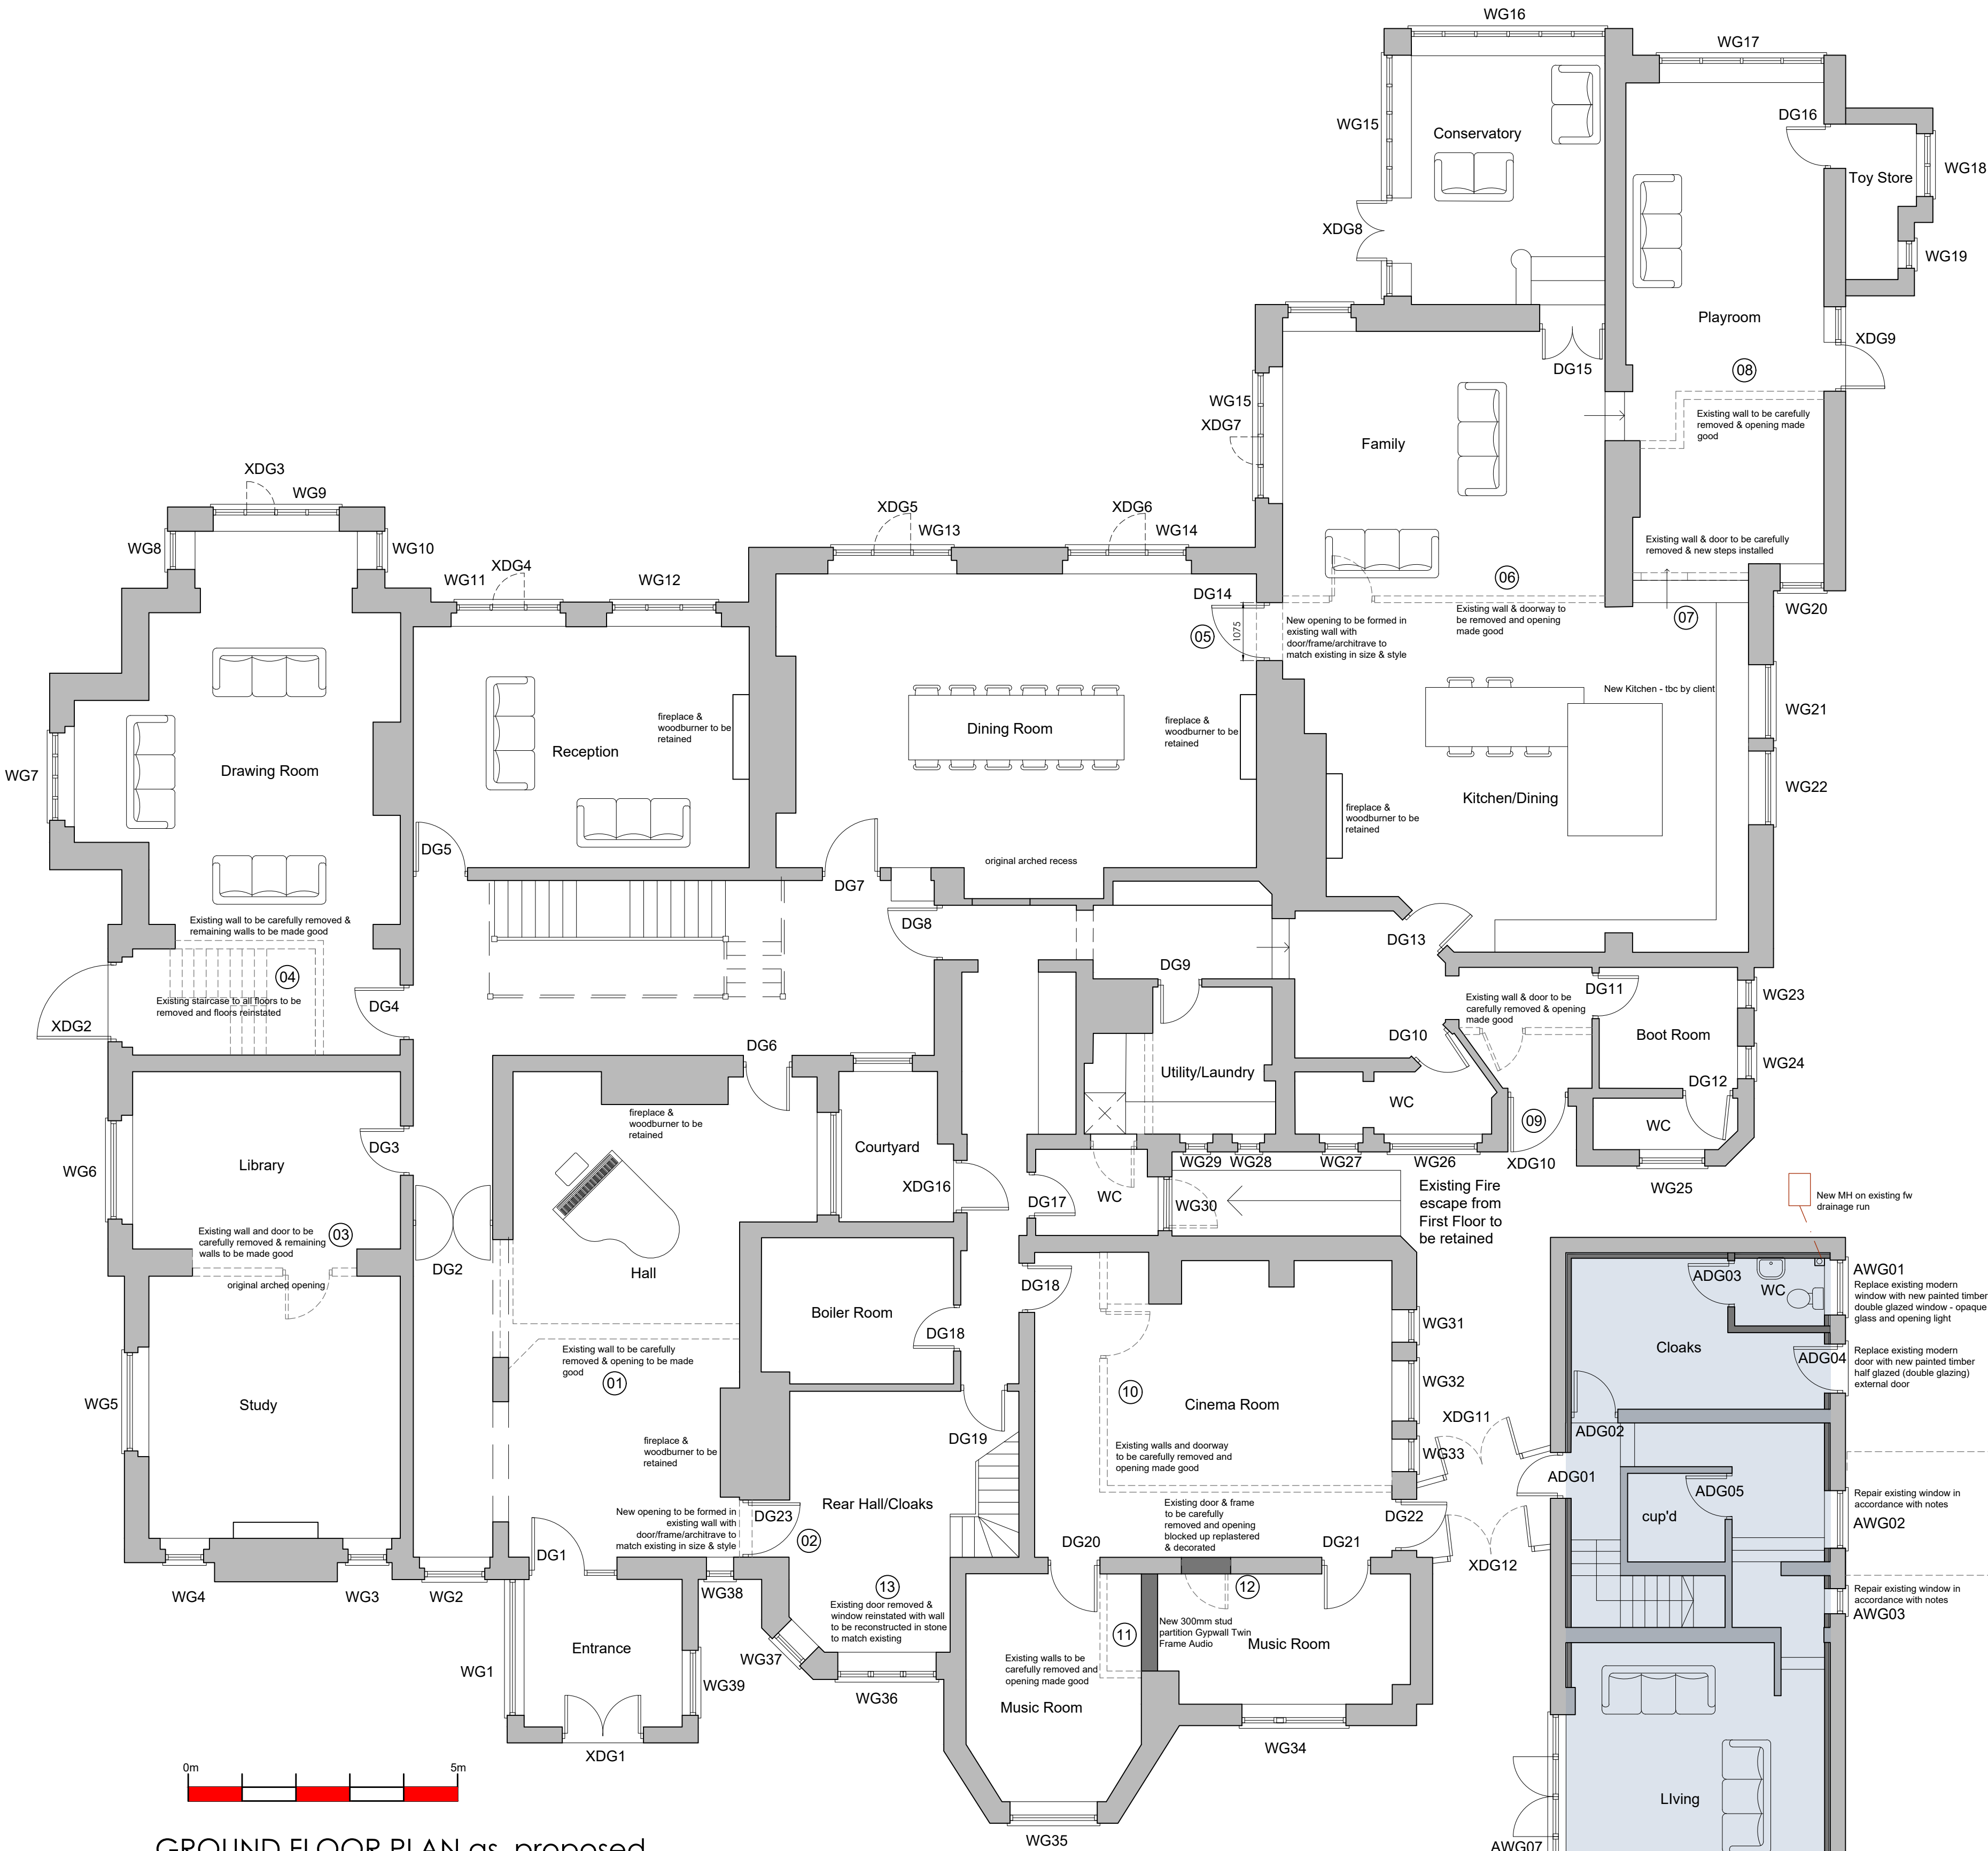
GROUND FLOOR PLAN as proposed

NEW NON-LOADBEARING STUD PARTITIONS

12.5mm British Gypsum Wallboard TEN either side.  
75mm x 38mm treated sw or metal studs at 600mm c/s.  
50mm Isowool partition roll within the cavity. Deflection head detail employed where required. All joints to be well sealed.

EXTERNAL WINDOWS & DOORS

Existing windows & doors to be stripped back and repaired as required ensuring all openings are functioning. Where rebates allow re-glaze with Histoglass D12 or similar approved sealed double glazed heritage units (12mm thick).

LOCALISED ROOFING REPAIRS

**Pitched Roofs**  
Clean/Clear valleys/gutters of all debris/vegetation  
Replace damaged/broken/shaling tiles with reclaimed roof tiles to match existing.  
Localised repair to torching to underside of tiling where necessary.  
Re-point mortar where it has become detached in sloping valleys using lime mortar.  
Replace cement mortar with lime mortar where inappropriate repairs have been carried out.  
All repairs to mortar to be carried out using lime mortar.

**Flat Roofs**  
Clean/Clear all debris/vegetation from roof surface and gutters.  
Replace self-adhesive flashings with new lead flashings for longevity.  
Repair bitumen type flat roof finishes/upstands where necessary.

**Chimneys**  
Clean/Clear all debris/vegetation from chimney stacks and cowl.  
Where mortar haunching is cracked/deteriorating replace with lime mortar haunching.  
Any open joints to the chimney stacks to be re-pointed using lime mortar  
Lead flashings appear to be in reasonable condition but should be inspected and repaired/replaced if necessary.  
Any uncovered metal cowls to be replaced with covered metal cowls to prevent moisture ingress whilst maintaining ventilation.  
All repairs to mortar to be carried out using lime mortar.

STONE REPAIRS

Minor cracking to stonework is to be monitored.  
Re-pointing to be carried out where necessary/where mortar joints have opened, using lime mortar.
