GEO-ENVIRONMENTAL SITE ASSESSMENT MOUNT ROAD, LEEK

REC REFERENCE: 100693p1r2

REPORT PREPARED FOR: GREEN GATE HOMES (NW) LTD

AUGUST 2016

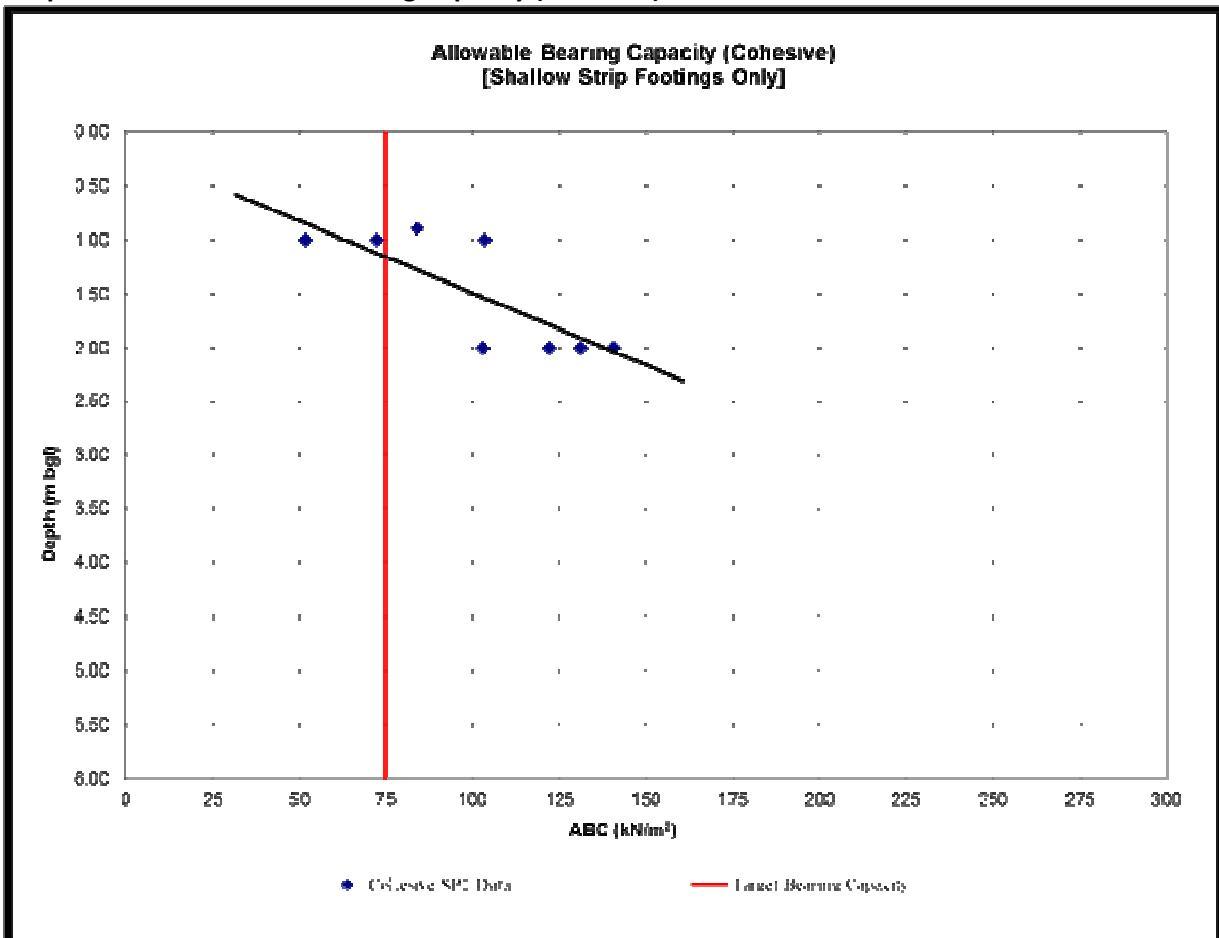
An assessment of the Allowable Bearing Capacity (ABC) for cohesive strata at the site has been undertaken using data obtained from in-situ SPT tests. The results of the tests have been plotted as Allowable Bearing Capacity (ABC) for a strip foundation against depth and are shown on Graph 10.1 overleaf.

As can be observed from the Graph, the ABC's generally increase with depth across the site, with an average bearing capacity of 72kN/m² anticipated at a depth of between 1.00m and 1.45m bgl.

Standard strip foundations are considered suitable for the development (when using an assumed line loading of 75 kN/m²); however deep trench fill foundations, or other alternative foundation solutions, may be required for plots within the influencing distance of existing and proposed trees, an assessment of tree influence should be made in accordance with NHBC standards..

When taking into account both the anticipated bearing capacity and volume change potential, a preliminary assessment would indicate that a minimum foundation depth of 1.50m bgl should apply, with the foundations deepened to key into the target stratum of stiff, high strength clay.
