Bat and Barn Owl Survey and Report

GREEN FARM

Jonathan Ayres CEnv MCIEEM FLS | 17/05/2018

Document title: Bat and Barn Owl Survey, Green Farm

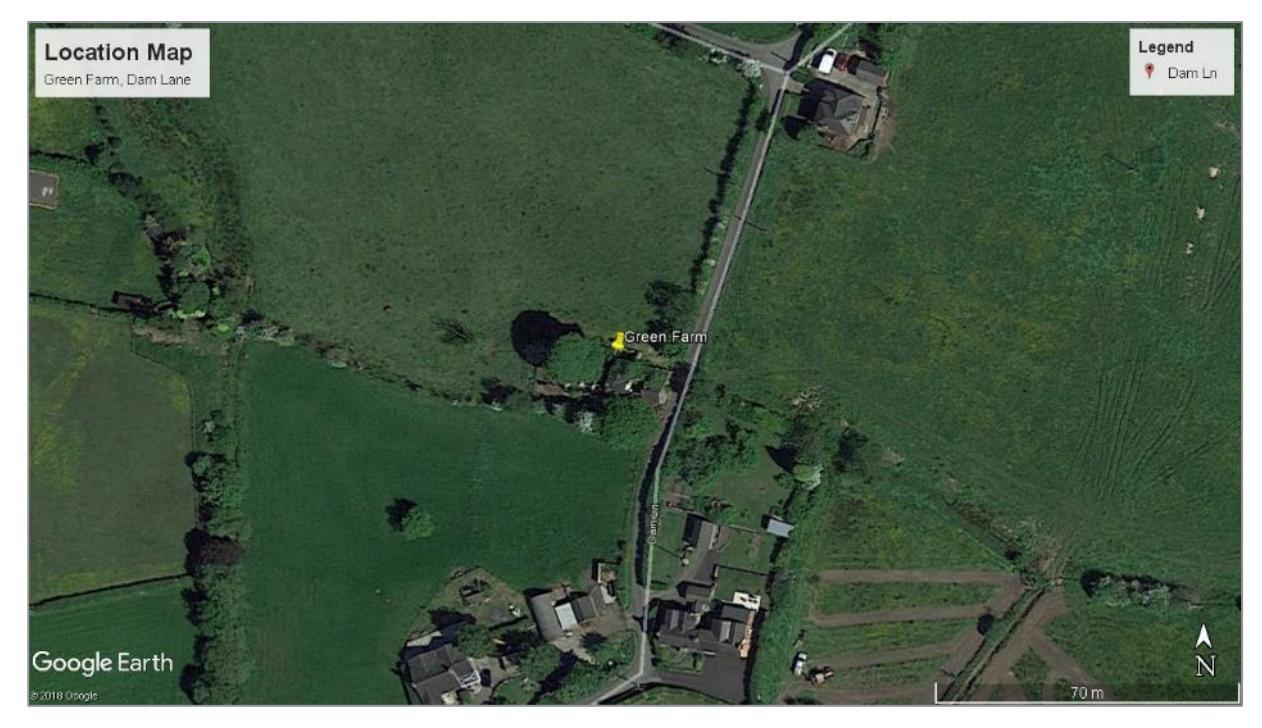
Figure 1 – Existing Site Layout and Surrounding Habitats

The building is situated in a rural location to the north of the village of Biddulph Moor. The site consists of three disused farm buildings a main farmhouse and two smaller outbuildings, none of the buildings have been occupied since the 1960's and are in disrepair, a mature oak and sycamore are present within the site along with associated hard standings and an unmanaged line of hedgerow trees. The wider landscape is dominated by sheep grazed paddocks, hedgerows link the site to the wider area and to the far west is a tree lined watercourse.

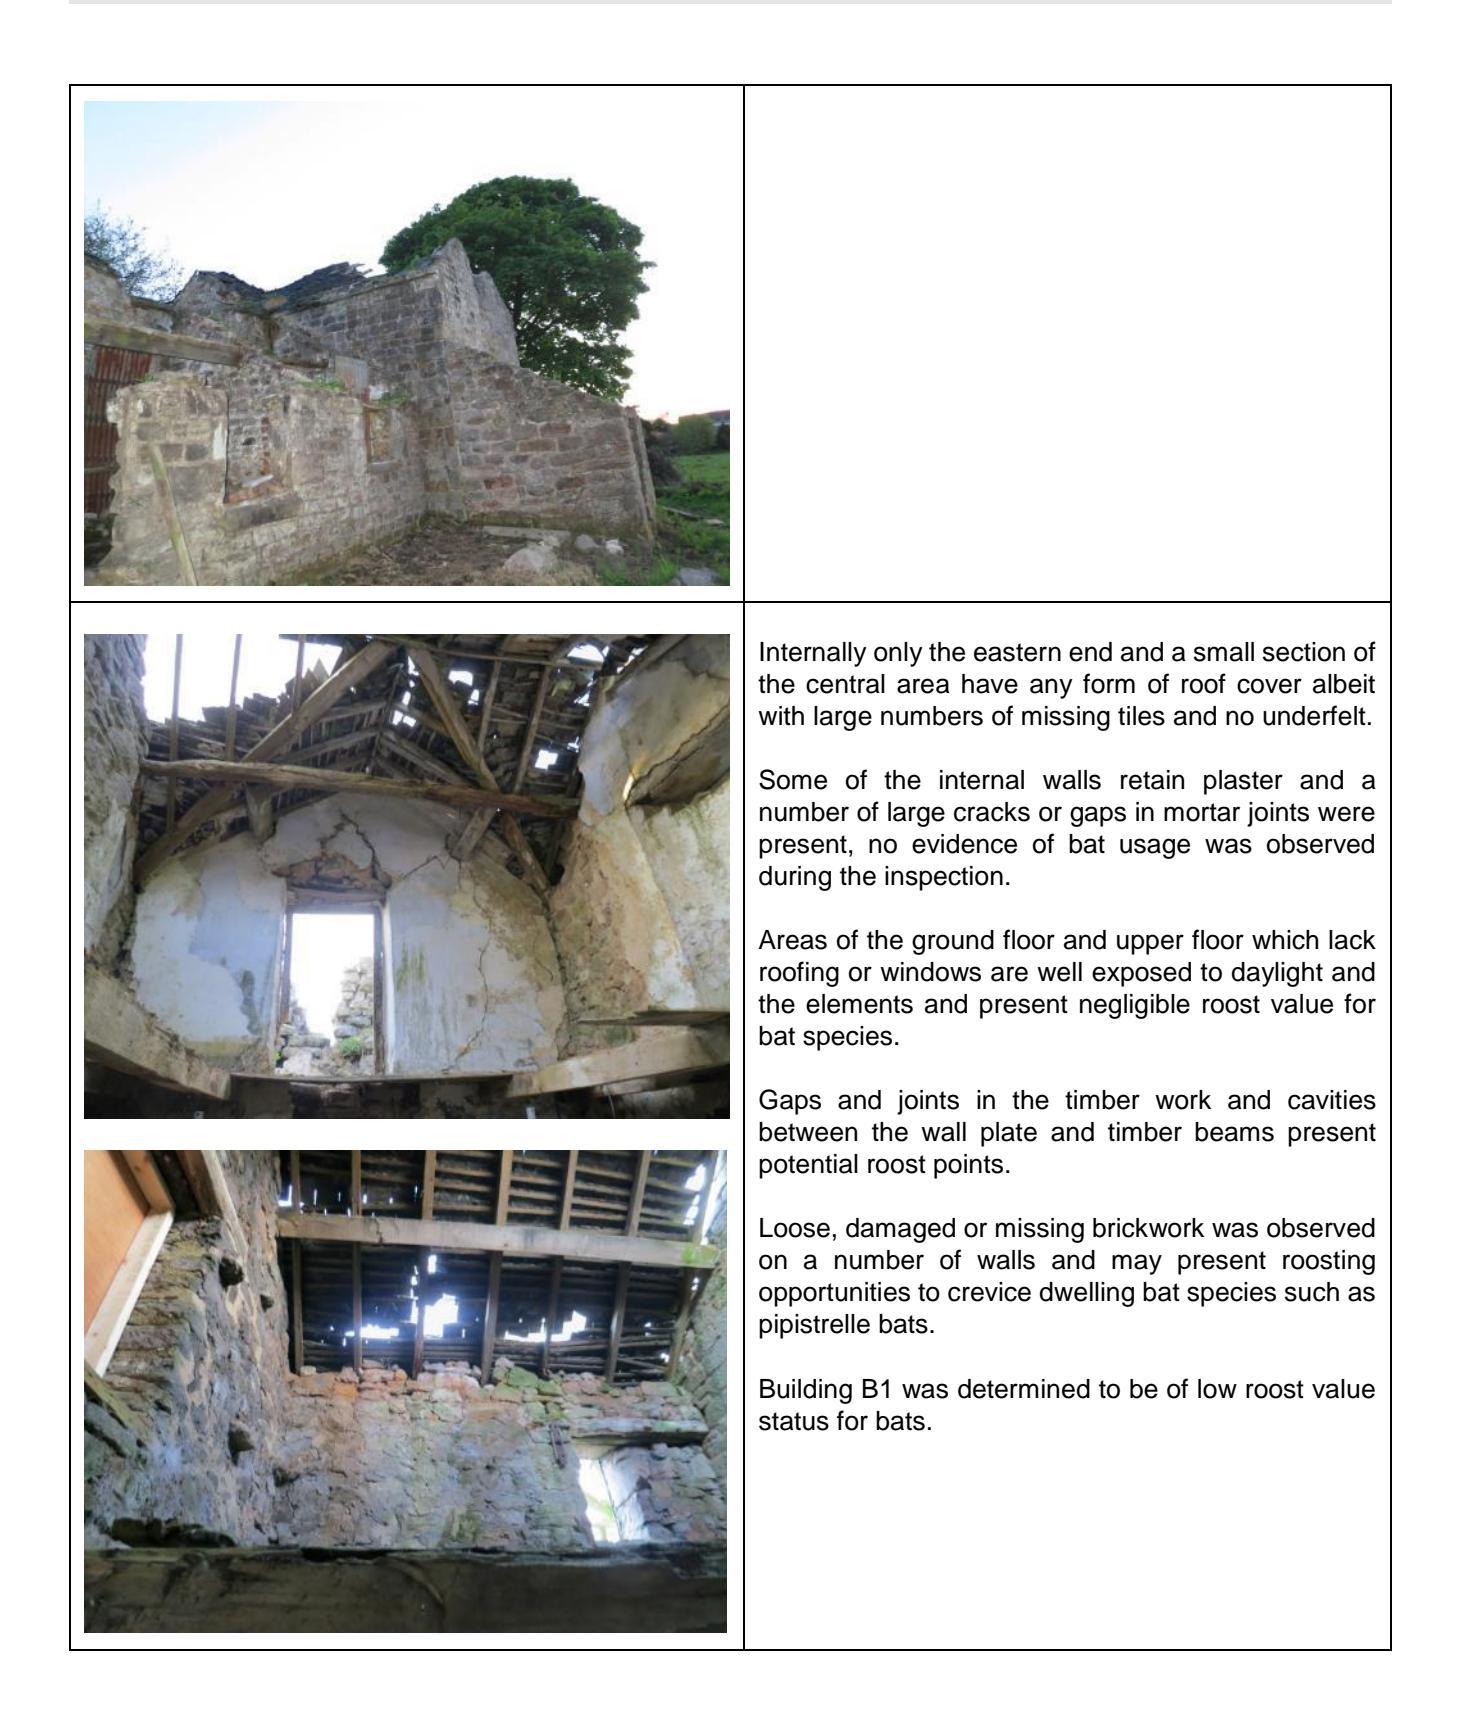
| Photograph | Description |
|---|--|
| | The main building (B1) a derelict house located adjacent to a field of improved grassland. The building is in a poor condition having suffered from a lack of maintenance for an extended period of time. A number of external and internal walls are missing and no windows or doors are present and only 10% of the roof is remaining. The age and construction of the building lack modern insulated wall cavities or soffits, numerous large cracks occur within the blockwork and within missing mortar. The majority of the upper floor lacks roofing and is |
| | therefore well lit by natural daylight and open to the elements reducing the favourability for bat roosting. |

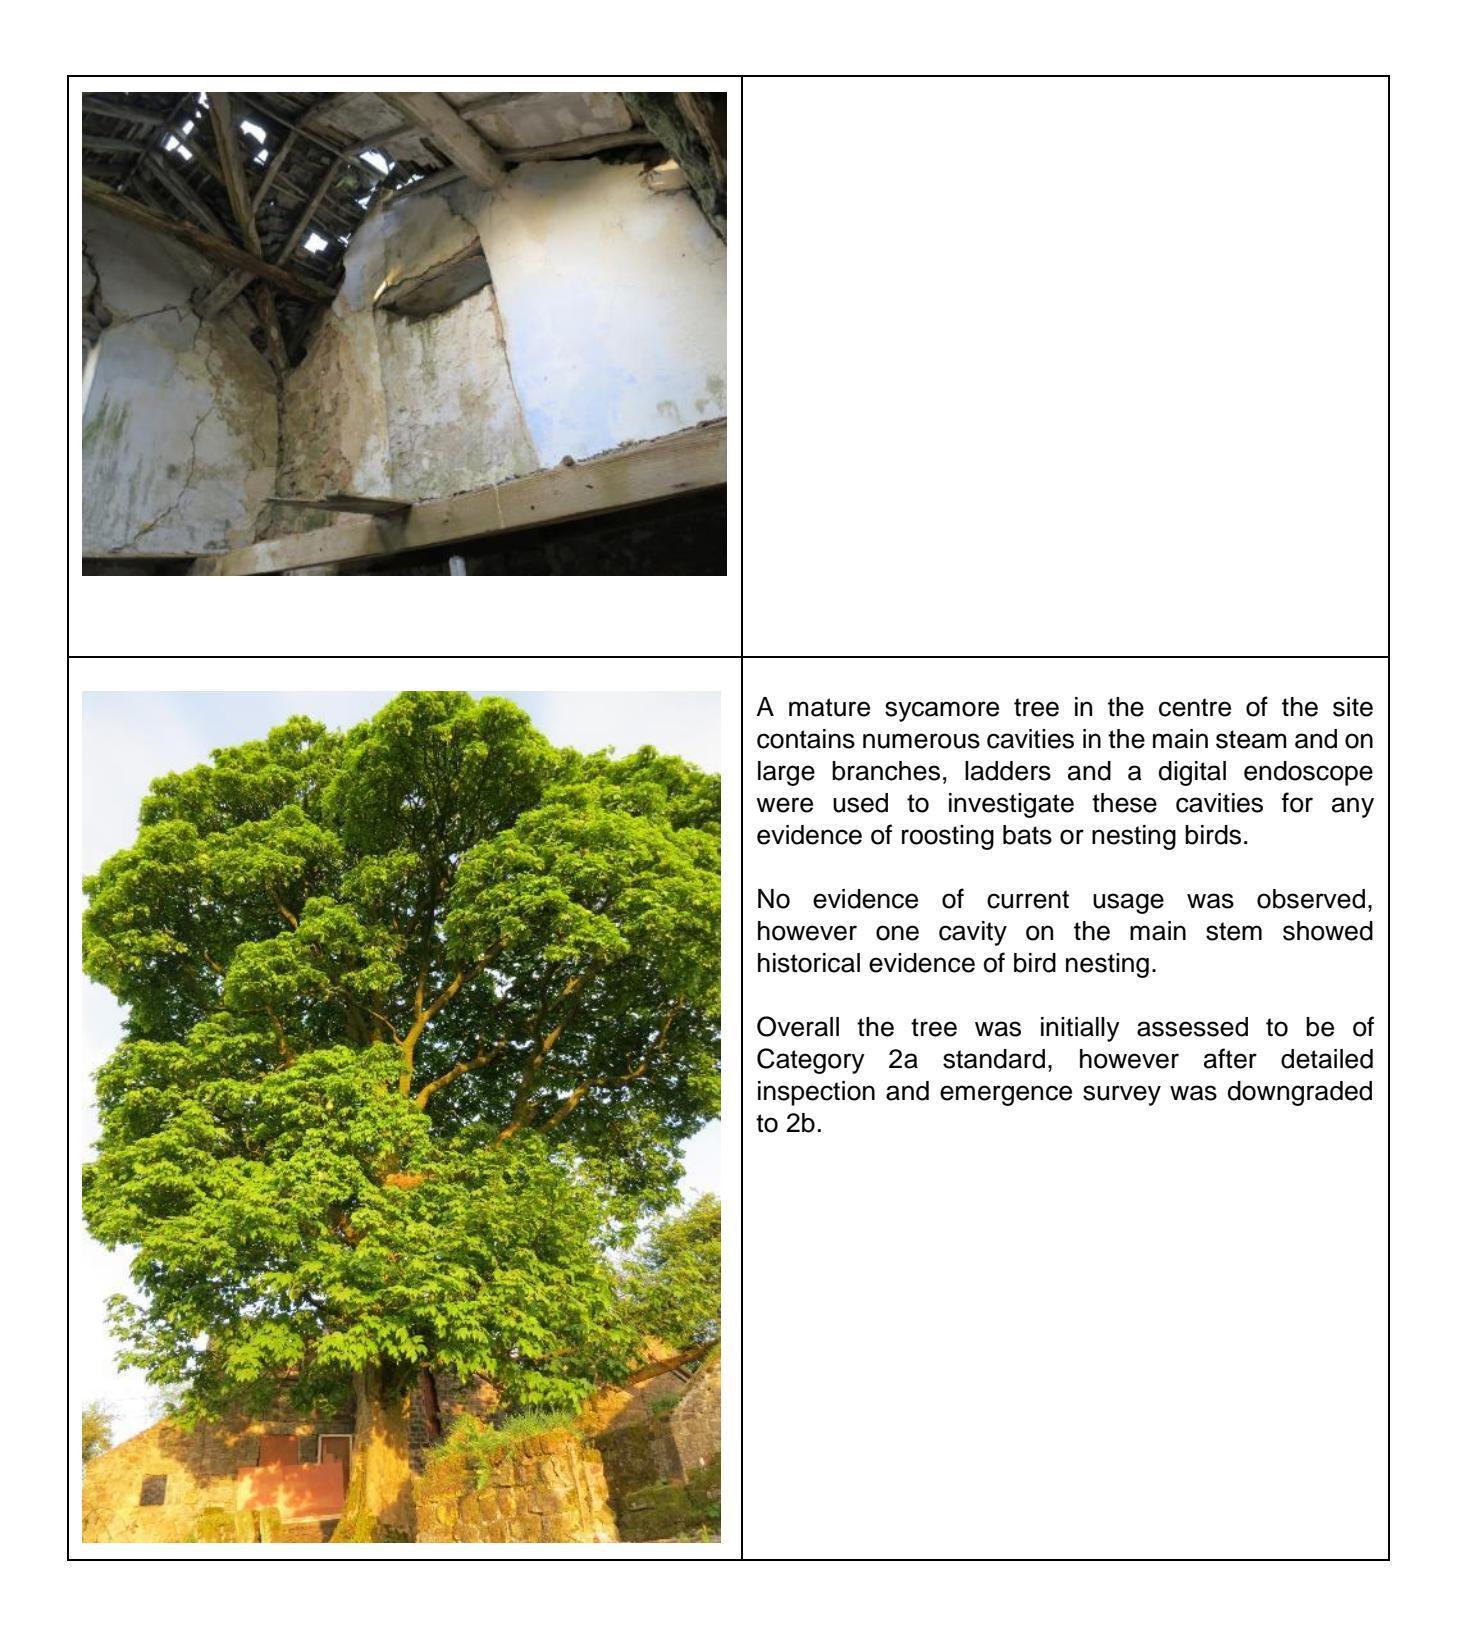
| Photograph | Description |
|---|--|
| | The section of roof to the south-eastern side of the house still has a small number of unlined ridge and roof tiles in place and a chimney, all of which are potential roosting areas for bats typically pipistrelle species. Other potential roost areas include missing brickwork, gaps between roofing and wall plates and timber work. The northern and western elevations of the building are in extreme disrepair and have largely collapsed and lack any roof cover. |

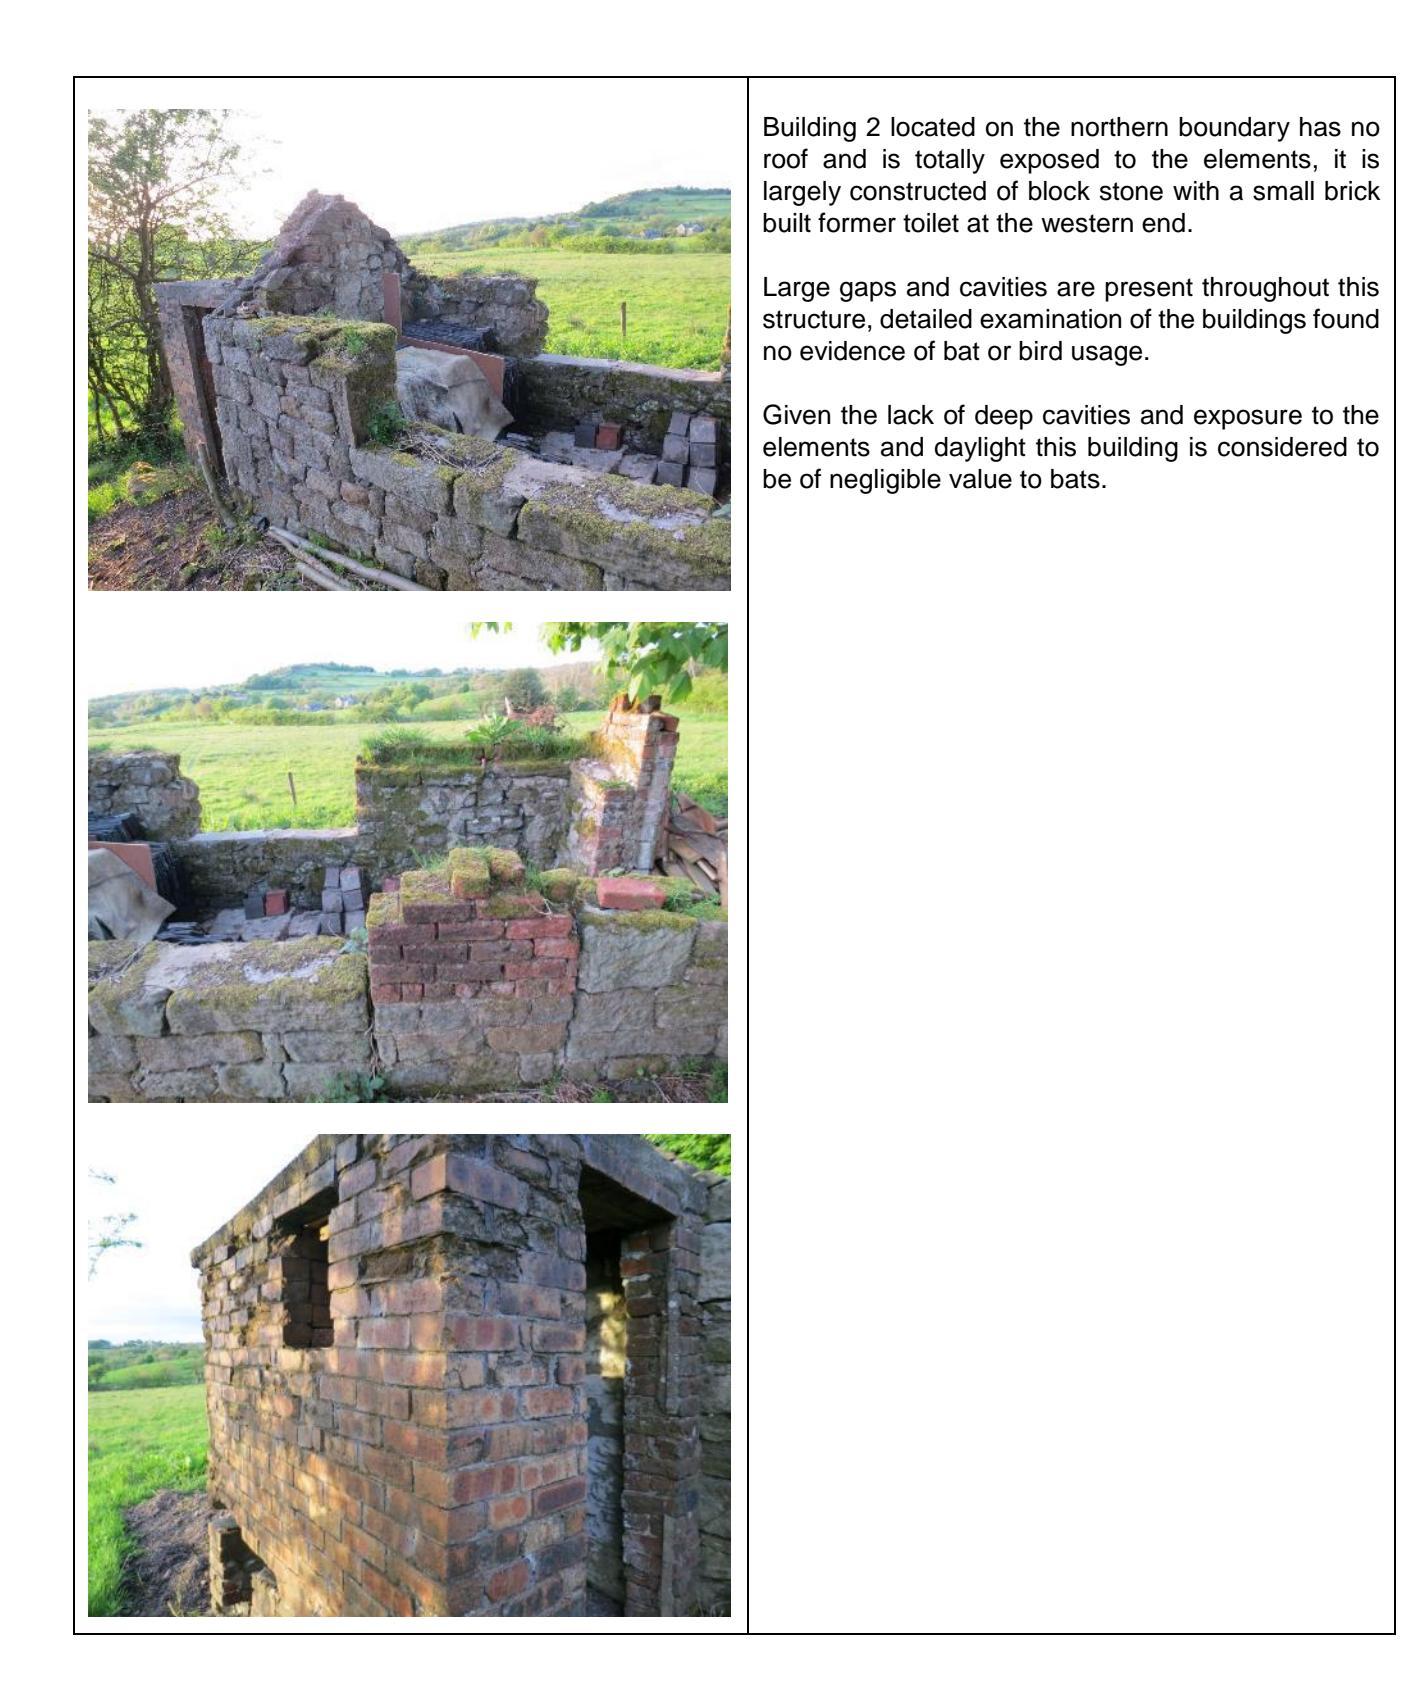
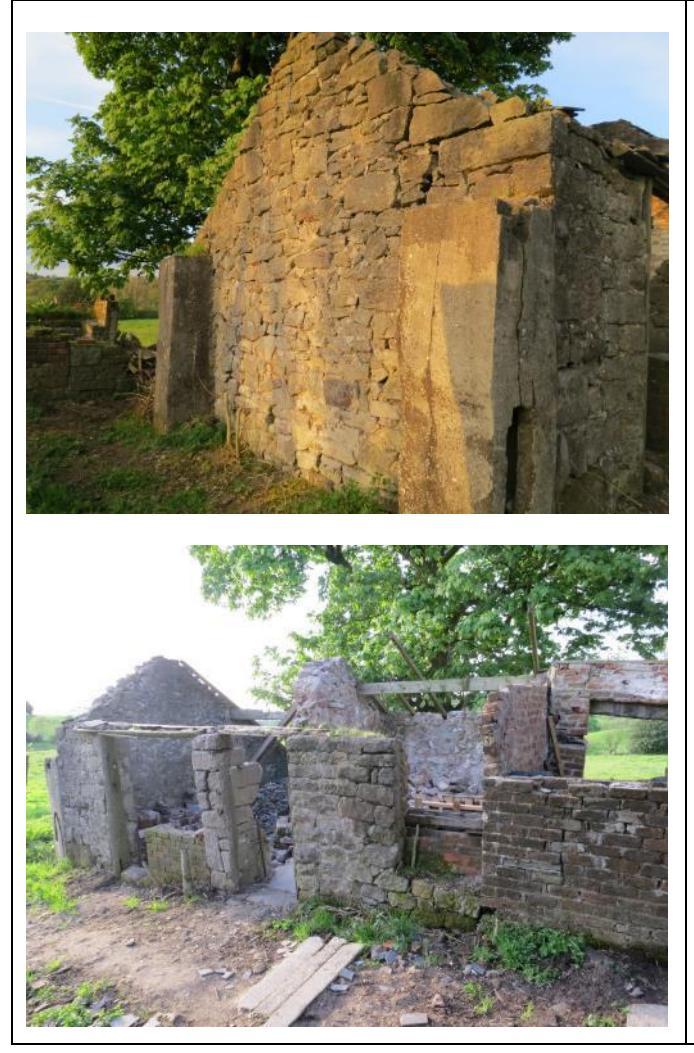
Building 3 is in a poor state of repair with no roof covering and lacking any doors or windows making the interior section open to the elements and high levels of natural light.

The building is a mix of block and brick construction, large parts of which have collapsed and contain numerous large gaps and cracks.

No evidence of bat or breeding bird usage was observed during the detailed examination and due to the exposed open nature of the structure it was determined to be of negligible value to roosting bats.

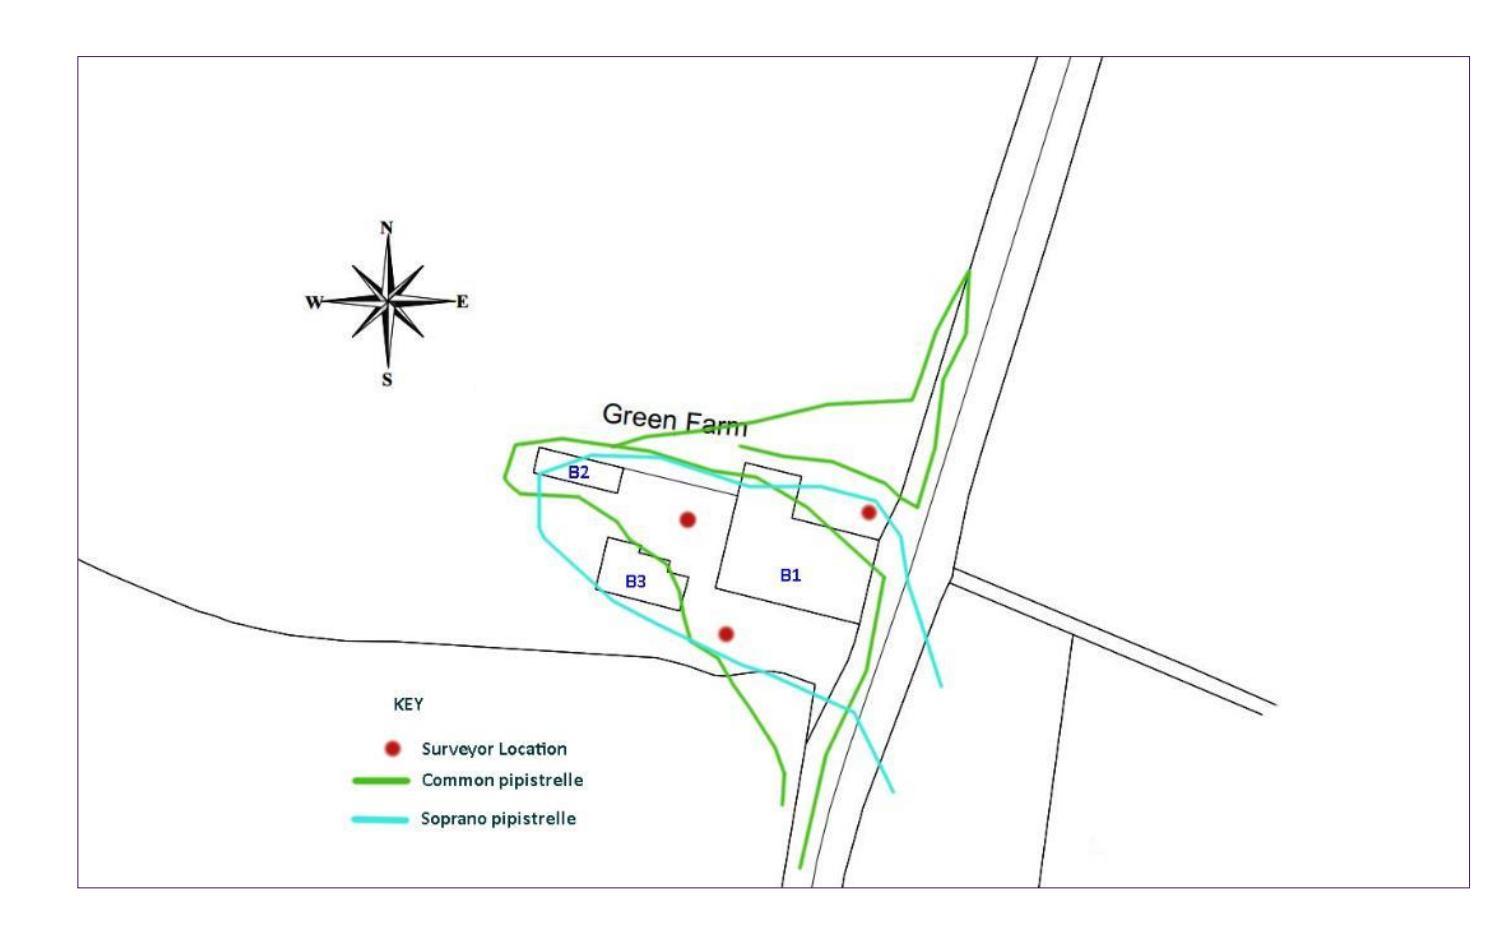
Appendix B. Bat Flight Routes During Emergence Survey

| Dusk Emergence | 21:28 - a single common pipistrelle bat was observed from the south heading north along Dam Lane and west over the site. 21:36 - a single soprano pipistrelle was seen heading north along Dam Lane and continued west across the site. |
| Foraging and Commuting | The single common pipistrelle continued to forage over the site until the end of the survey, foraging passes were observed around the large sycamore and over the hedgerows to the north and south of the site, the bat also used Dam Lane moving north and south along the lane and over the house and gardens to the south of the site. The single soprano pipistrelle was observed foraging over the site following a similar pattern to the common pipistrelle, social calls between the two bats were observed in the |

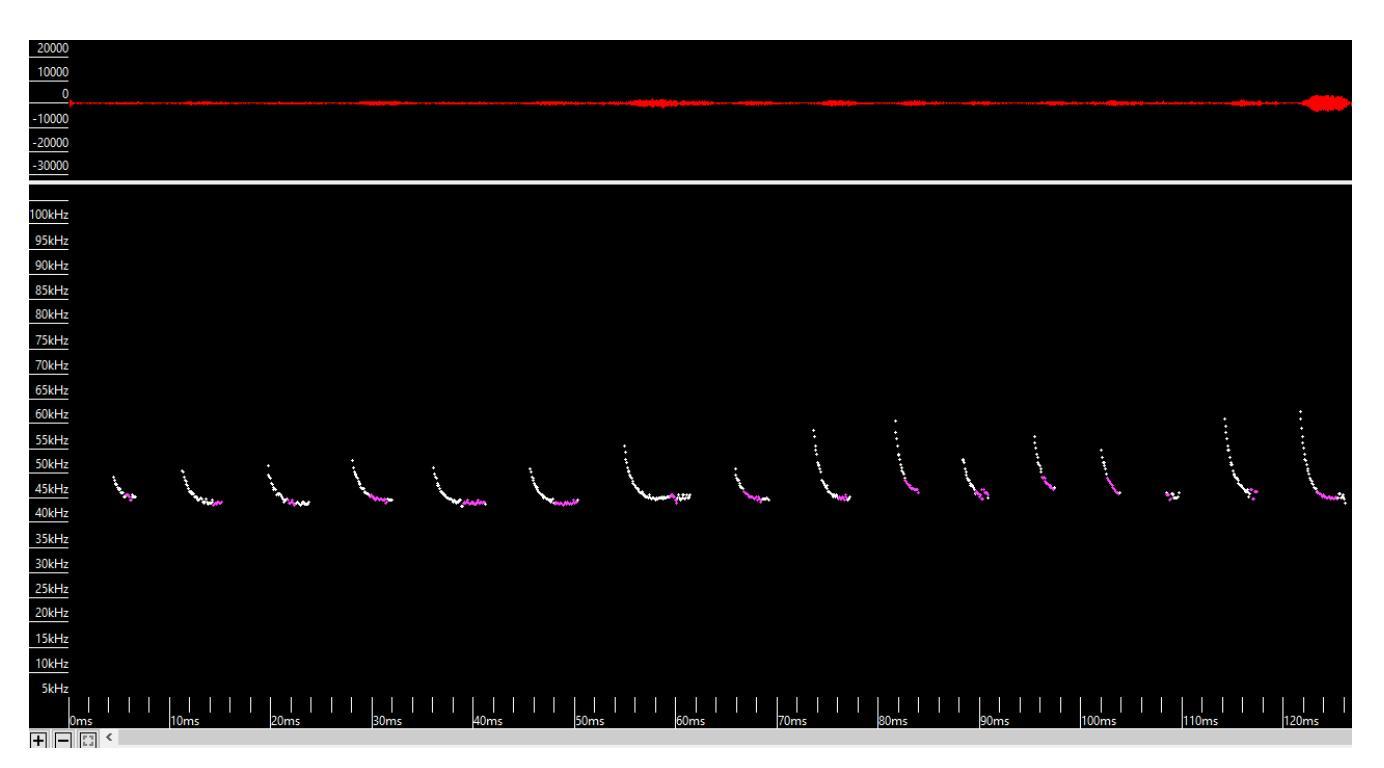
Sonogram 1 – Common pipistrelle foraging calls recorded along the eastern boundary of the site.

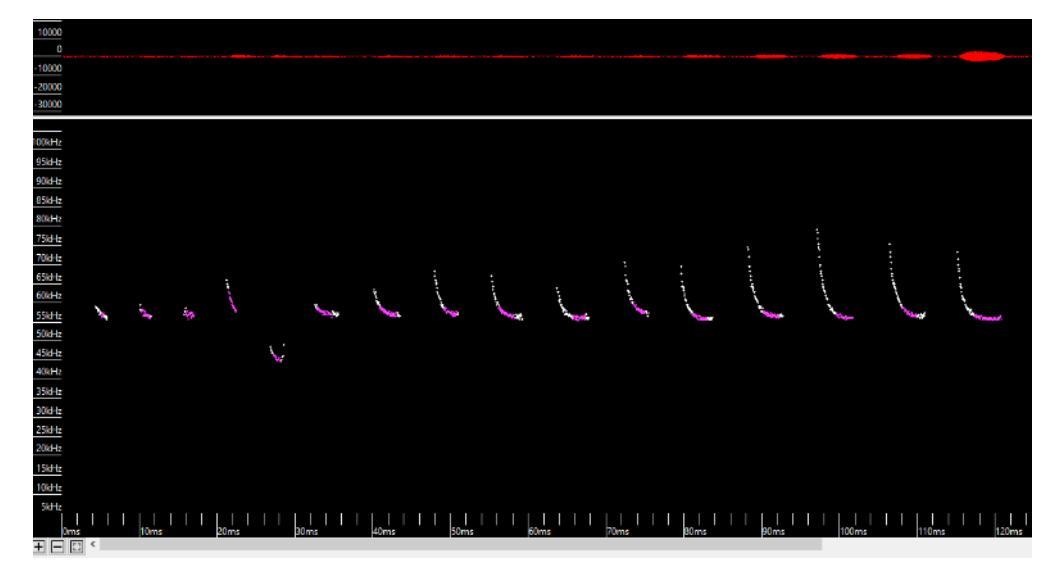
Sonogram 2 – A soprano pipistrelle bat call, bat was observed foraging over Dam Lane.
