ST JOHN'S SCHOOL, WETLEY ROCKS.

BAT SURVEY REPORT.

Ref No: 180948.

Date: 21^{st} September 2018.

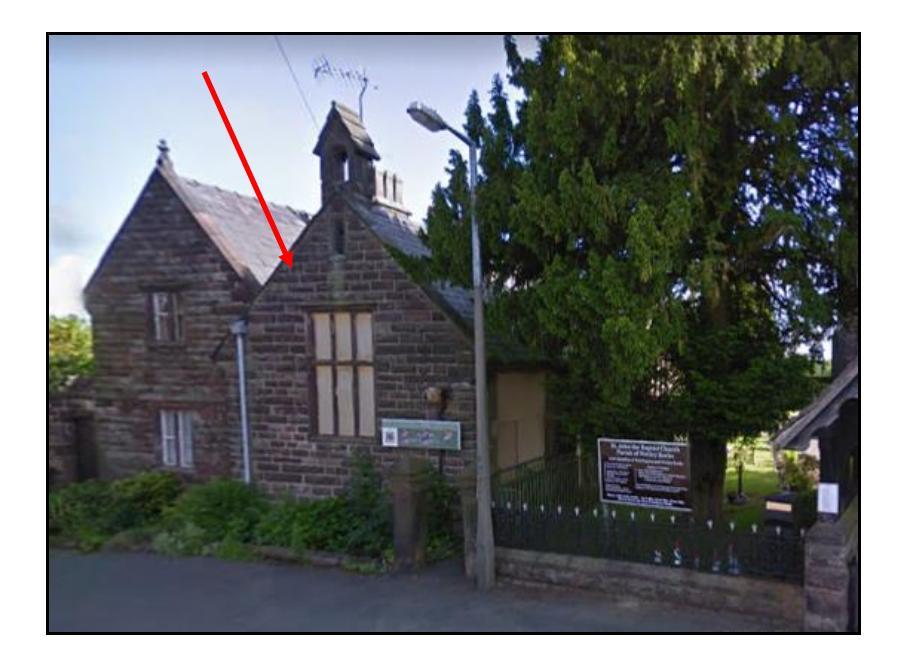
3.3.1.1. The school is a traditional village school constructed with coursed stone walls and a pitched, slate covered roof. The photograph below shows the southern aspect onto Mill Lane.

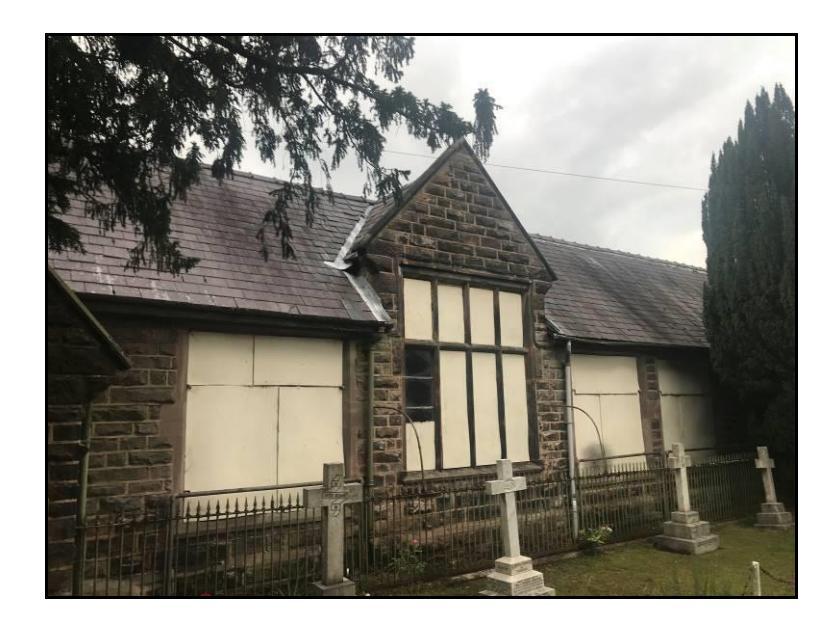
3.3.1.2. The building is single storey with traditional high ceilings for the school hall and classrooms. There is a central dormer window on either side of the building. Most of the windows are boarded up.

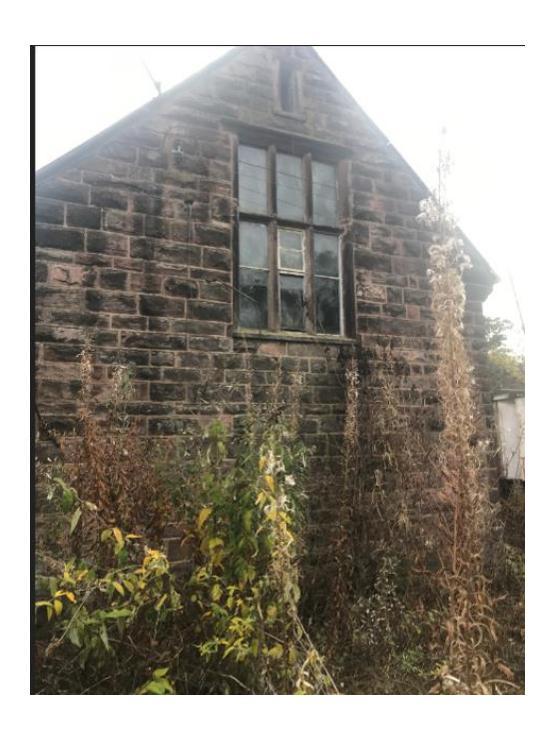
3.3.1.3. The back of the school is a large window that has not been boarded up.

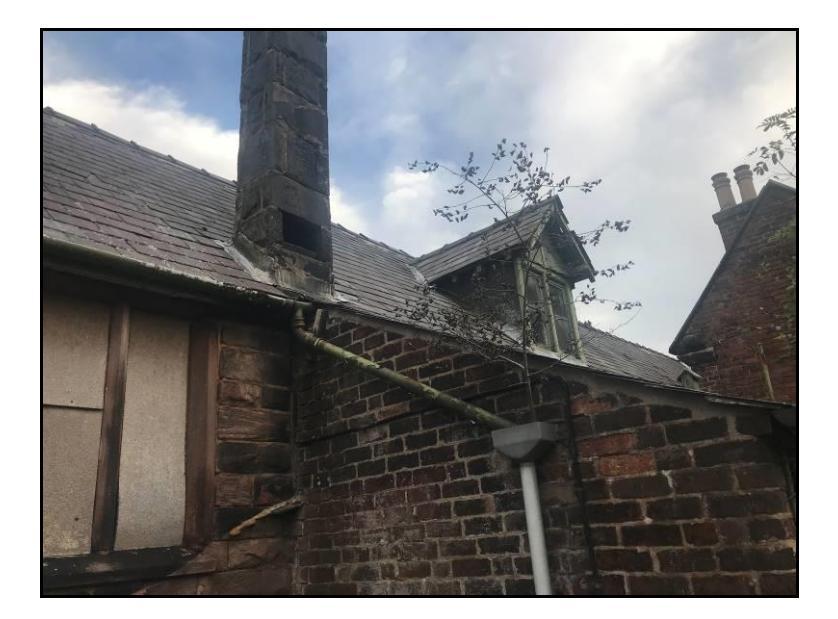
3.3.1.4. There is a narrow strip of land down the western side of the site with portable cabins along the boundary. There are also lean-to extensions that are in a poor state of repair, particularly the roofs.

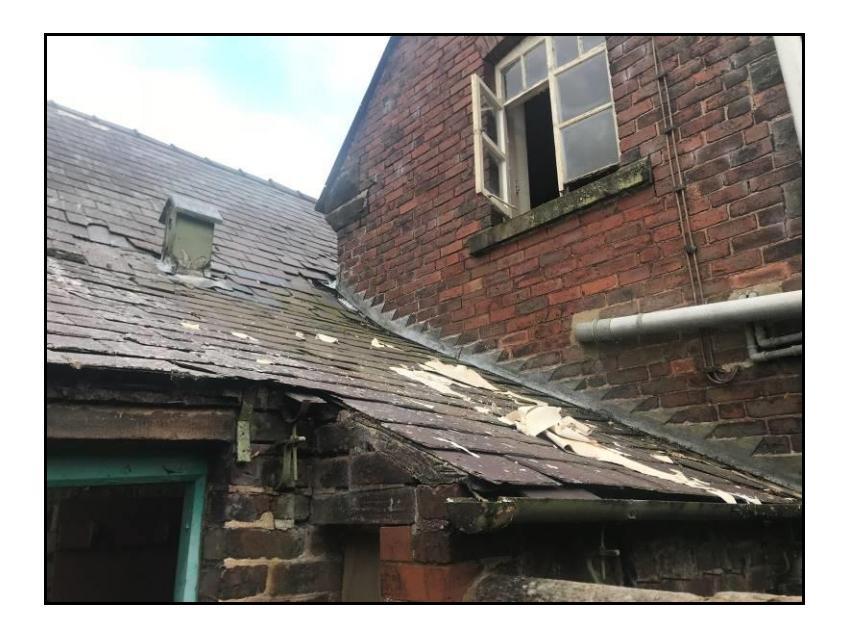
3.3.1.5. The roof around the back of the schoolhouse is in a poor state of repair with slipped and loose slates as can be seen below. The school inside is very damp and the parquet floors are distorted and buckled due to the ingress of water.

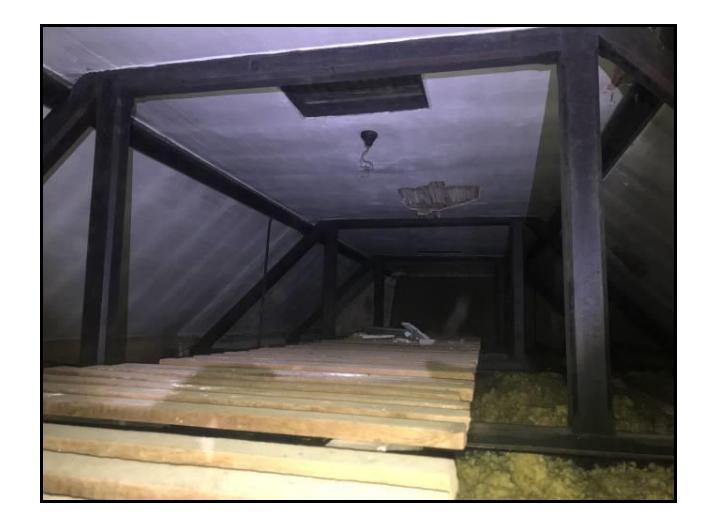
3.3.1.6. Inside the building there is a central landing accessed by a ladder. From the landing, two attics can be seen leading off in either direction, to the front and back of the school. The upper attic is the original loft area above the original school rooms. These have been underdrawn with a suspended ceiling and this has created the second, lower attic space. The photograph below shows the lower attic above the suspended ceiling with a boarded walkway for access.

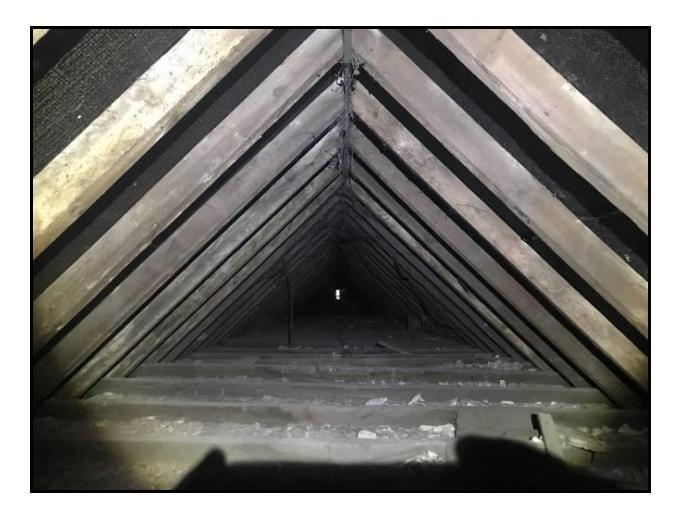
3.3.1.7. Above the original ceiling there is the upper attic, as shown in the photograph below. The underside of the slates is lined with an old bitumastic felt that is deteriorated and ripped.

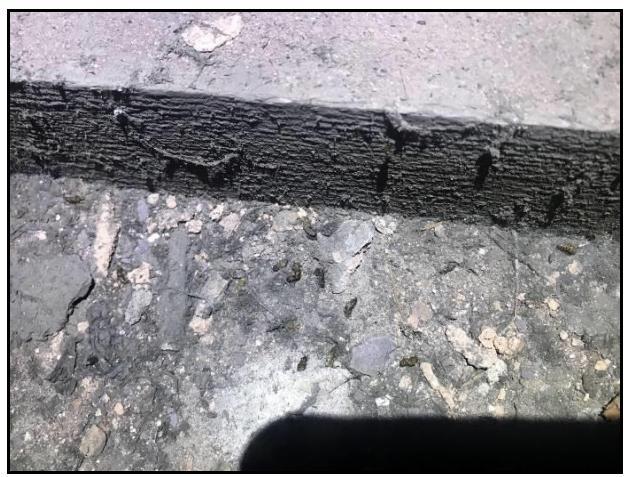
3.3.1.8. During the day time survey a bat was seen flying within the upper attic space and bat droppings were found on the floor.

3.3.1.9. The School building was therefore assessed to have a **high** potential for small numbers of roosting bats.

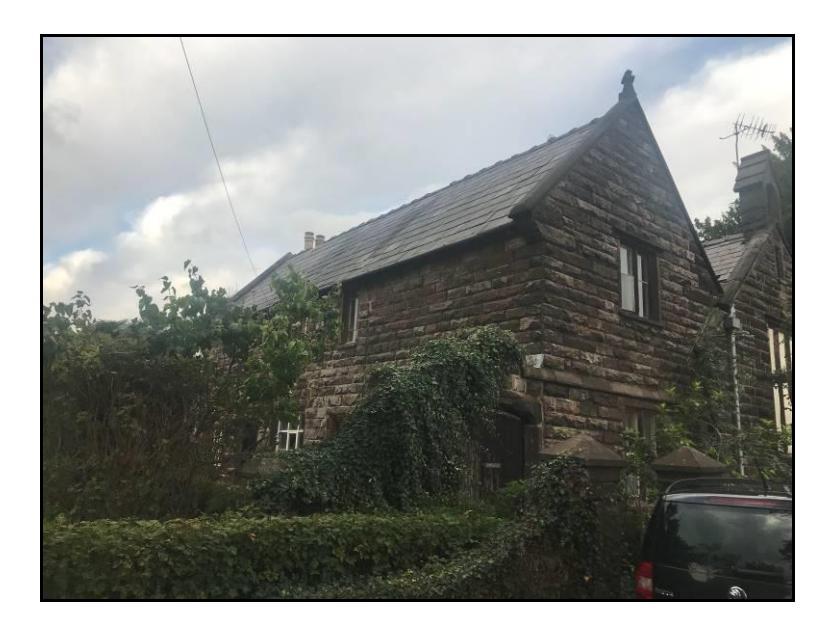
3.3.2.1. The schoolhouse is a two storey dwelling house connected to the school building. It is a two storey building with coursed stone walls and a pitched, slate covered roof.

3.3.2.2. The walls are in a good condition although the window frames are rotten providing gaps for bats to access the building.

3.3.2.3. There are slipped and missing roof slates although the valley between the house and the school roof is impossible to see from ground level.

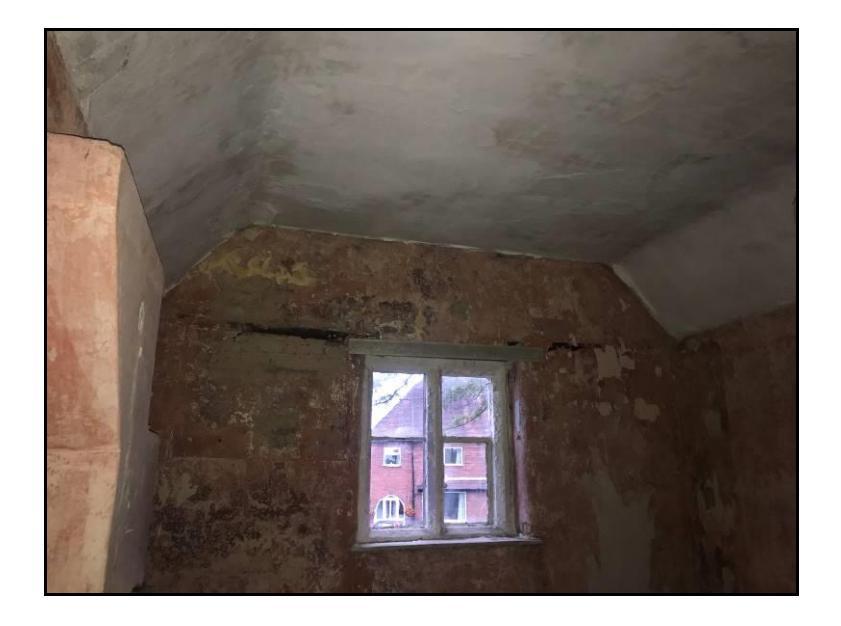
3.3.2.4. Inside the house the top floor rooms extend into the roof space leaving a very low loft space. This loft space was totally inaccessible with no loft hatch anywhere in the ceilings.

3.3.2.5. The schoolhouse building is assessed to have a **medium** potential for roosting bats.

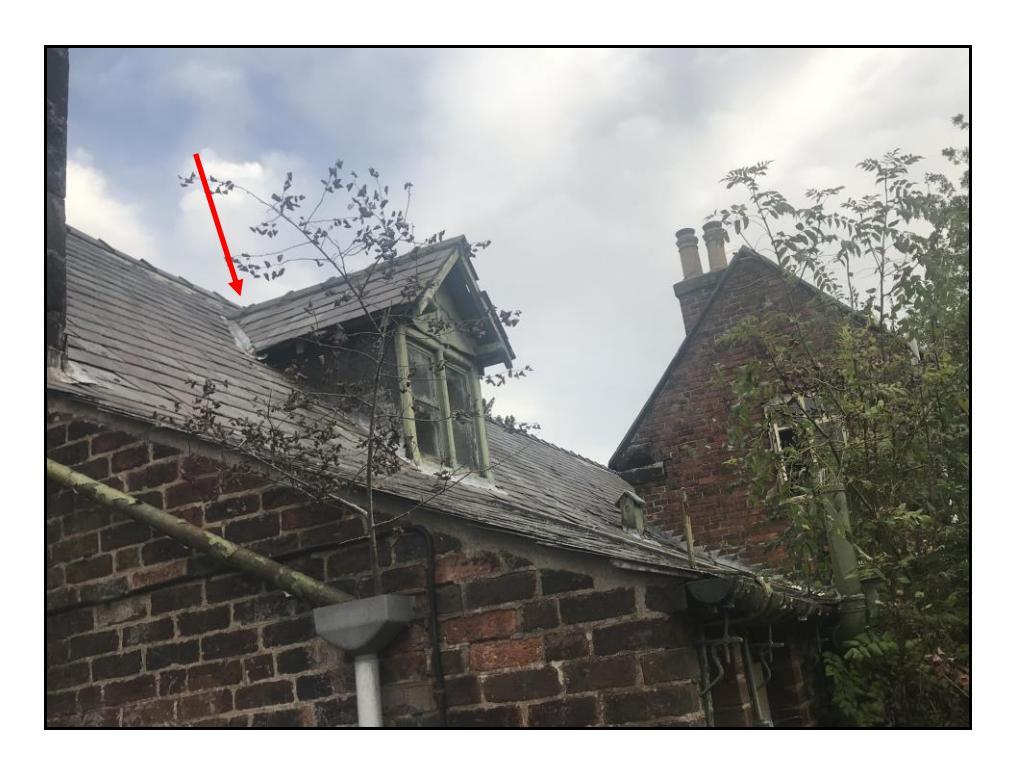
3.5.7.1. Three Myotis bats swarmed around the roof of the school and eventually entered roosts in the top of the dormer window on the west side of the school.

5.1. Because Common Pipistrelle, Whiskered/Brandt's and Brown long-eared bat day roosts have been identified in school buildings, it will be necessary to apply for and be granted a Natural England EPS licence before works can commence.

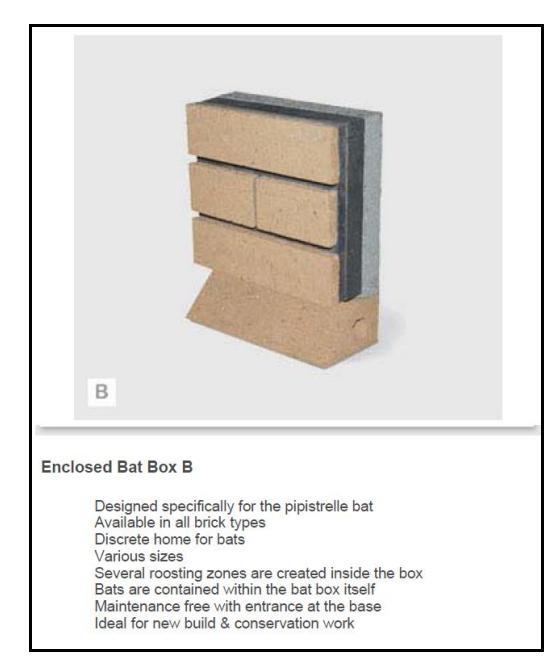
5.5. Common Pipistrelle and Whiskered/Brandt's roosts can be easily provided by incorporating an integral bat brick in the outer wall of the development. The back wall of the existing schoolhouse would be a good location as that wall is brick and also within the new houses to be built on the site. A typical bat brick is as shown below.

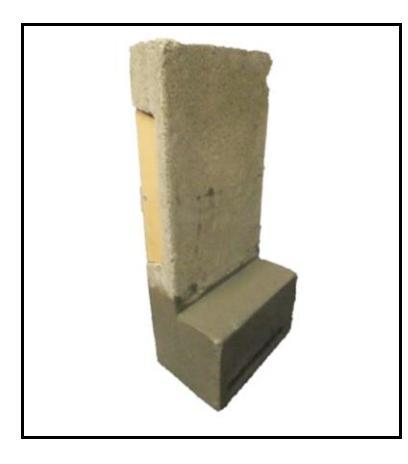
5.6. Alternatively, or additionally, the bat tube shown below can be built into a stone wall and faced with stone to provide roosting opportunities in stone walls.
