Desk Study Report

Former Hope & Anchor Pub,

off Leek Road, Cellarhead,

REPORT NO: 13SEC001/DS

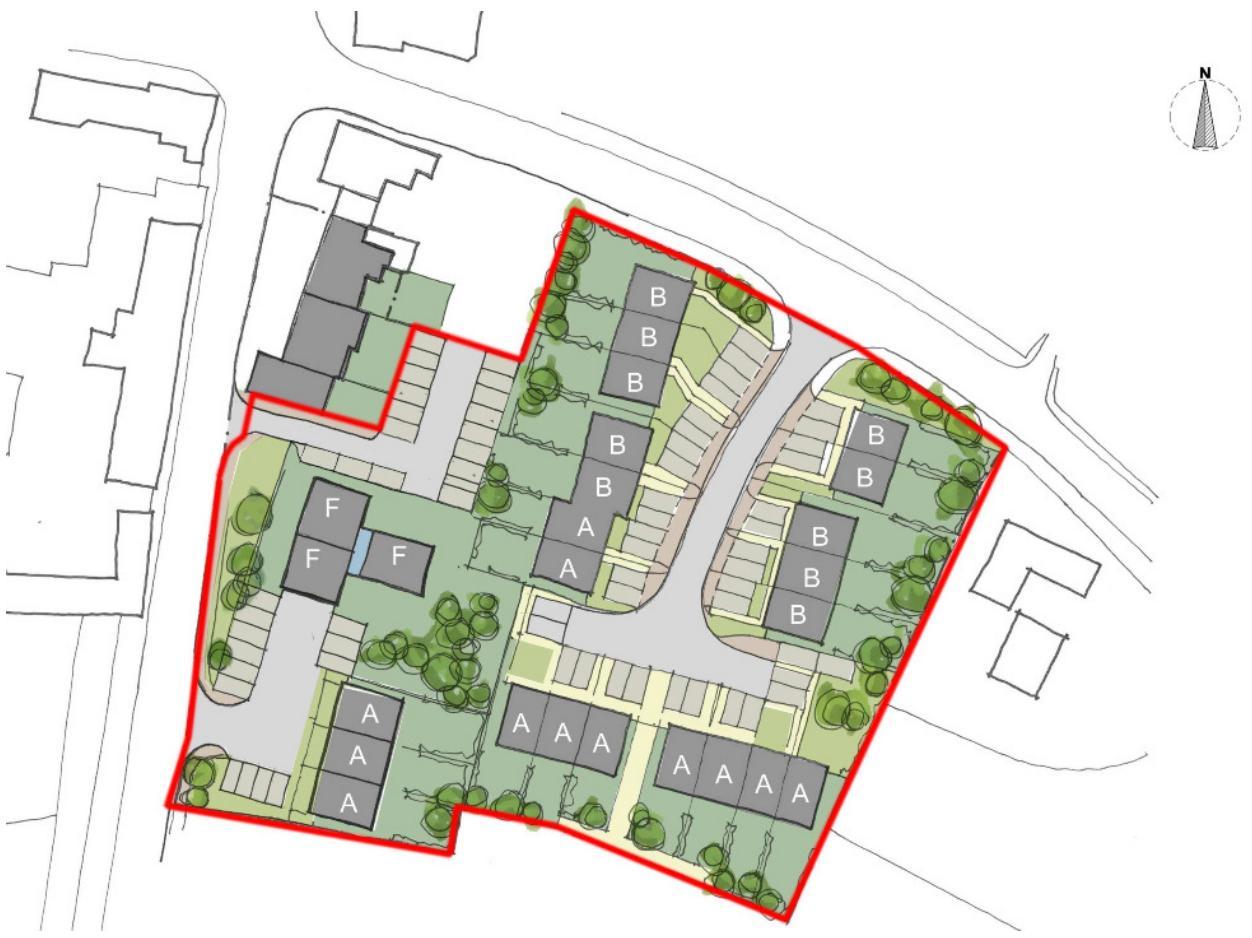
Hope and Anchor PH Proposed Site Plan @ 1:1500 Rev. B by John McCall Architects

The proposed development comprises the construction of residential properties with associated gardens, hardstanding and infrastructure.
