# Preliminary Ecological Appraisal

Endon Riding School, Staffordshire

July 2013

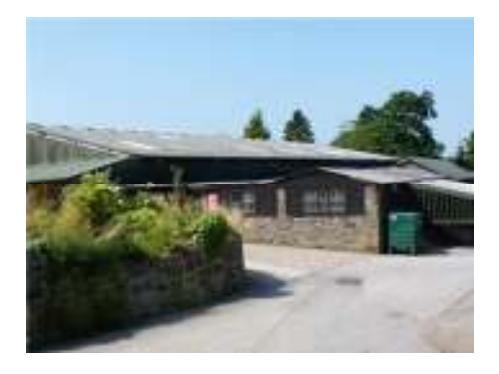
4.6 On the south-west part of the site is a large complex of metal corrugated sheet buildings. The internal roofing is all open to roof level. Many of the buildings are open-fronted structures which are deteriorating. The largest building, currently used for equines, has a number of sky lights, thus has a low potential for bats.

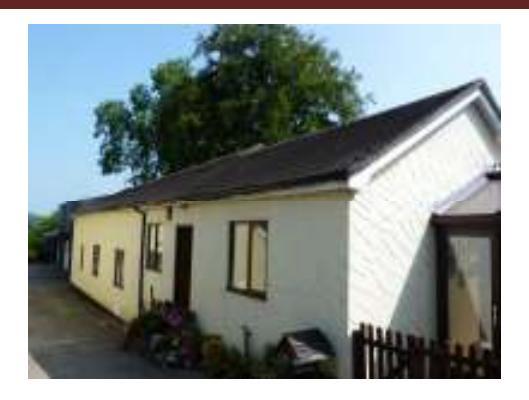
Target Note 9

4.7 Dwelling 1 is located immediately to the south of the main access drive. The building is a twostorey, rendered brick construction with three gable ends aligned north, south and west. It forms part of a curtilage of farm buildings considered to have been built pre 20th century. The overall dimensions of the building are approximately 16 m long x 14 m wide. The roof is of a pitched and tiled design, and appears to have some gaps under some of the ridge tiles and a number of missing, lifted tiles. This building has medium potential for bats.

Number	Target Note
1	Mature oak tree with crack running along trunk; potential for bats.
2	Common alder with a number of cracks and woodpecker holes; potential for bats.
3	Mature oak tree with cracks and woodpecker hole; potential for bats. Indian balsam.
4	Stone-structured bridge running over stream; potential for bats.
5	Semi-improved grassland margin with brash woodpile; ideal for sheltering/basking reptiles.
6	Semi-improved grassland margin; ideal for sheltering/basking reptiles.
7	Semi-improved grassland margin; ideal for sheltering/basking reptiles.
8	Indian balsam.
9	Residential building with various egress points for bats.
10	Residential building with various egress points for bats.

- 5.14 The two dwellings, bridge on site are assessed to have at least moderate potential for roosting bats, but no internal survey was undertaken at the time.

- 5.15 In order to identify if any bat roosts are present, further bat surveys are required. They should include internal and external building inspections of the farmhouse and garage and the disused garage. Depending on the nature of the development (e.g. if demolition is proposed), it is likely that at least two dusk emergence/dawn surveys of the buildings should also be undertaken, spread throughout the peak breeding season (May to August inclusive). These surveys should be combined with general activity transects around the site to assess the level of bat activity and identify any important foraging areas or commuting routes.

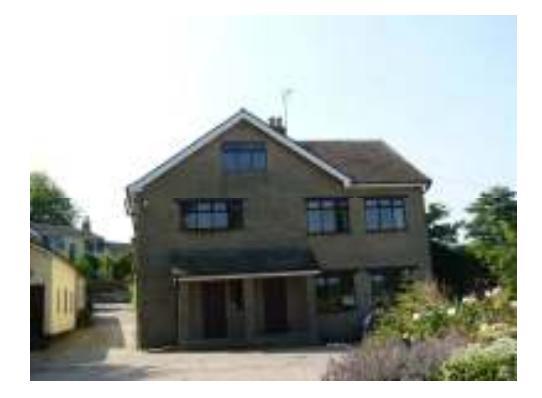
Target Note 10

- 4.8 All windows and doors are intact, preventing any potential access for bats or birds.
- 4.9 Dwelling 2 is located immediately to the east of the main access track. The building is two-storey and constructed similarly to building 1, with brick rendering. The majority of the gable ends are aligned north to south and east, with an attached flat roof on the east elevation. It forms part of a curtilage of farm buildings and is considered to have been built pre 20th century. The overall dimensions of the building are approximately 23 m long x 8 m wide. The roof is of a pitched and tiled design and appears to have some gaps under some of the ridge tiles and a number of lifted tiles. There are sky lights in the roof, which may indicate that there are living areas within the roof void. This building has medium potential for bats.

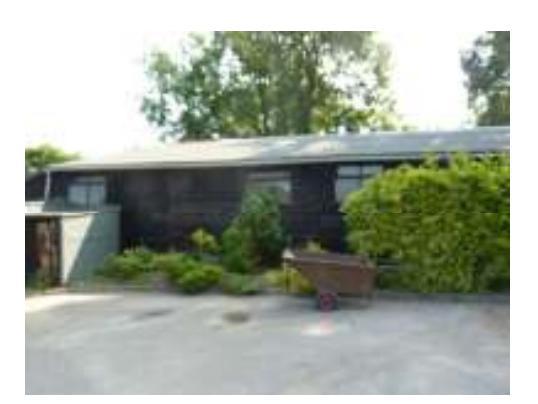
- 4.10 All windows, doors and soffits are tightly fitted, preventing any potential access for bats or birds.
- 4.11 The wooden stable has a felt shallow-pitched roof. The open stable doors allow potential bat access to the interior. However, the inside of the stable is light and draughty due to the half-open stable doors.
- 4.12 There is an overhang at the front of the stable providing a small triangular space between the wood panels and the felt roof, and there is a hole in the wood which could give potential bat access to this space. This building has low potential for bats.

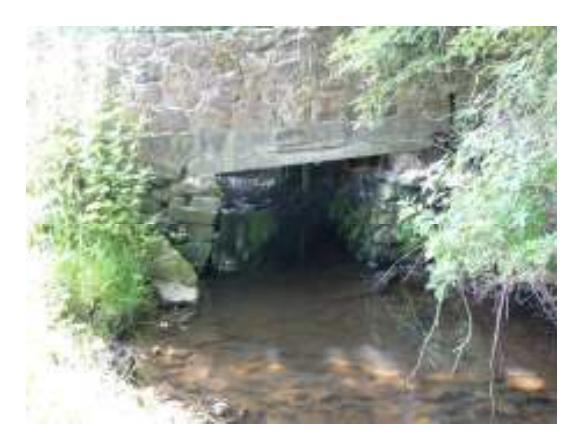
Target Note 4

4.13 There is a stone bridge situated over the running stream which connects the site. The stone structured bridge has a number of crevices which bats could use for roosting. It was also noticeable that this bridge is not regularly used by vehicles, which cause disturbance such as noise and vibration. It is only used by the occasional tractor and walking horses, thus noise and vibration are minimal. In addition, part of the stream is slow running and may provide a food resource, and the linear features of the trees may be favourable as commuting features for bats. The bridge has medium potential for bats.

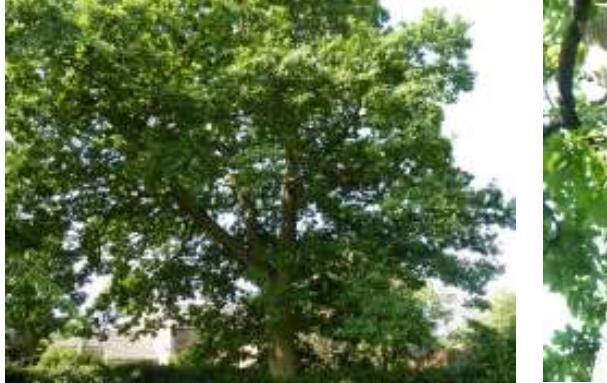
Target Note 1

4.18 There are occasional mature trees present on site, including beech (*Fagus sylvatica*), ash (*Fraxinus excelsior*), English oak (*Quercus robur*), Alder (*Alnus glutinosa*) and common cherry (*Prunus padus*).

- 5.16 There are three trees on site which are assessed to have high potential for roosting bats. These trees should also be surveyed using dusk/dawn survey methodology.

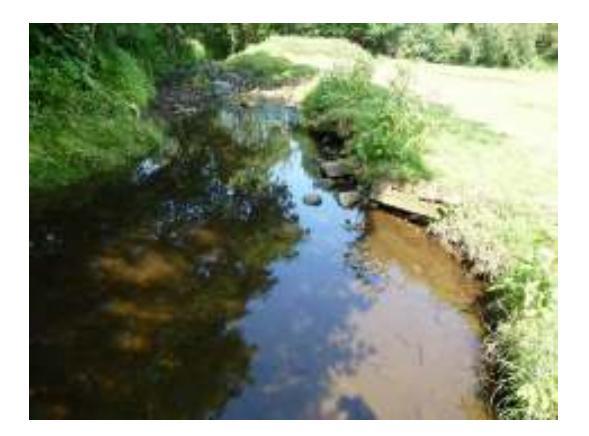
Potential for water vole and otter

4.22 Although the stream is not within the site boundary, it is considered necessary to include it in this report, as it could be affected by any change in site use. The stream is slow flowing with some deeper pools, and ranges from between 1 m and 4 m wide. The estimated water depth is 30–60 cm. The banks are steep and vegetated with grasses and herbs, and in places are lined with stone blocks and rubble. The water appears turbid, suggesting poor water quality. No aquatic vegetation could be seen.

There are records of water voles occurring within 1 km of the site. A search along the bank of the stream found no evidence of water vole, although the habitat appears suitable. There are stony areas with holes and rotten wooden piles along the bank of the stream which could be used by this species, although no evidence such as burrows, droppings or feeding remains were found. An in-depth inspection was not undertaken.

5.24 If the development is likely to affect the stream corridor (including in the form of increased human presence, lighting or increased traffic), an otter survey should be undertaken along the stream (and at least 50 m outside the site boundary either way) to check for any holts or resting sites that may be present. If the species is found to use the stream corridor adjacent to the site, mitigation may be required, and potentially a licence will be required from Natural England if any holt is to be affected.

5.25 If the development is likely to affect the stream or vegetation within 5 m of the banks, a further water vole survey should be undertaken along the stream (and at least 50 m outside the site boundary each way) between March and October. The survey would require walking along the stream and checking both banks to enable close inspection of any holes or other evidence to confirm whether the species is present. If present and potentially affected by the development, a licence from Natural England may be required.
