ARBORICULTURAL REPORT

Site: Westerdale Birchall Lane Birchall Leek Staffordshire ST13 5RA

Client: David and Shirley Jackson-Hulme

Date: 19th December 2014

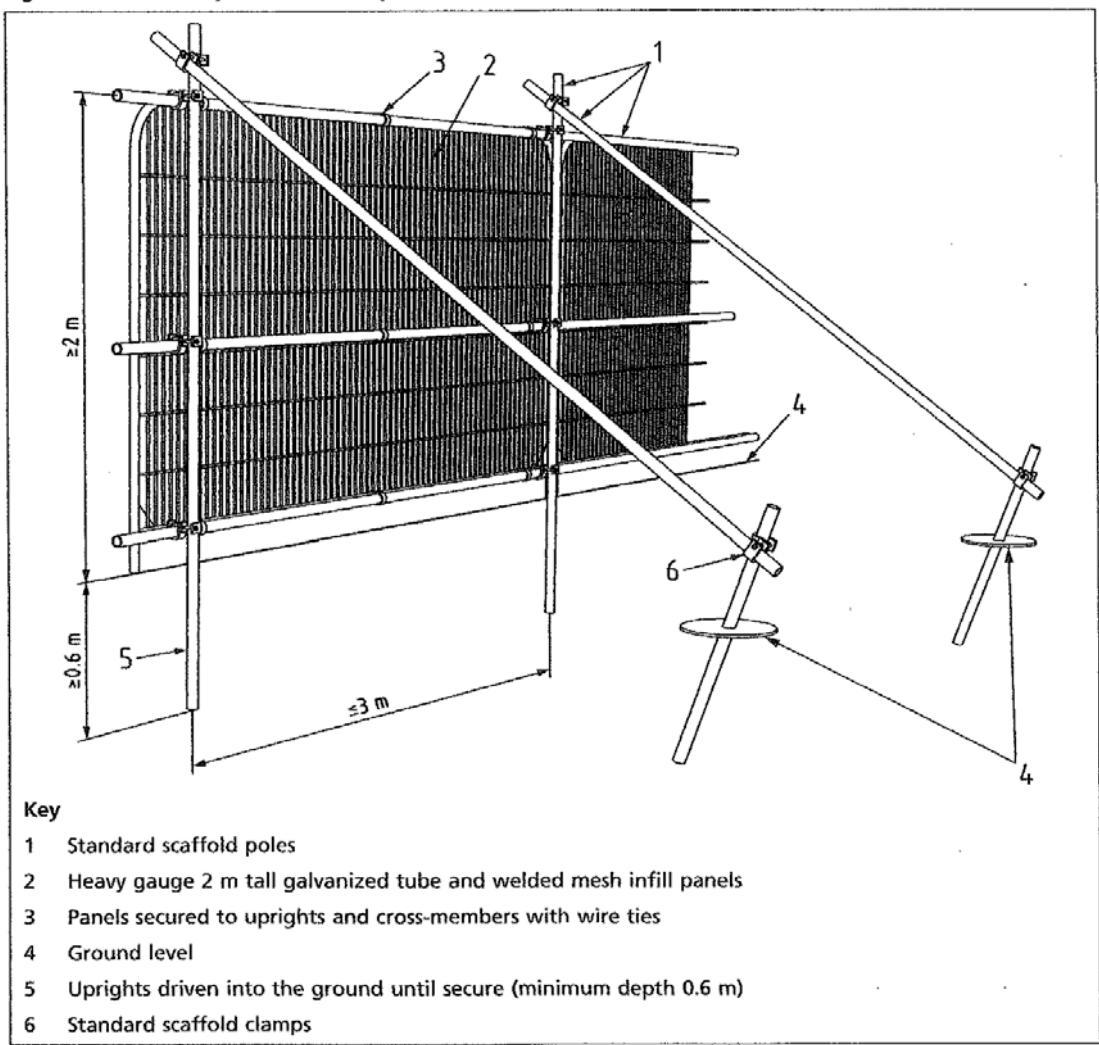
12.0 Appendix B: Tree Protection Barriers

5.3 To achieve an effective CEZ it is necessary to erect a protective barrier along the edge of the RPA. The details of this fencing are shown in Figure 2, which is includes as an appendix (B) to this report. The barrier should be erected a minimum distance from each tree. This minimum distance is provided as a radius in the Survey Schedule and shown on the plan. Is it essential that this barrier is well anchored into the ground to prevent is being moved. It is acceptable to use Herras fencing in concrete or rubber feet and appropriately back braced in area where site circumstance and the associated risk of damaging incursion into the RPA are low.

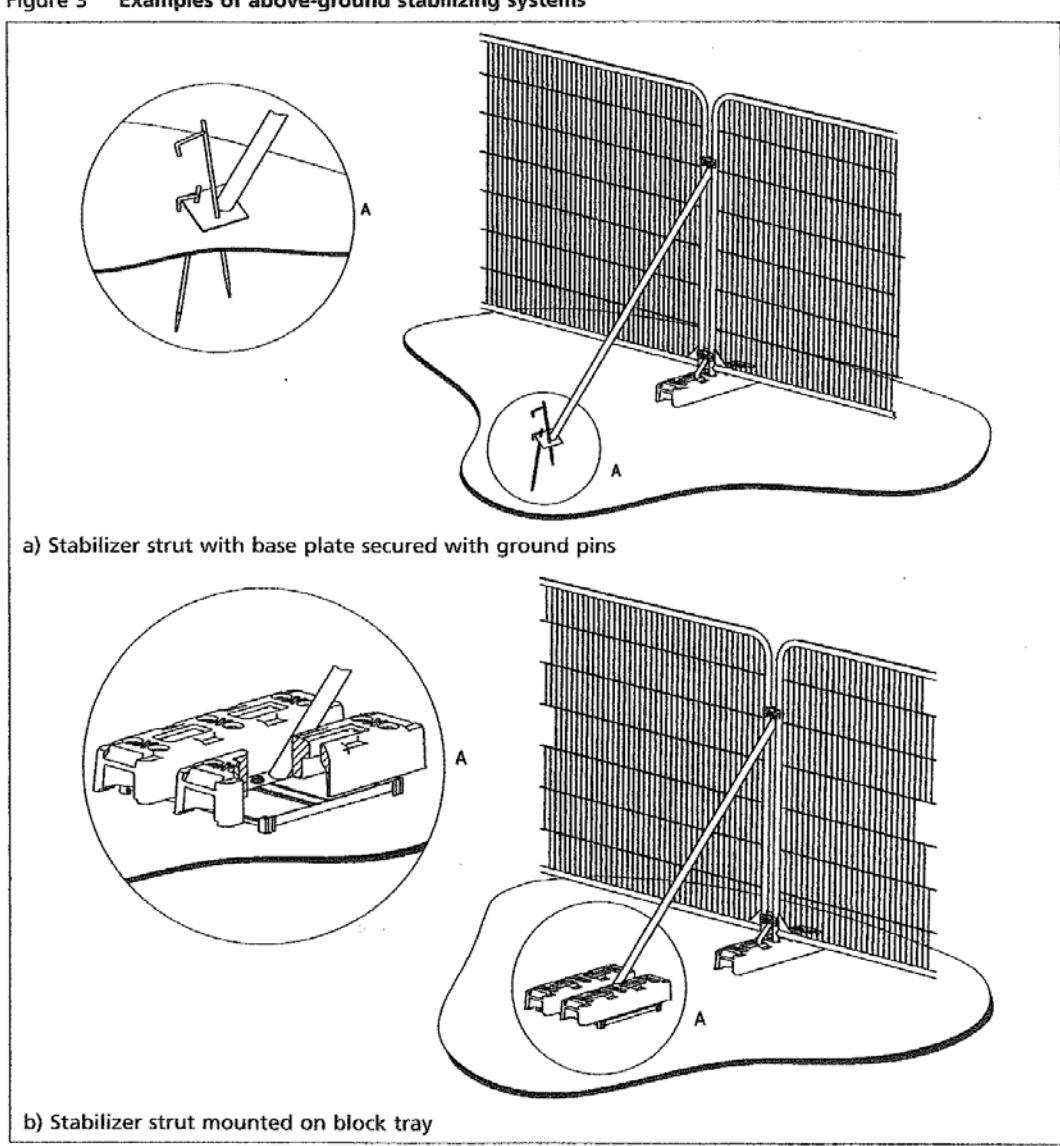
Figure 3 Examples of above-ground stabilizing systems

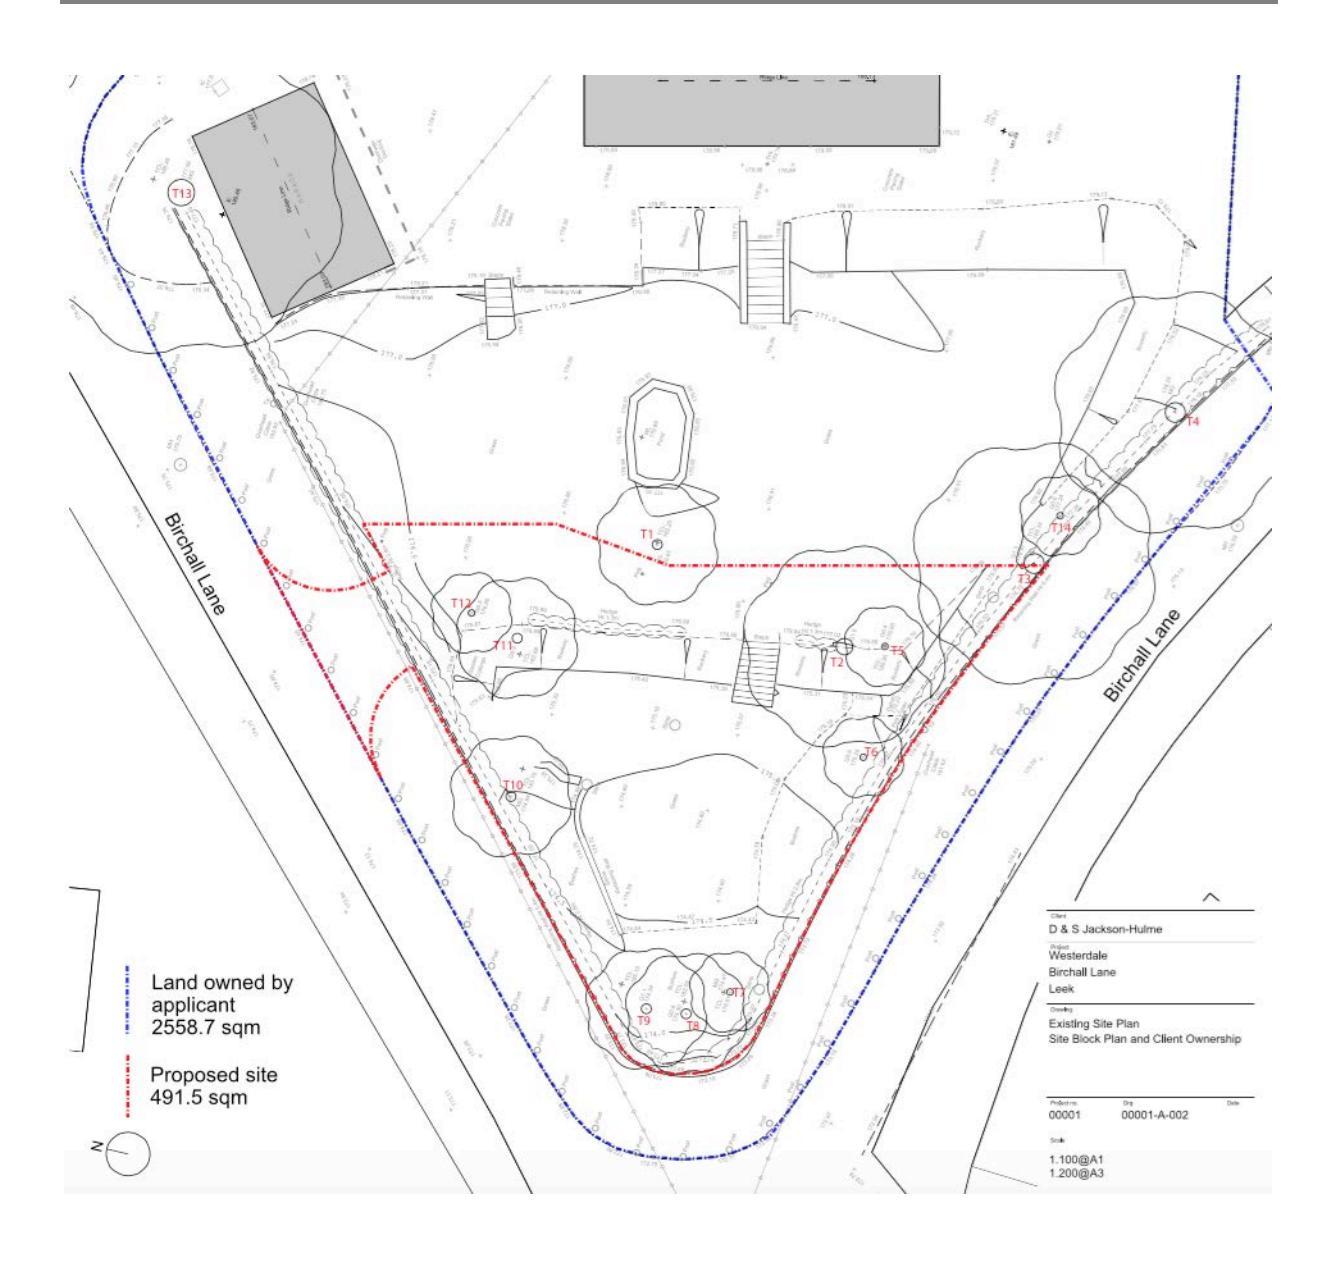
15.0 Appendix E: Tree Constraints Plan and Arboricultural Implications Assessment

proposed that the client sections this part off from the rest of the existing garden to form an independent building plot. The boundary line can be seen in red on the plan in Appendix E.

9.6 It is considered that given the RPA of T1 and the indication of the new boundary that there is sufficient distance for this tree to remain unharmed by any construction works.
